# Black Hills Professional Home Inspections LLC®

### HOME INSPECTION

**Amber Cottman**  
605-219-6573  
6655 Greenfield Dr  
Rapid City, SD 57703  
[ampercottman@yahoo.com](mailto:ampercottman@yahoo.com)

**REPORT**  
11-1-23

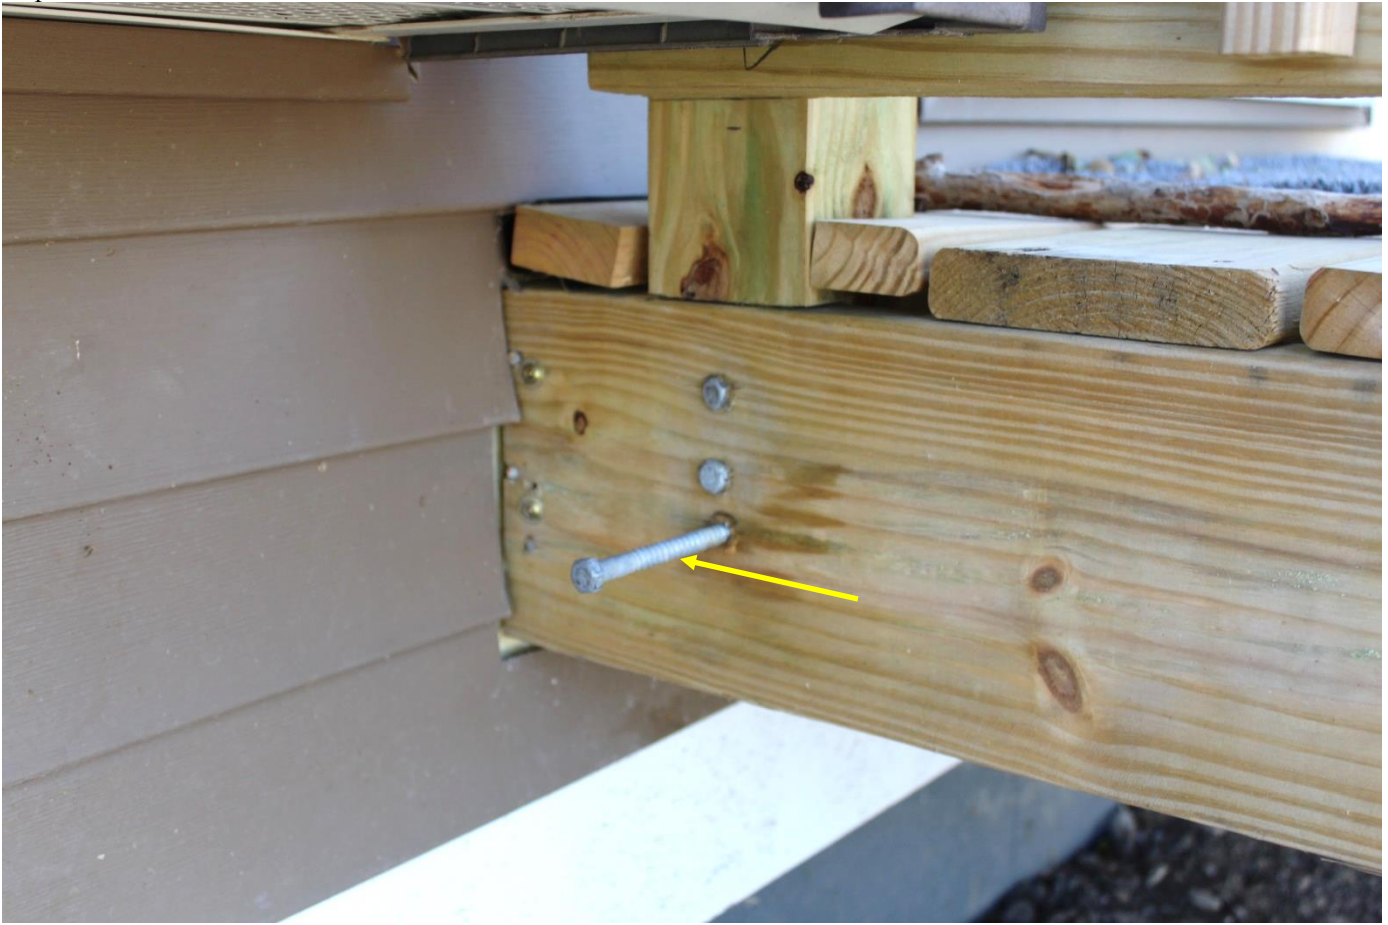
Unprofessional hardware installation noticed.

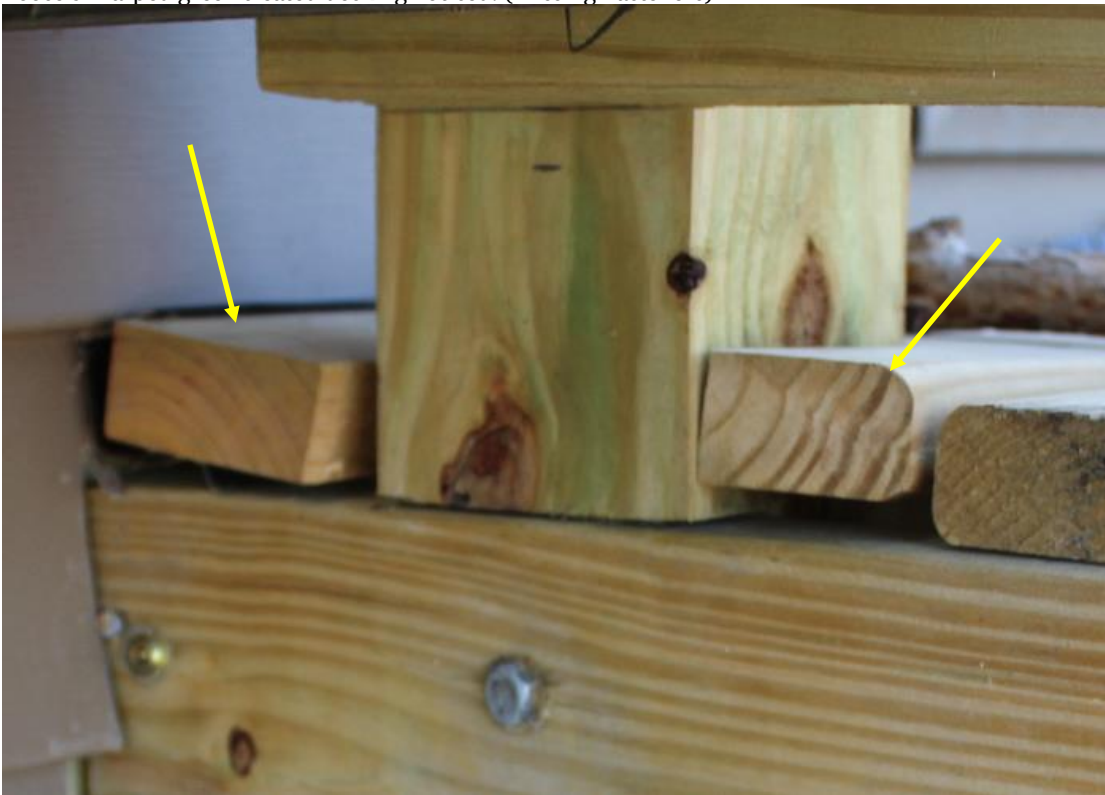
Loose & warped green treated decking noticed. (Missing Fasteners)

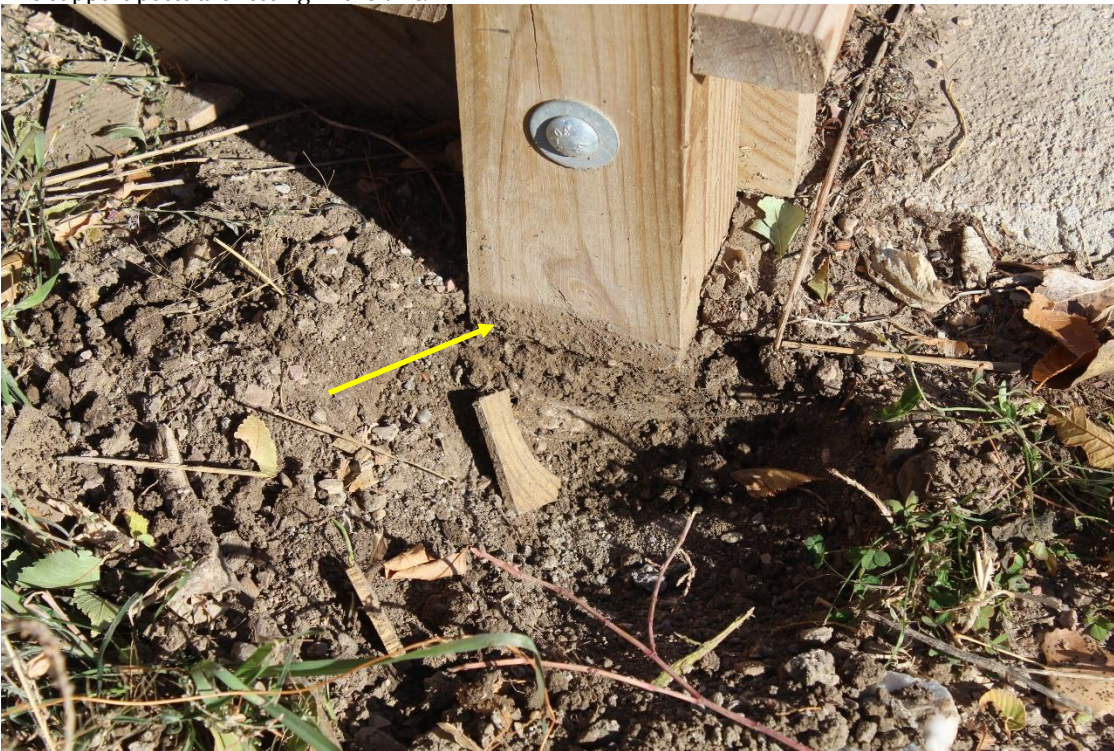
The support posts are resting in the dirt.

Support posts resting in the dirt will wick water into the posts and prematurely rot out the wood. Repair as needed.

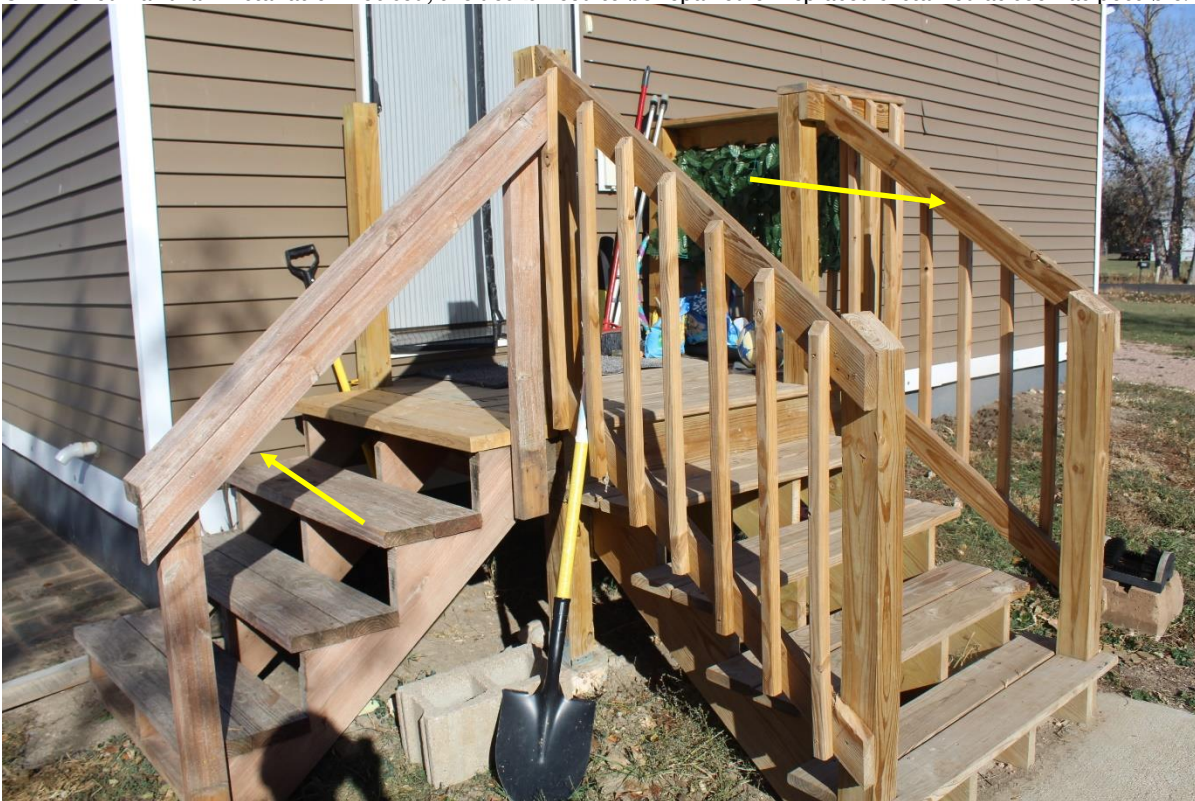
Unfinished handrail installation noticed, the decks need to be repaired or replaced & stained as soon as possible.

Graspable handrails should be installed to the stairs as needed.

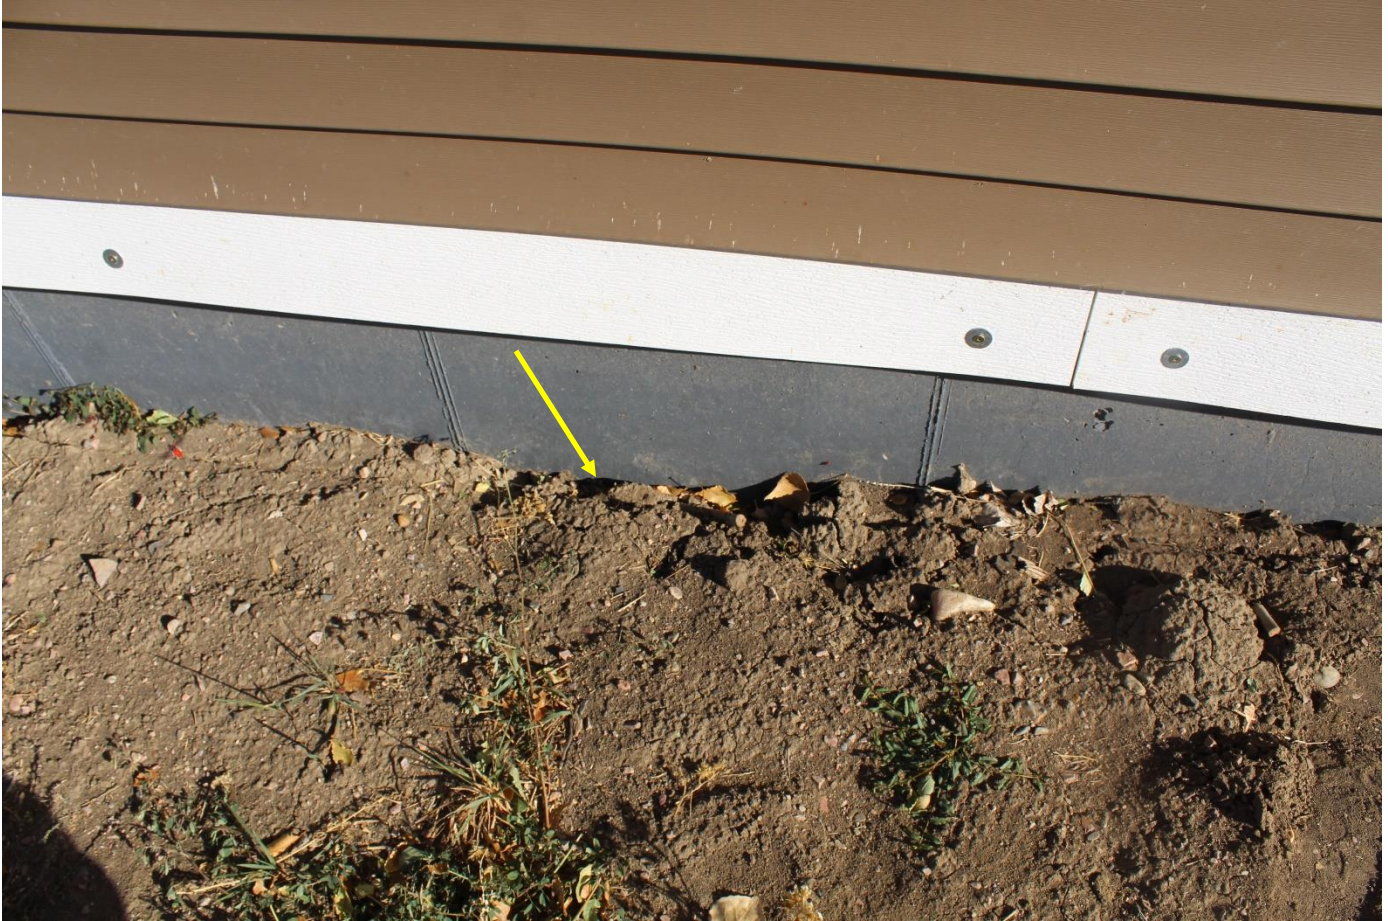
Negative grading noticed around the foundation.

Recommend re-grading the soil to divert water away from the home.

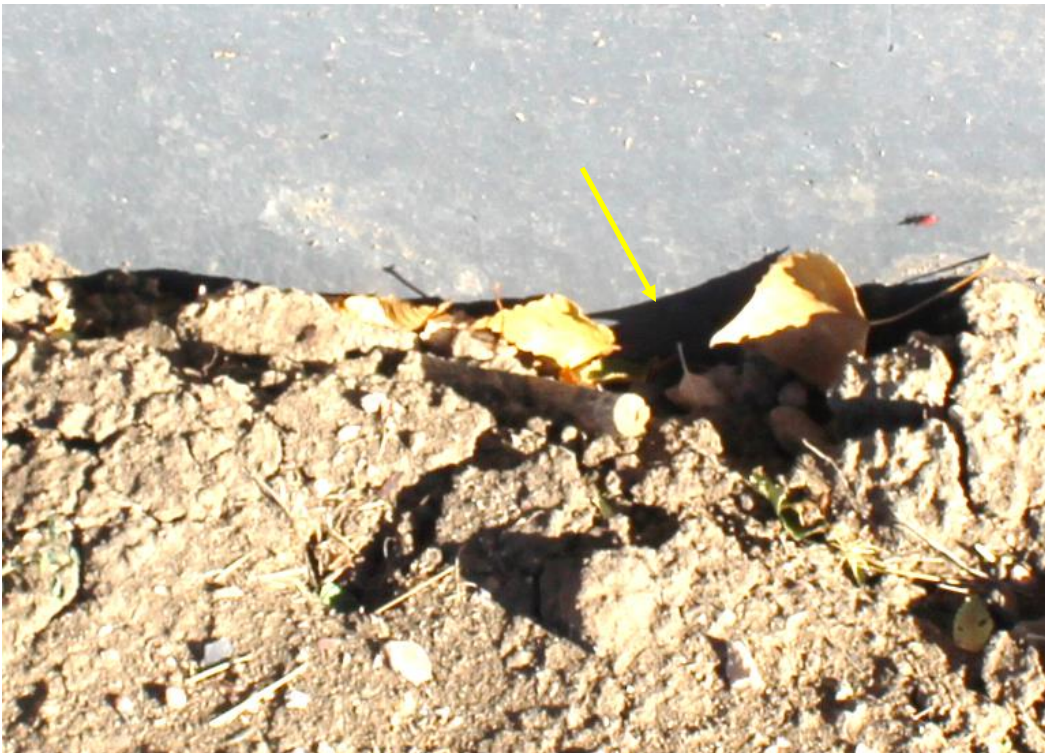
Holes & voids noticed in the dirt next to the foundation.

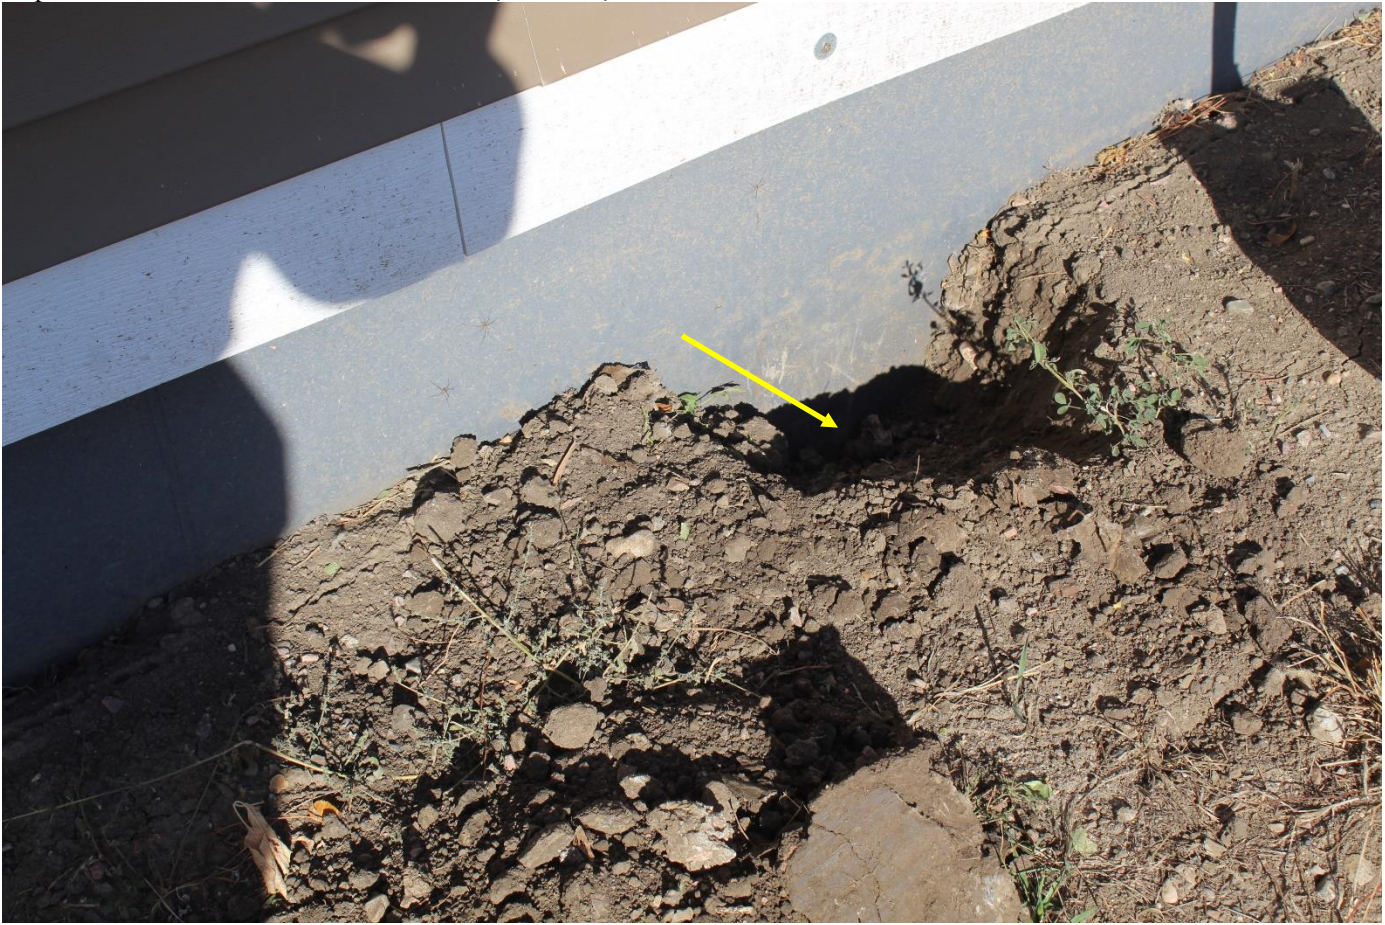
Unpacked soil noticed next to the foundation. (Loose Fill) Low and sunken areas noticed around the home's foundation.

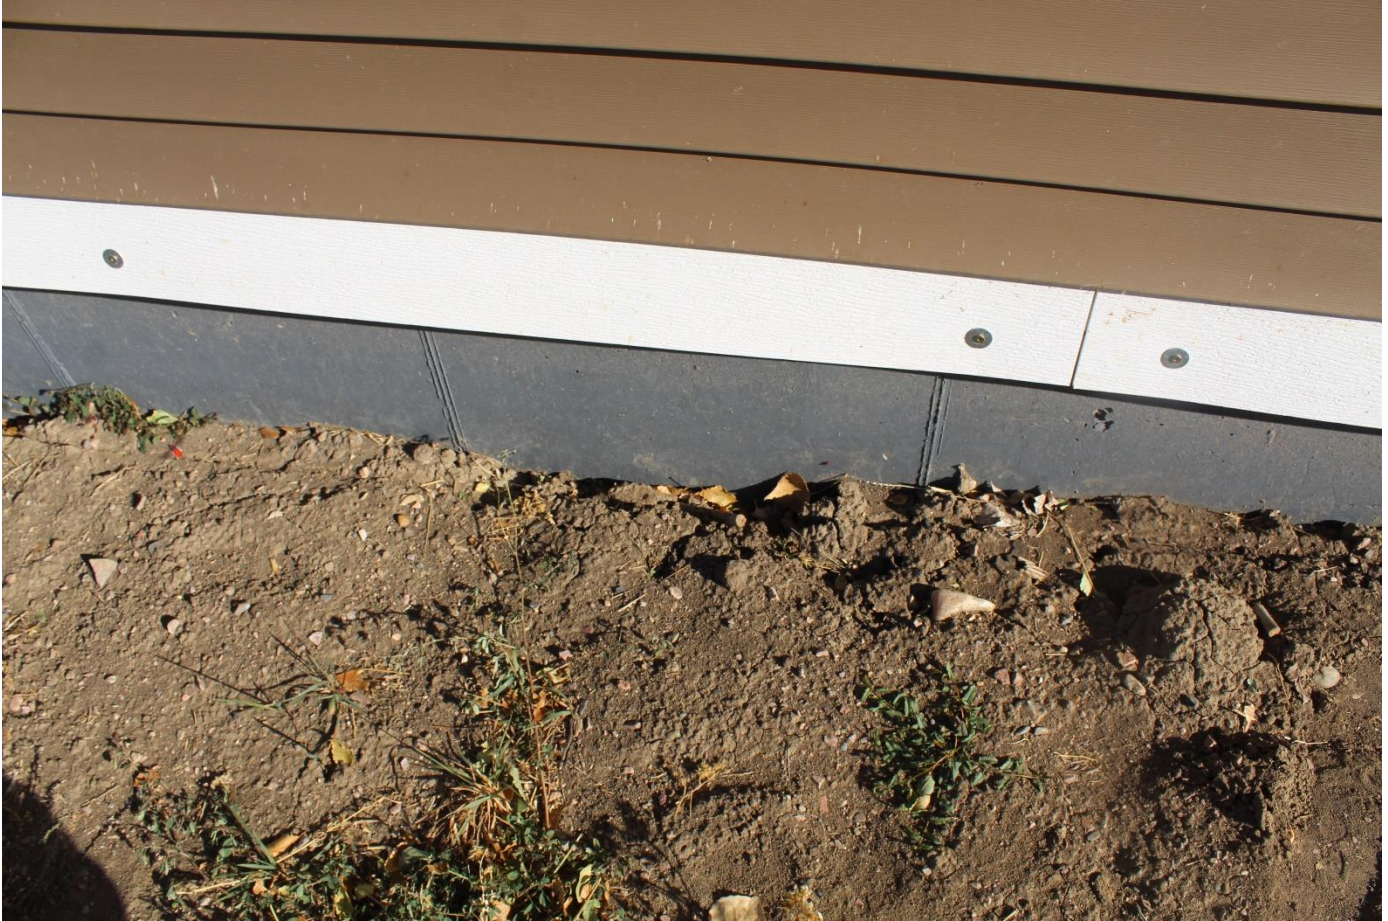
Unprofessional vinyl siding installation noticed.

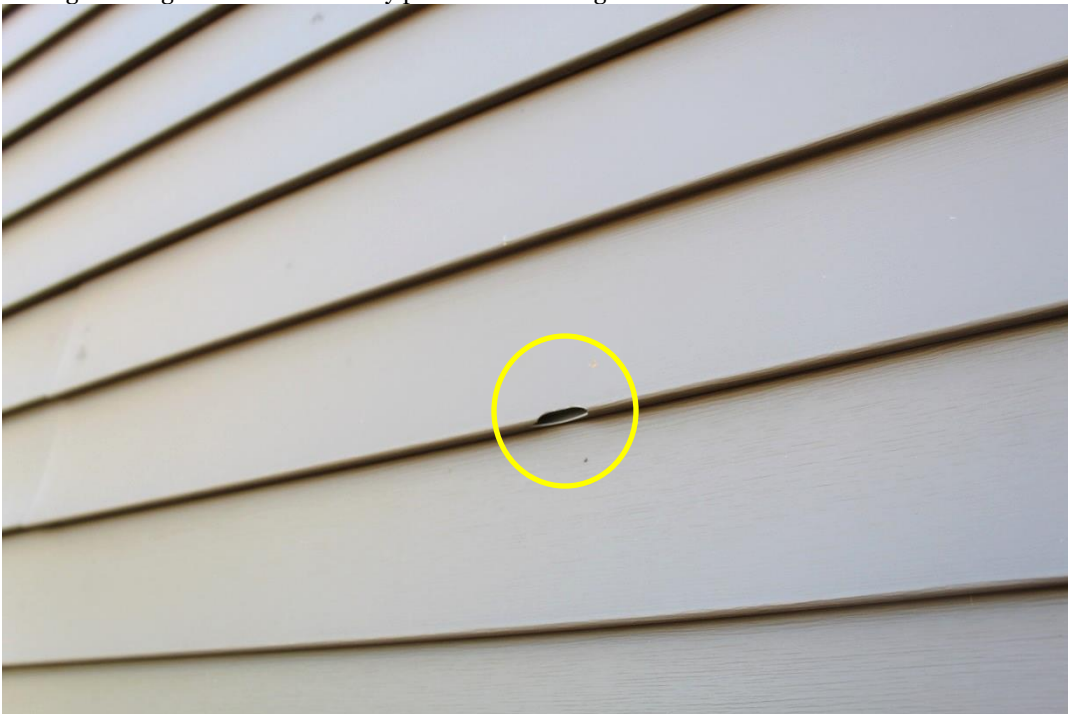
Damaged siding noticed. Water entry points in the siding noticed.

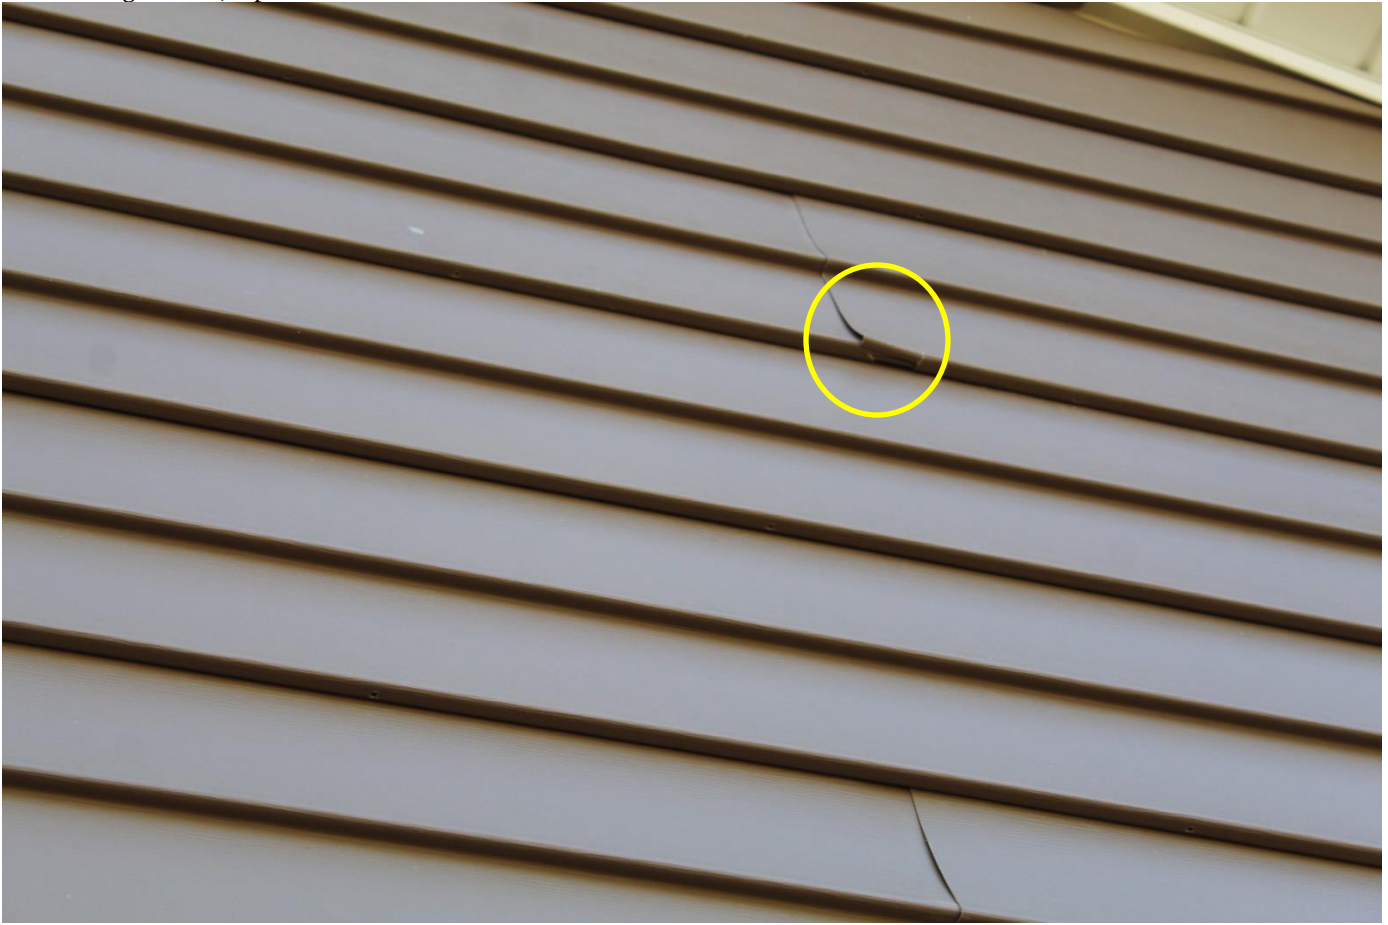
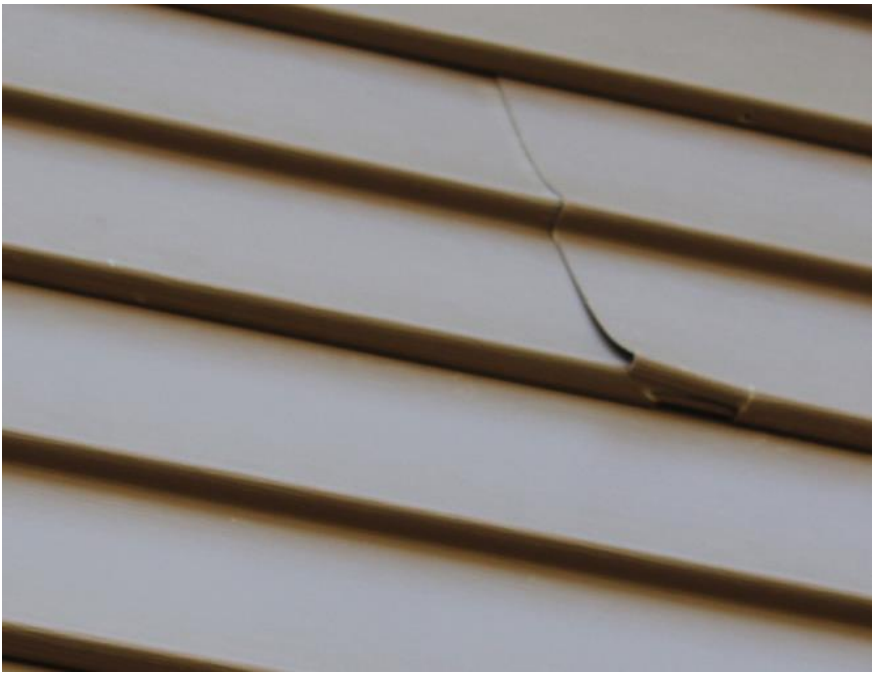
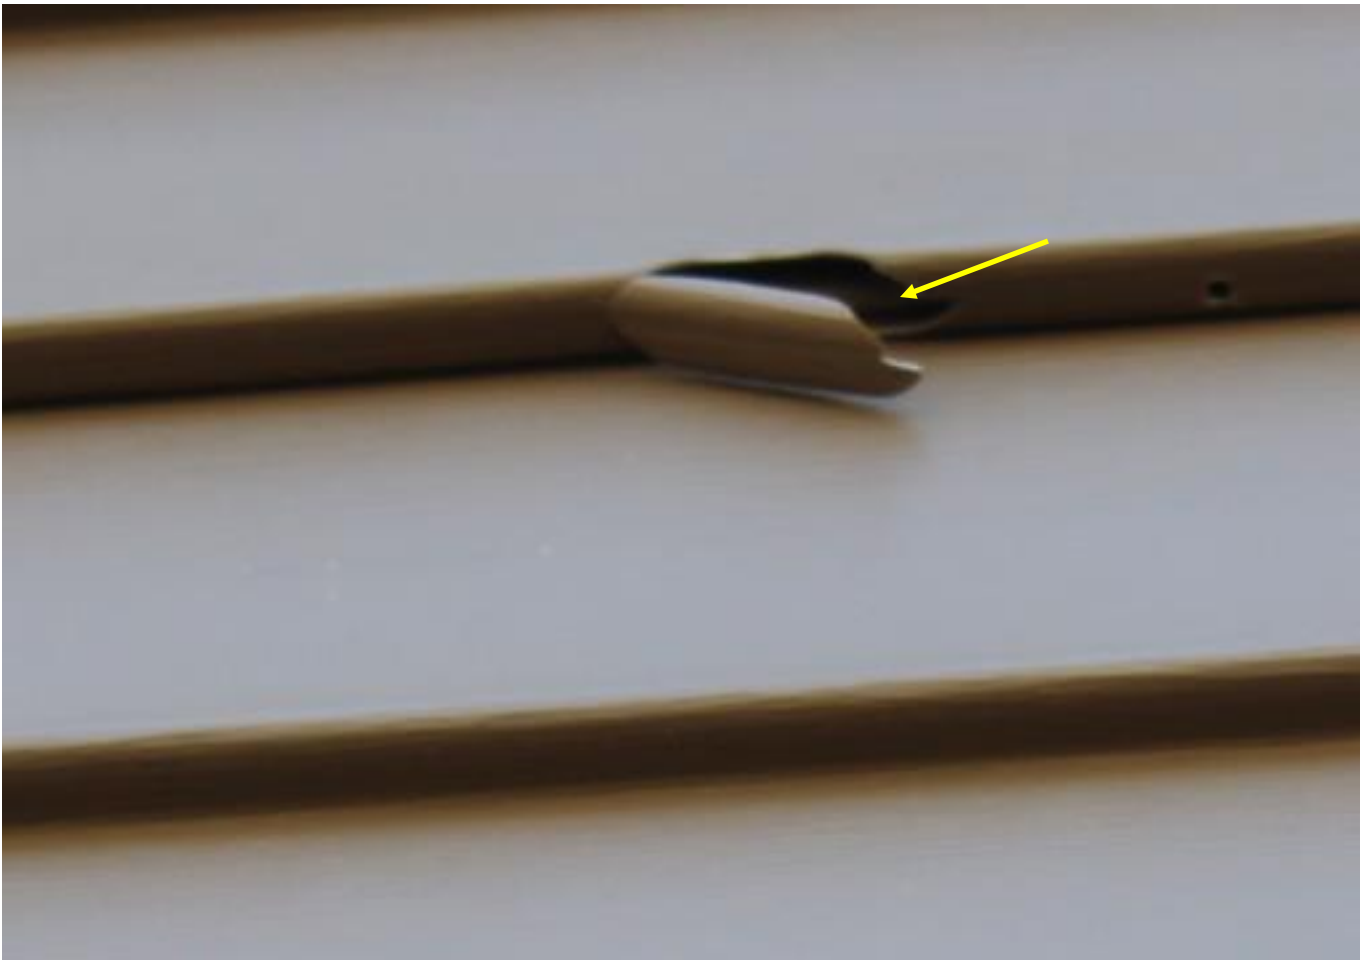
Loose siding noticed; repair as needed.

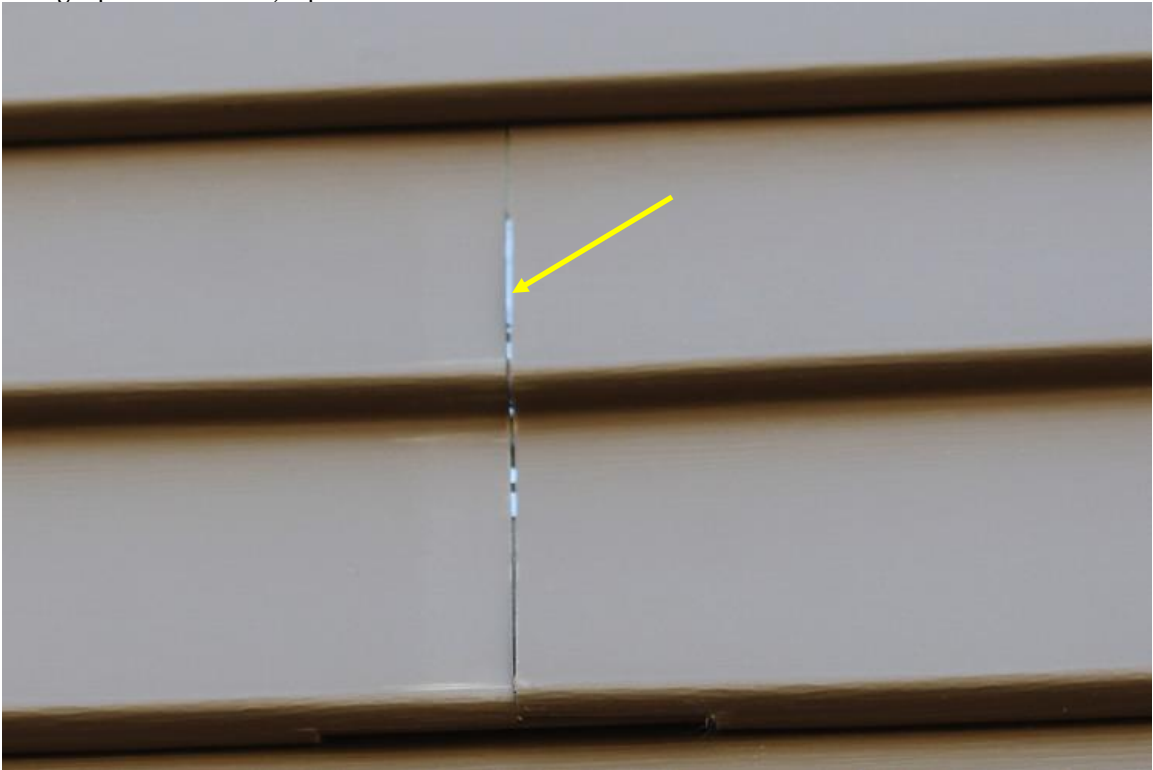
Siding separation noticed; repair as needed.

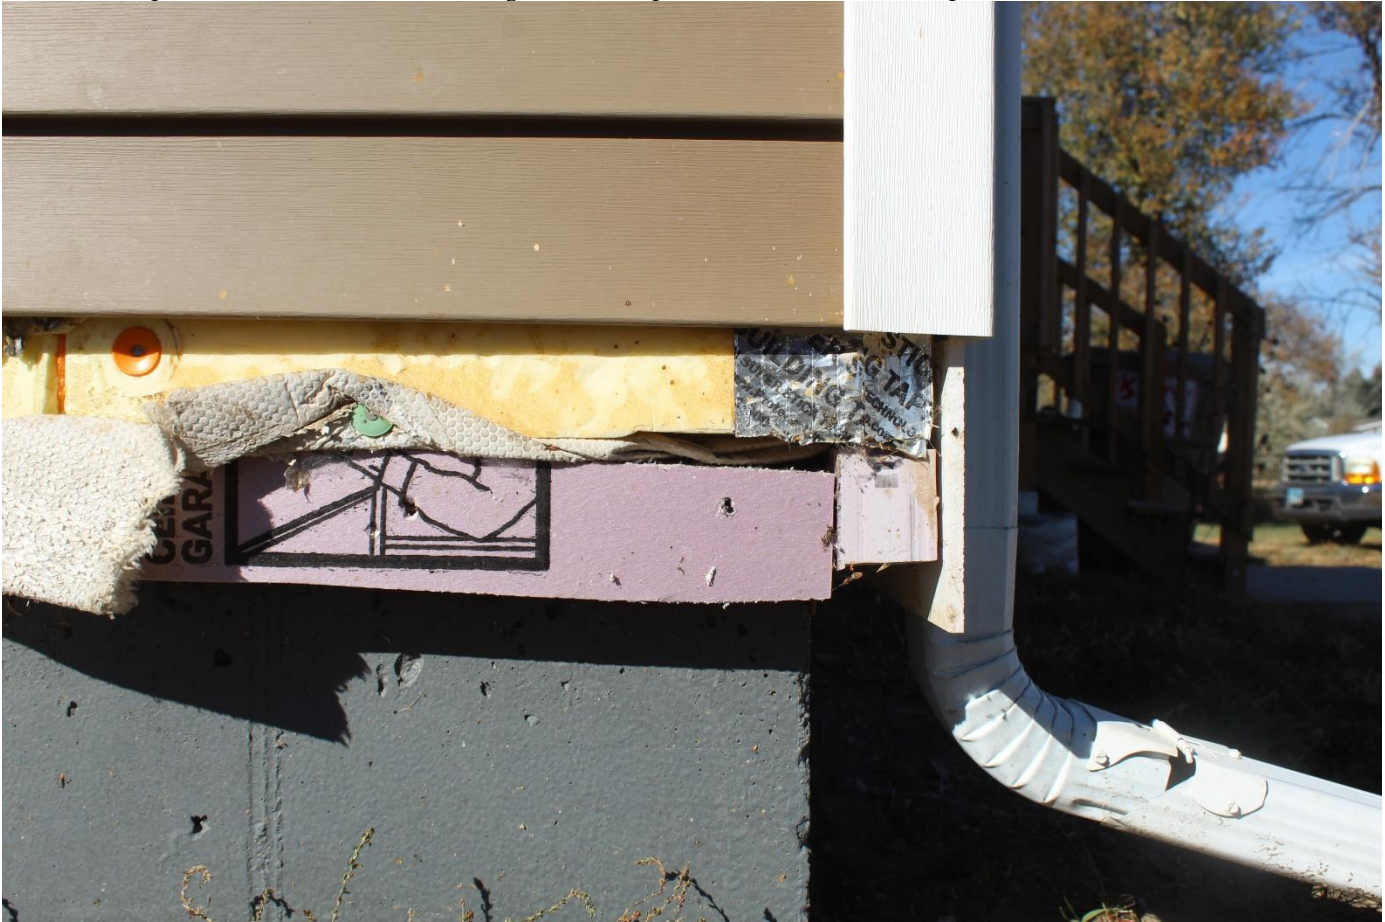
No starter strip noticed for the first row of siding below the top of the foundation wall. Unprofessional installation noticed.

A starter strip should be installed and hang at least an inch below the top of the foundation wall for the first row of siding. The starter strip serves as an anchor point for the rest of the siding and helps to ensure that the siding is properly aligned and secured. It also helps to keep water out of the wall and prevents damage to the siding. (COMMON PRACTICE)

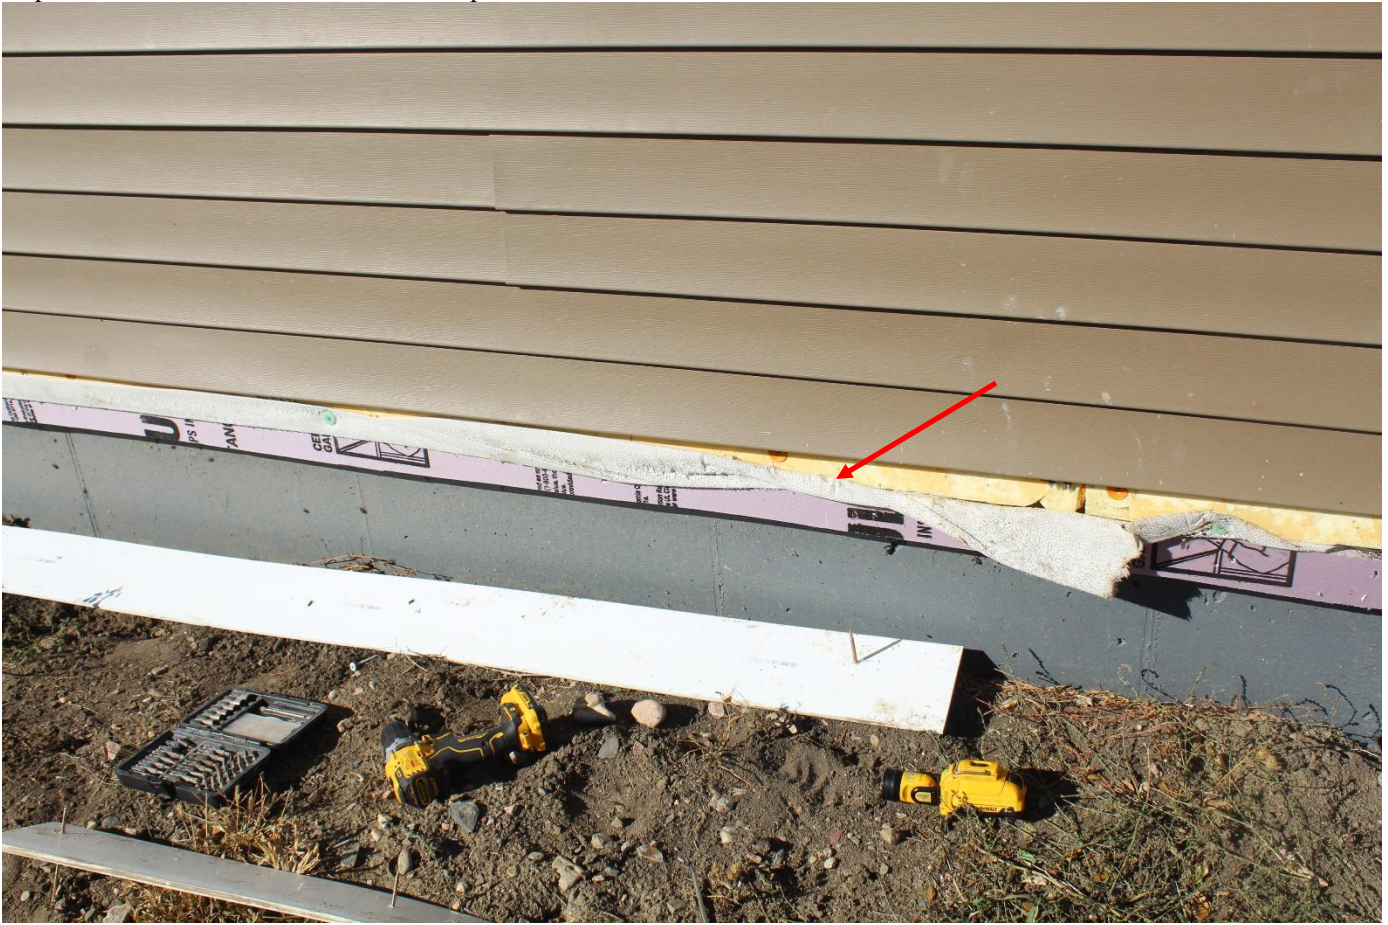
Unprofessional installation of the house wrap noticed.

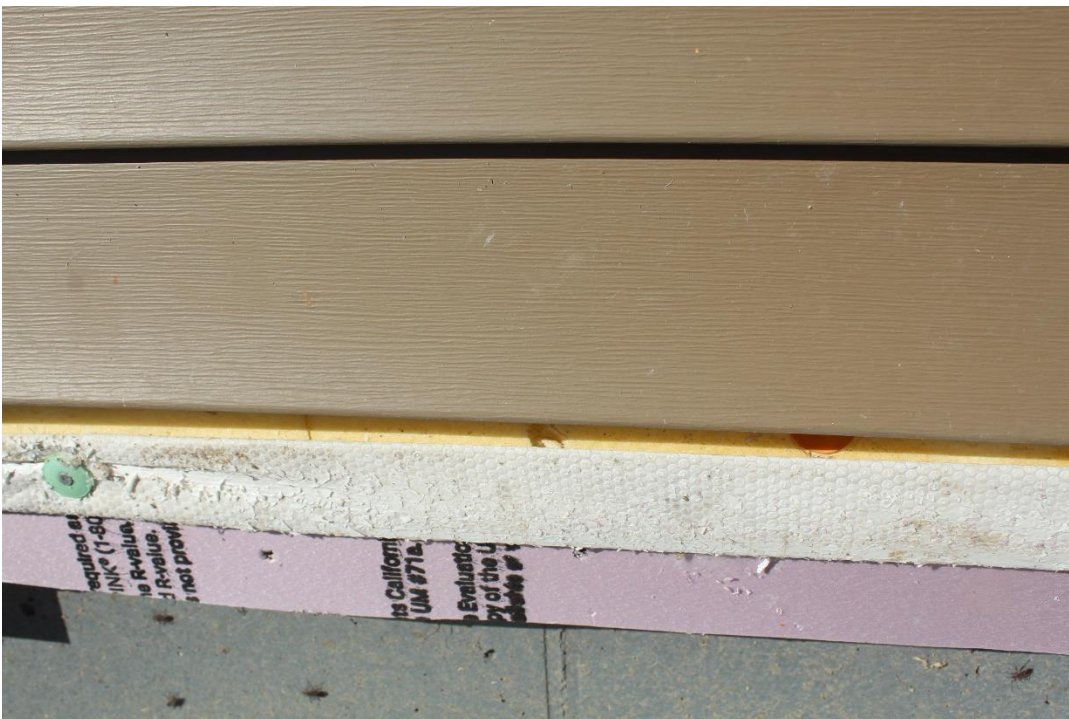
The house wrap was rolled upward, any water getting behind the siding will leak along the whole top of the foundation wall and into the crawlspace and down the foundation wall. (Uncommon Practice)

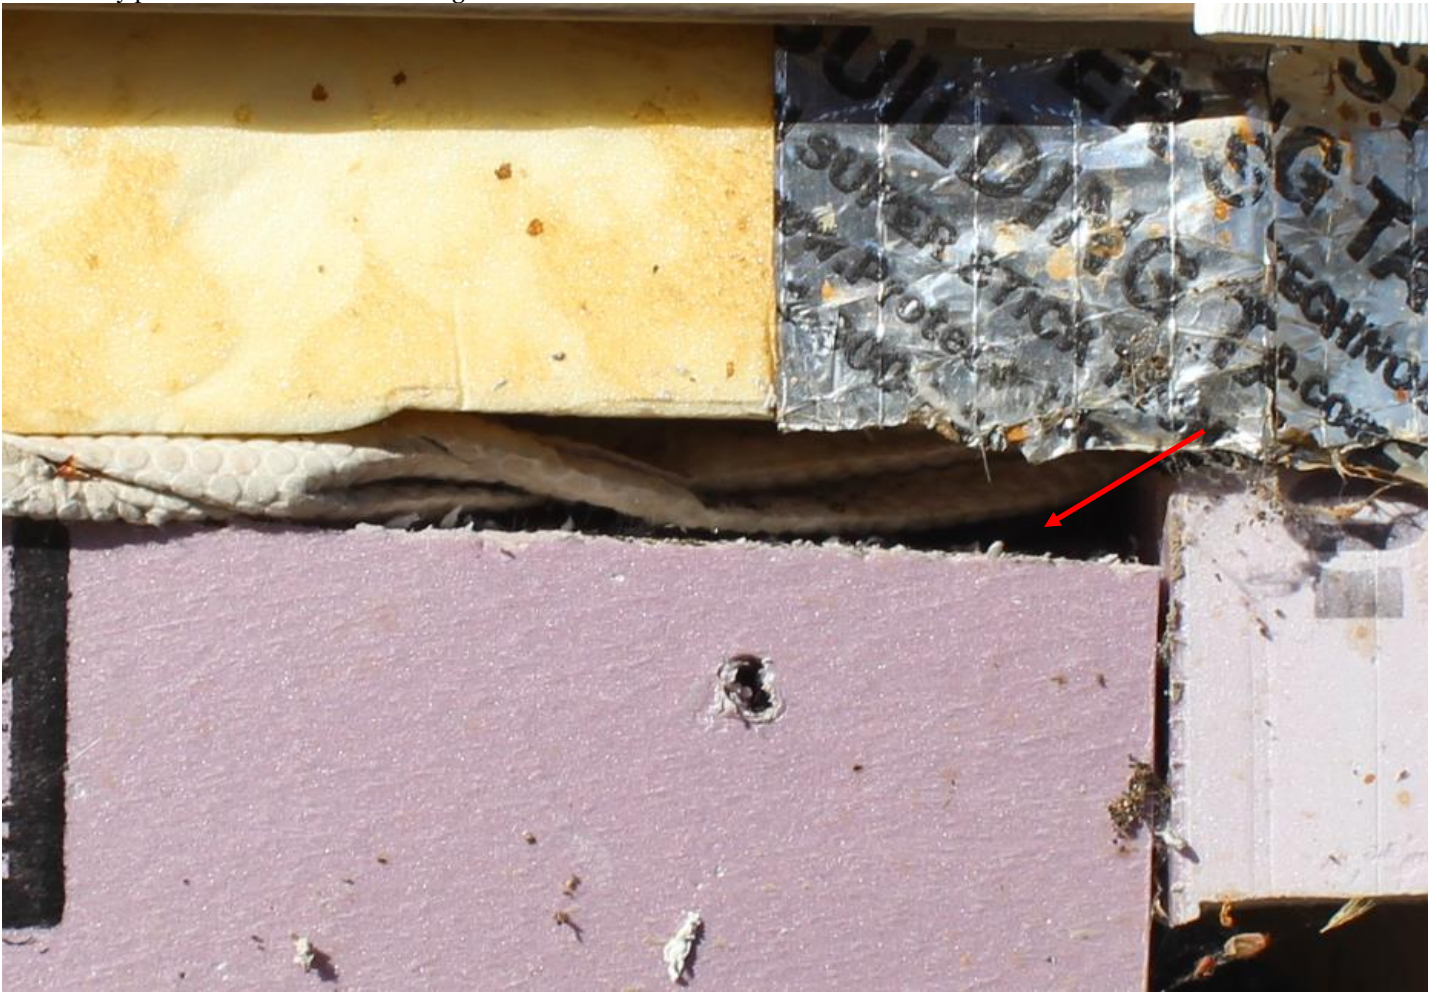
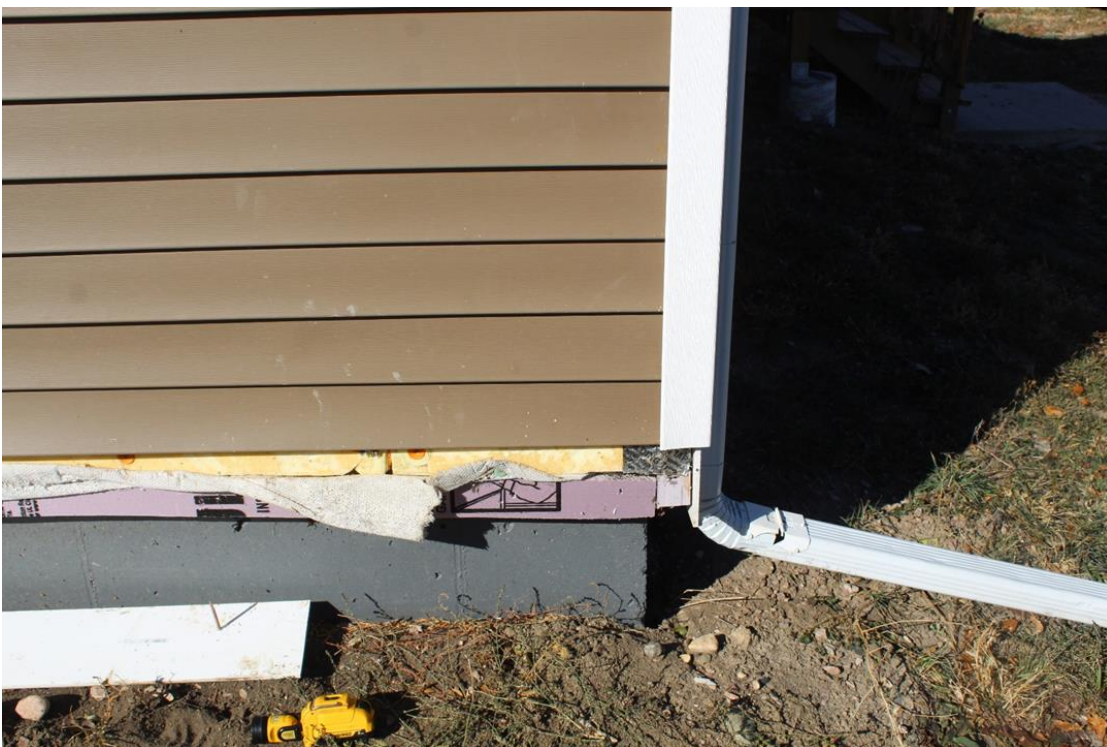
Water entry points noticed under the siding.

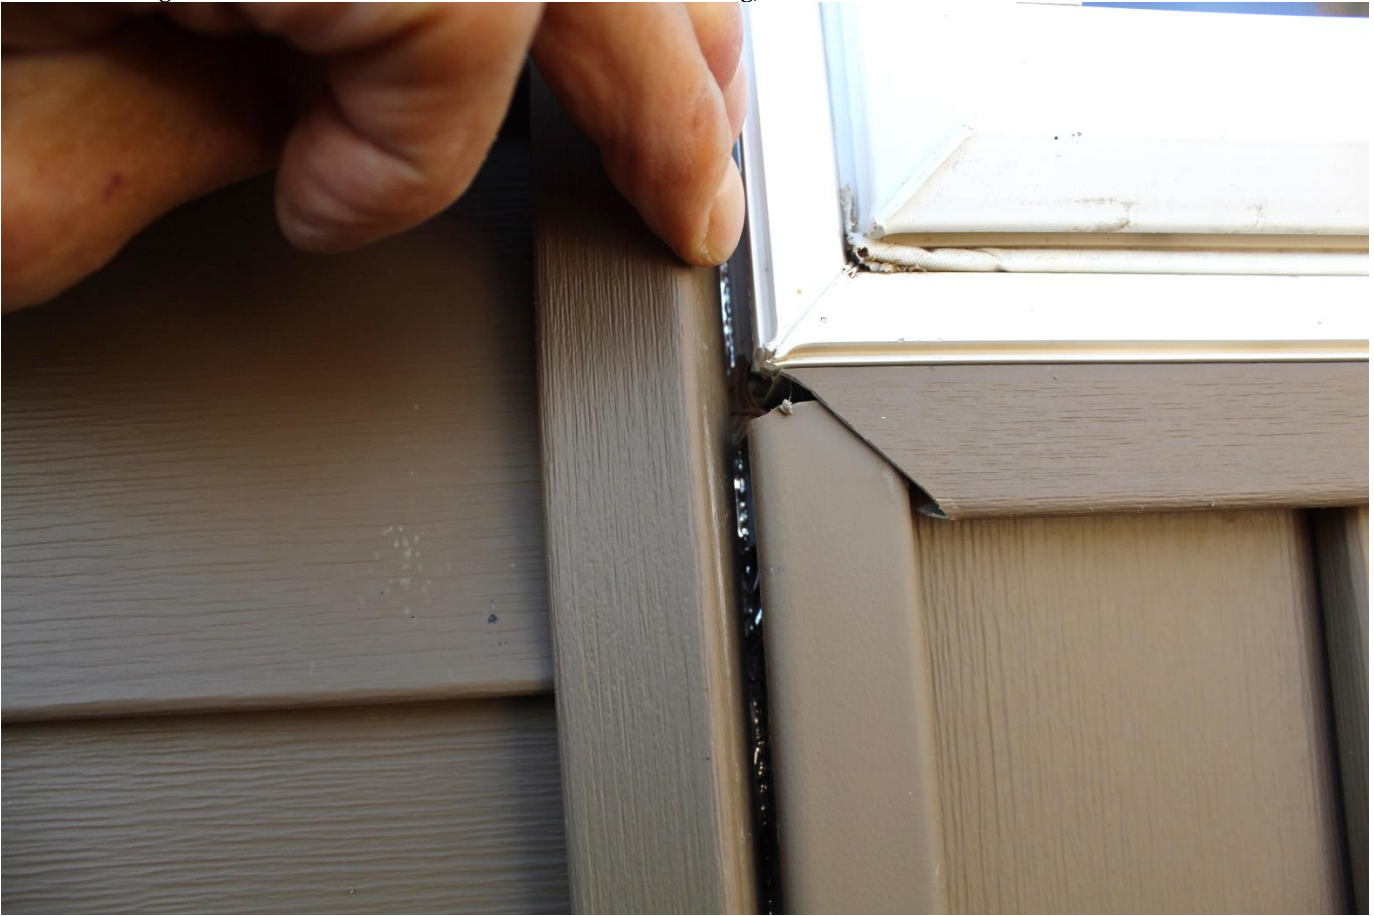
Water entry points noticed behind the siding.

Further investigation would be needed to evaluate the rest of the siding, windows & door installation.

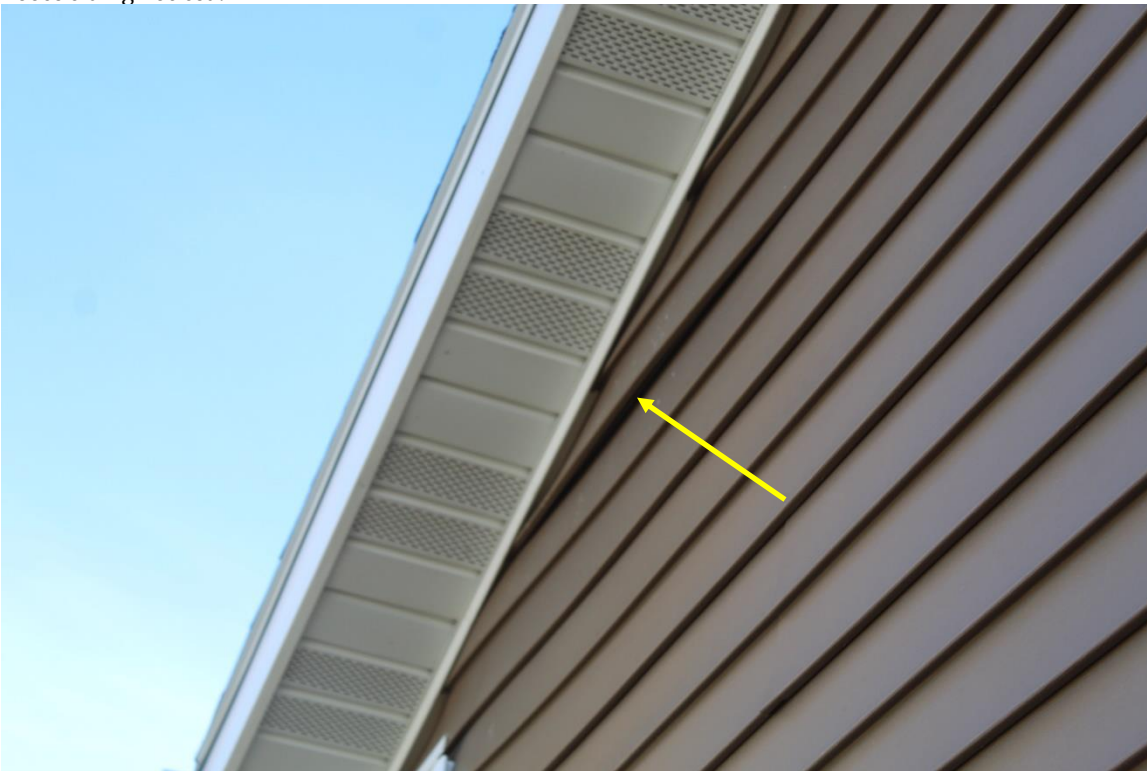
Loose siding noticed.

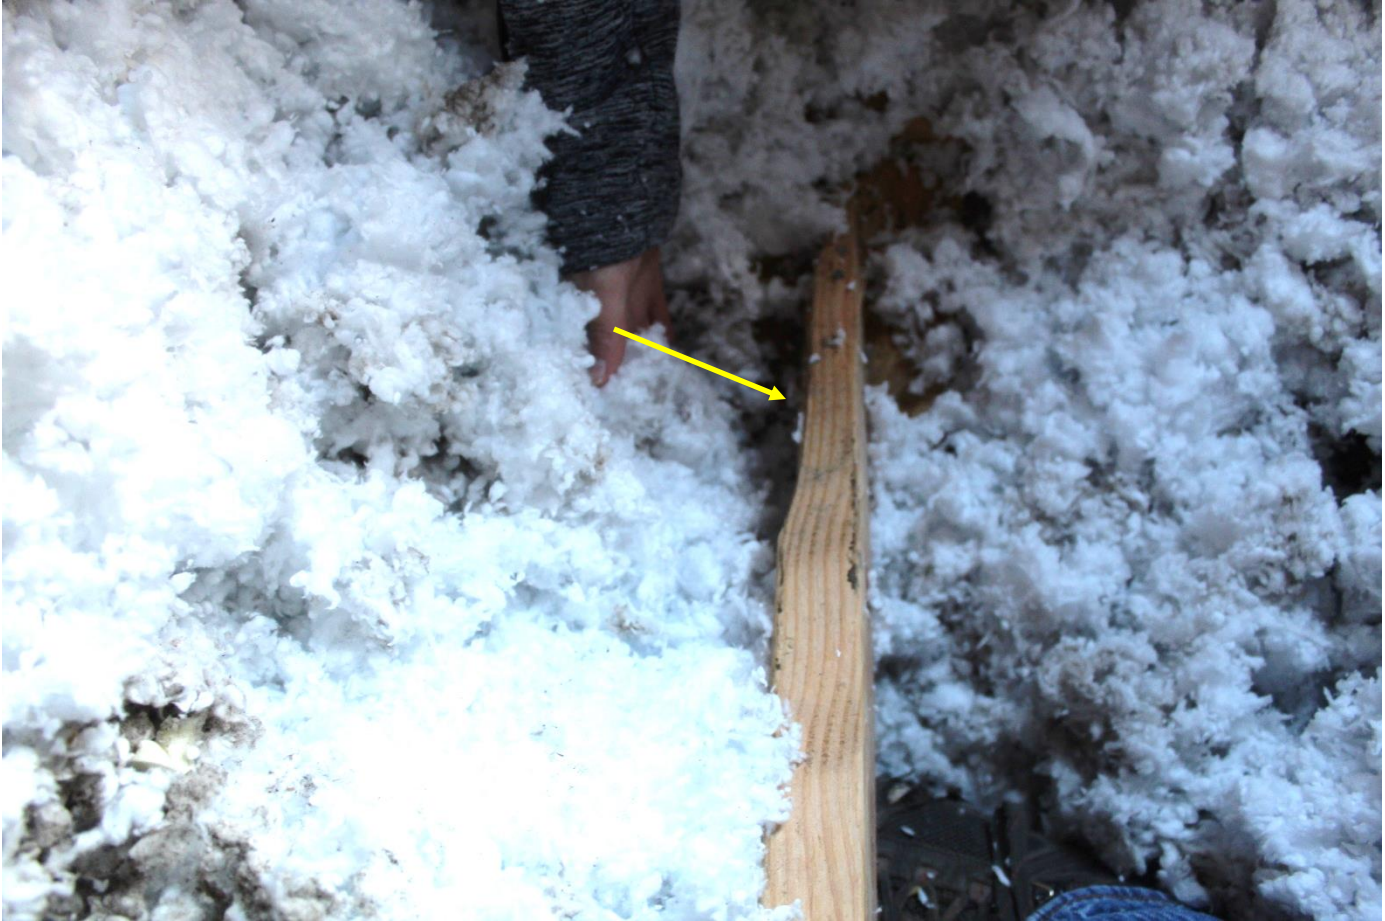
Broken & loose wind braces noticed in the attic.
