# Black Hills Professional Home Inspections LLC®

### HOME INSPECTION

**Amber Cottman**  
605-219-6573  
6655 Greenfield Dr  
Rapid City, SD 57703  
[ampercottman@yahoo.com](mailto:ampercottman@yahoo.com)

**REPORT**  
11-1-23

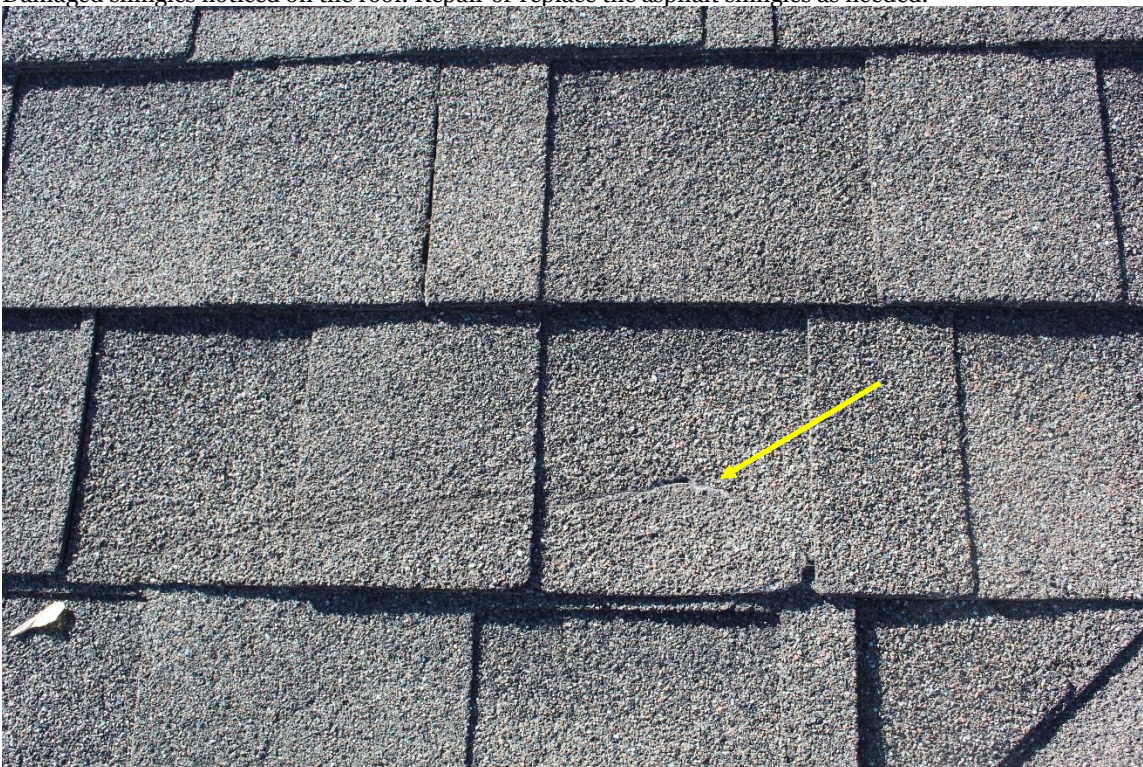
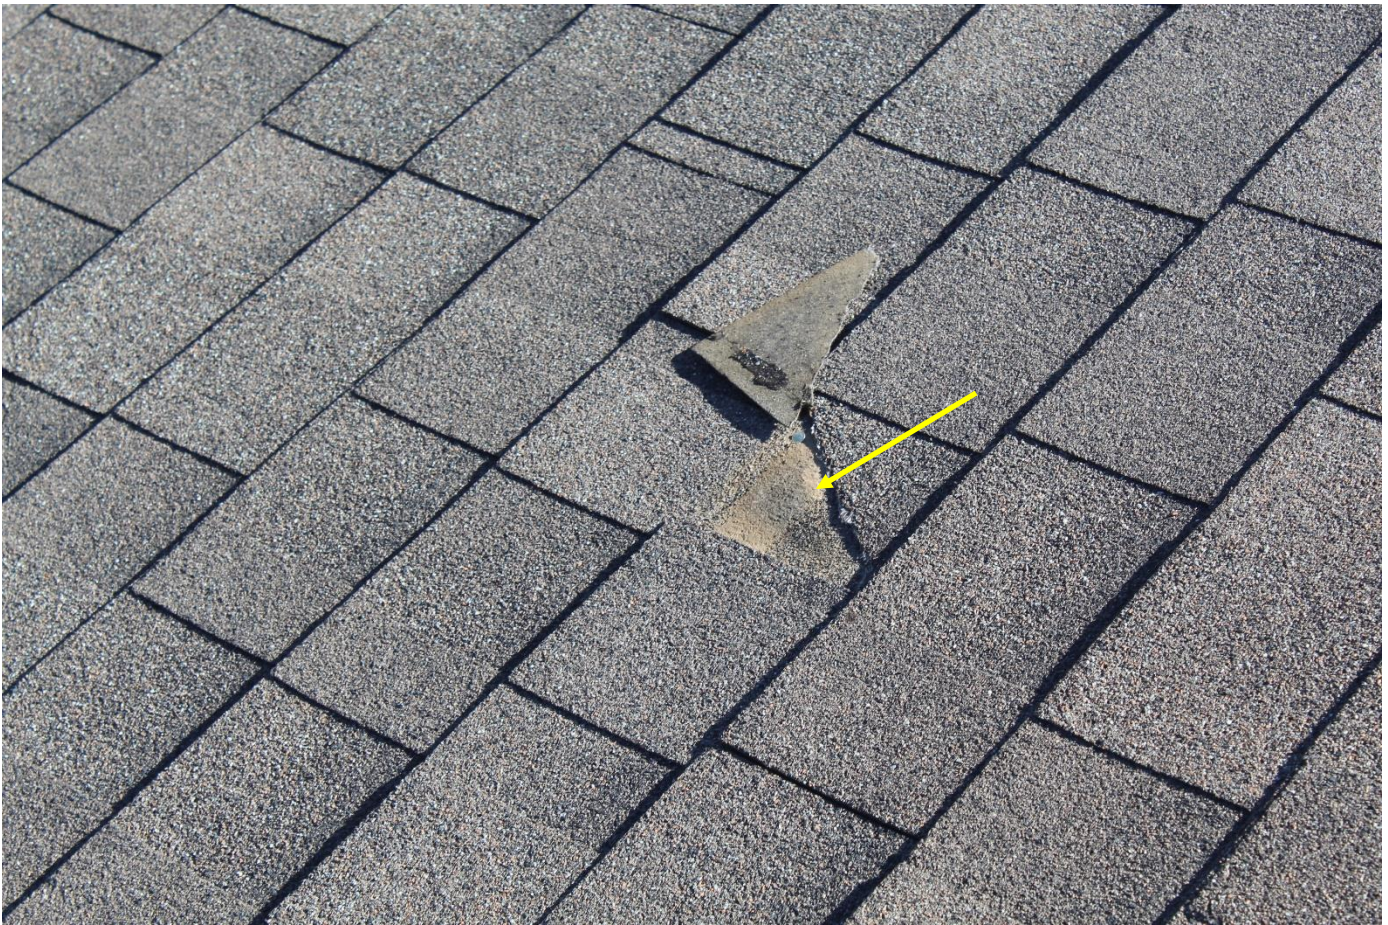
Damaged shingles noticed on the roof. Repair or replace the asphalt shingles as needed.

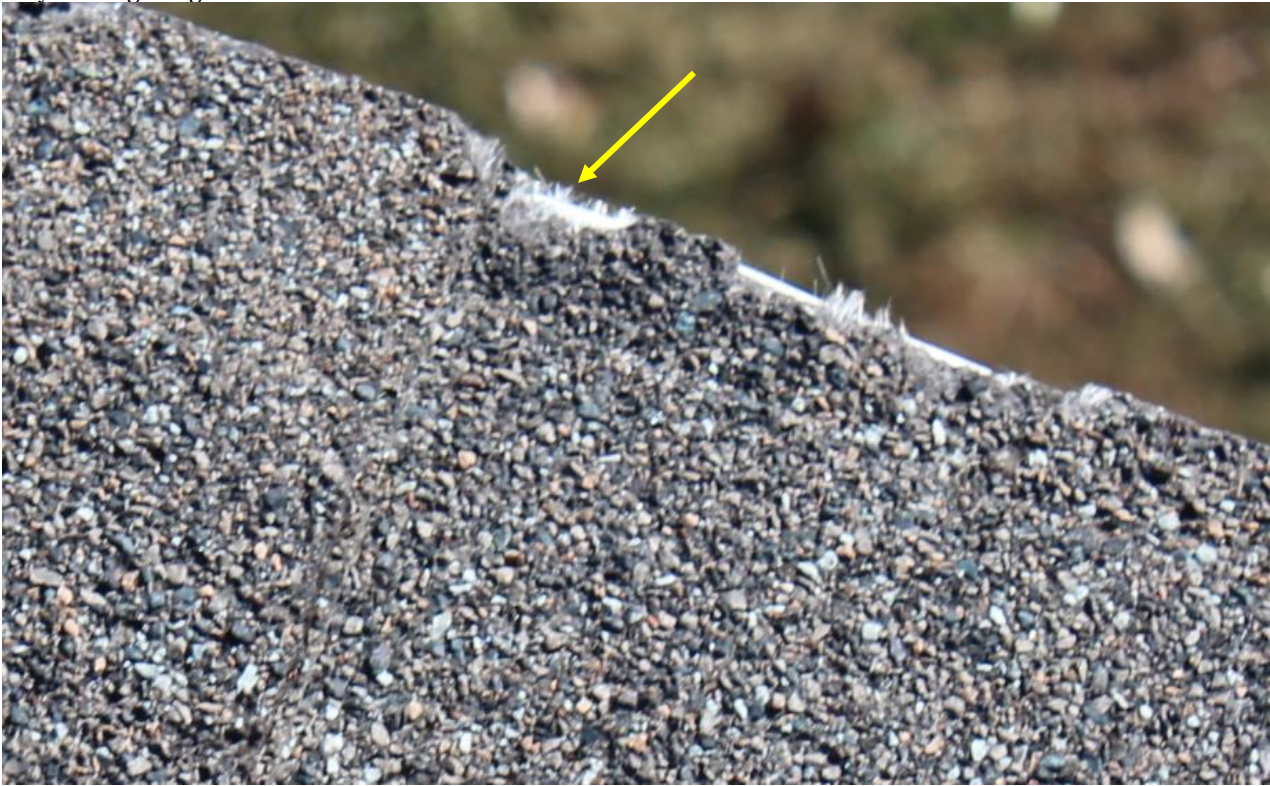
Frayed shingle edges noticed.

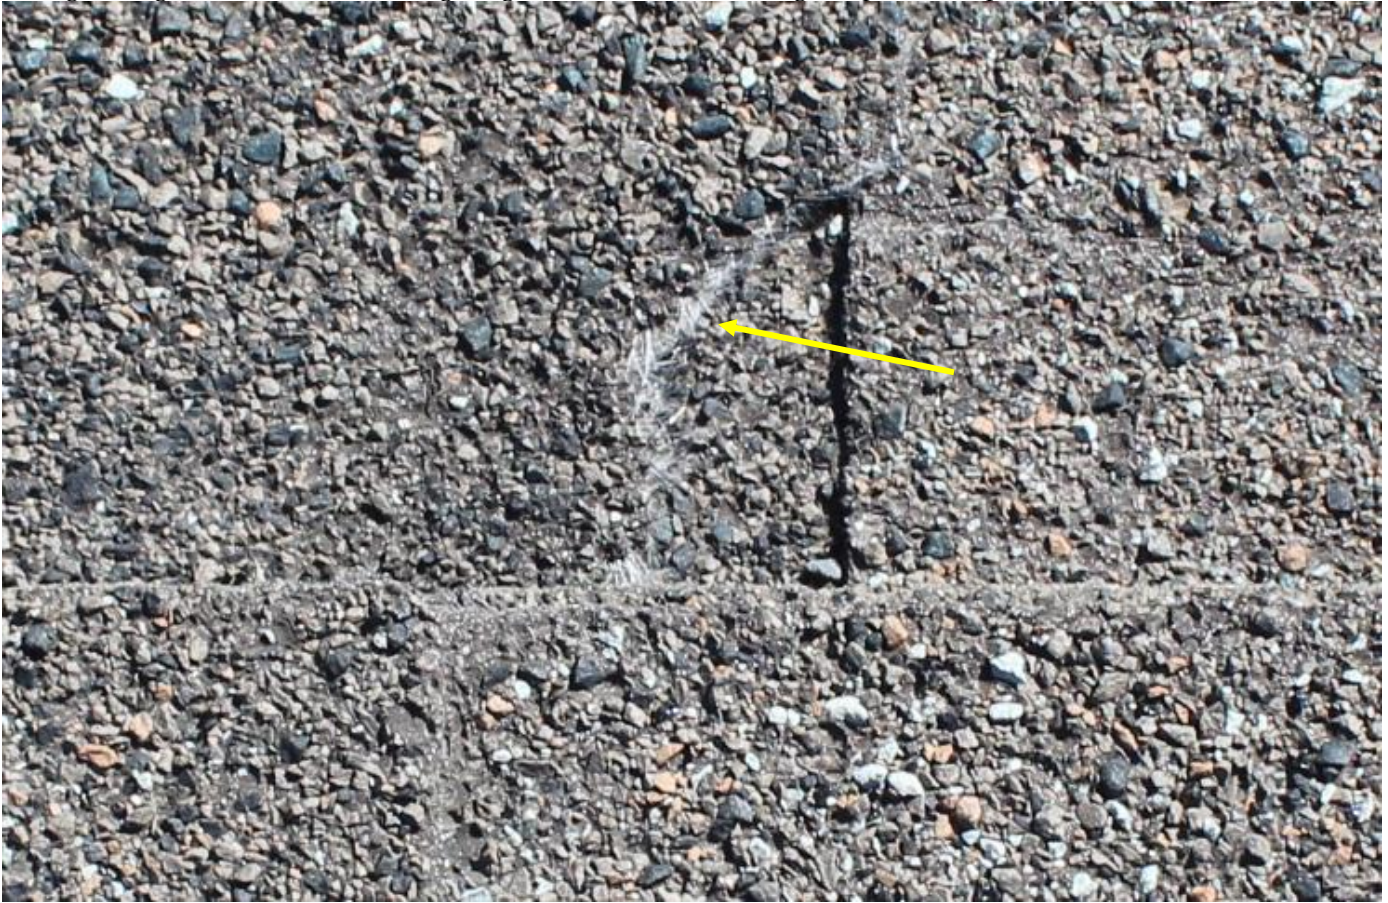
Damaged shingles noticed, I recommend getting estimates to have the shingles repaired or replaced as needed.

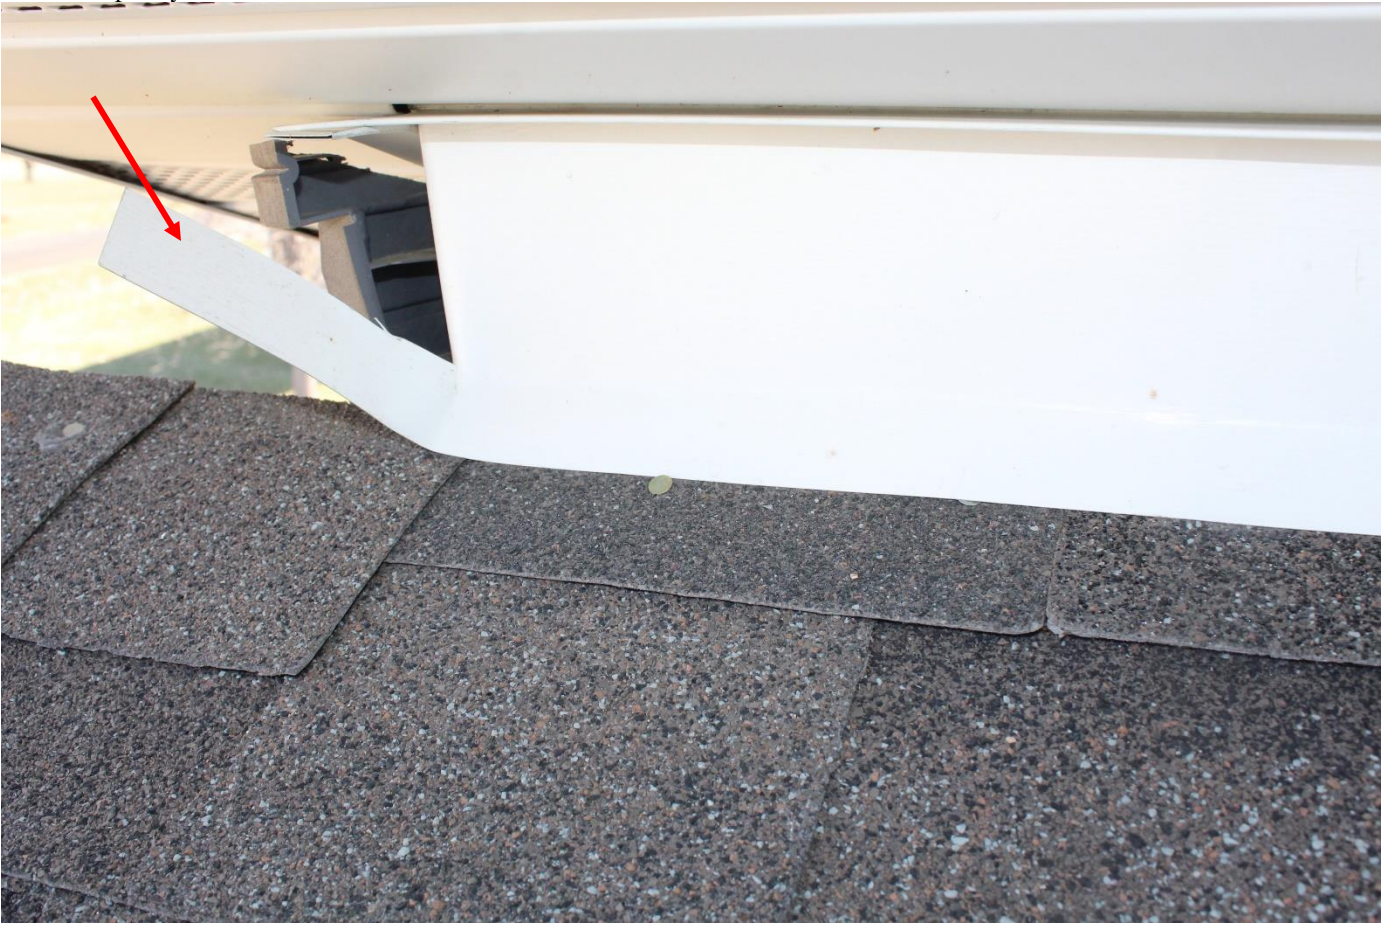
Loose and poorly installed fascia metal noticed.

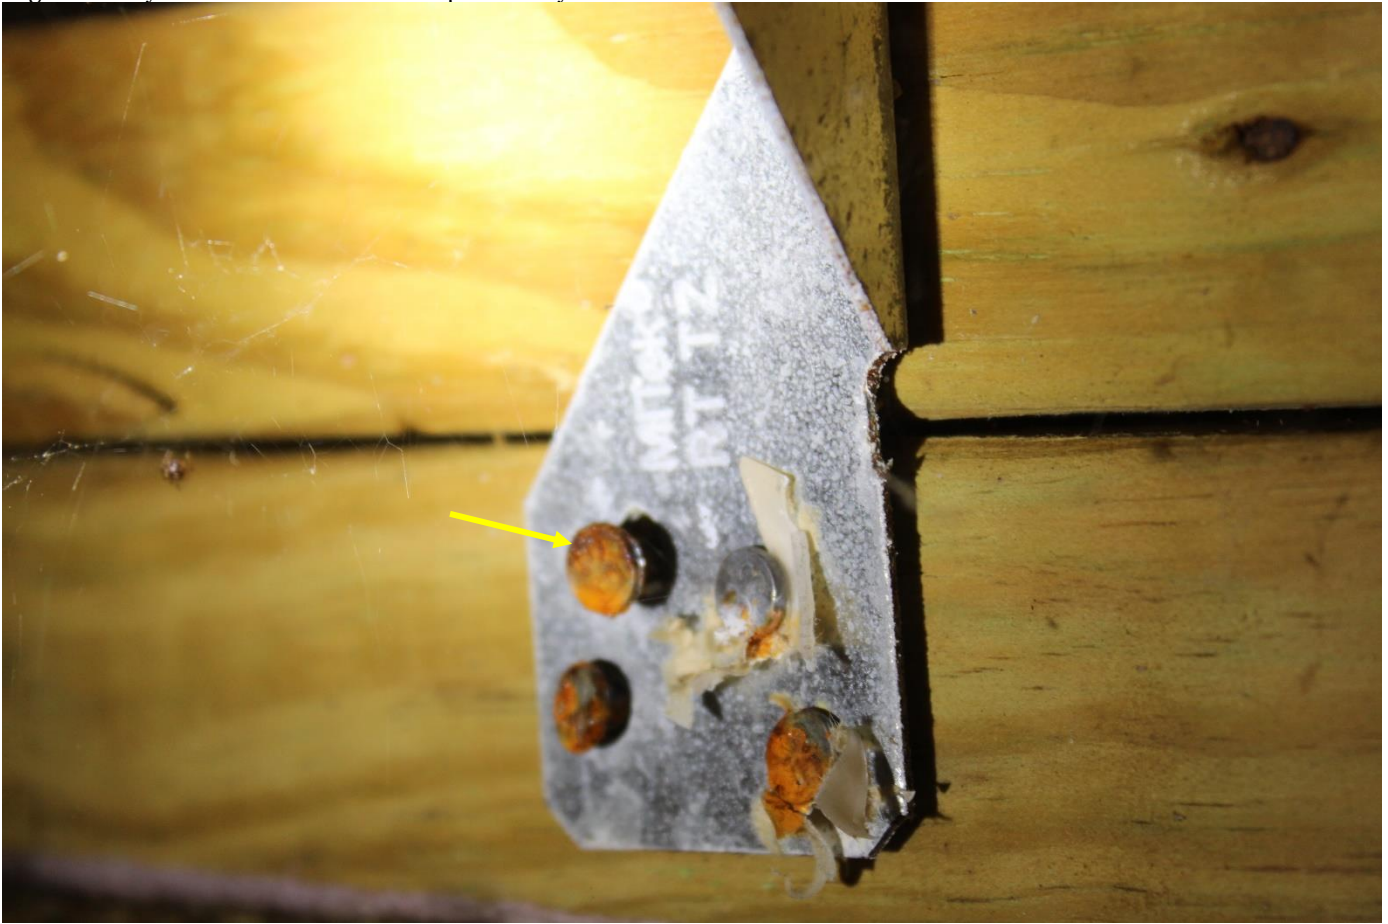
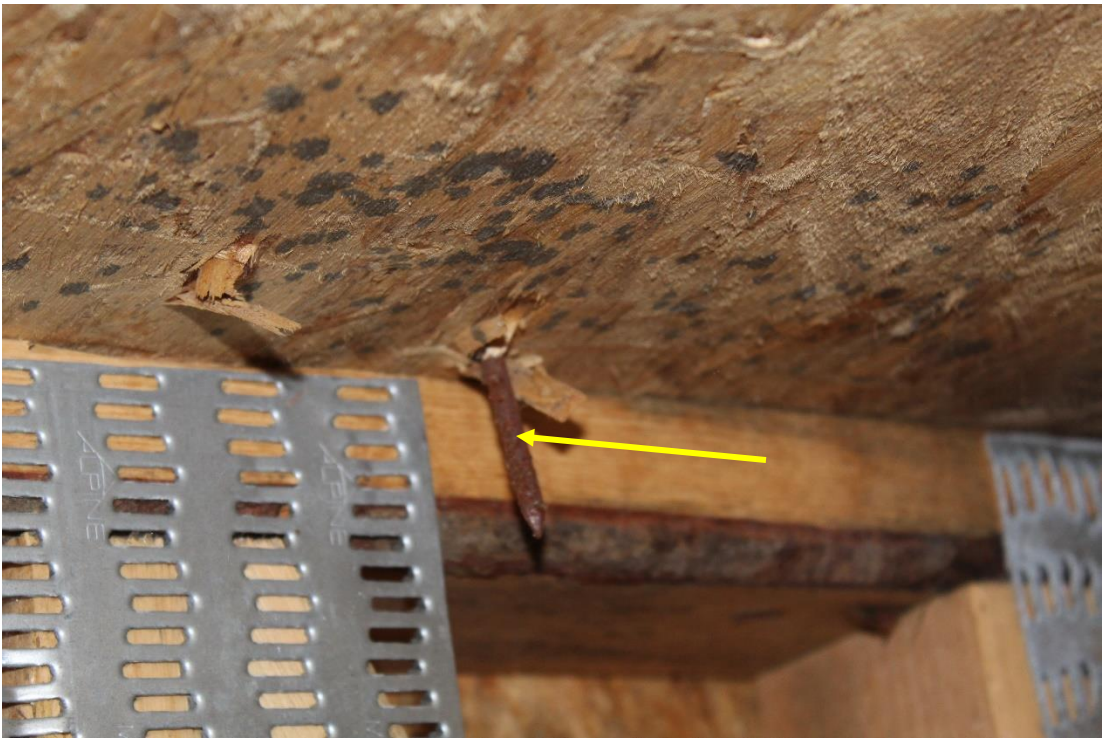
High humidity levels noticed in the crawlspace. Rusty fasteners were also noticed.

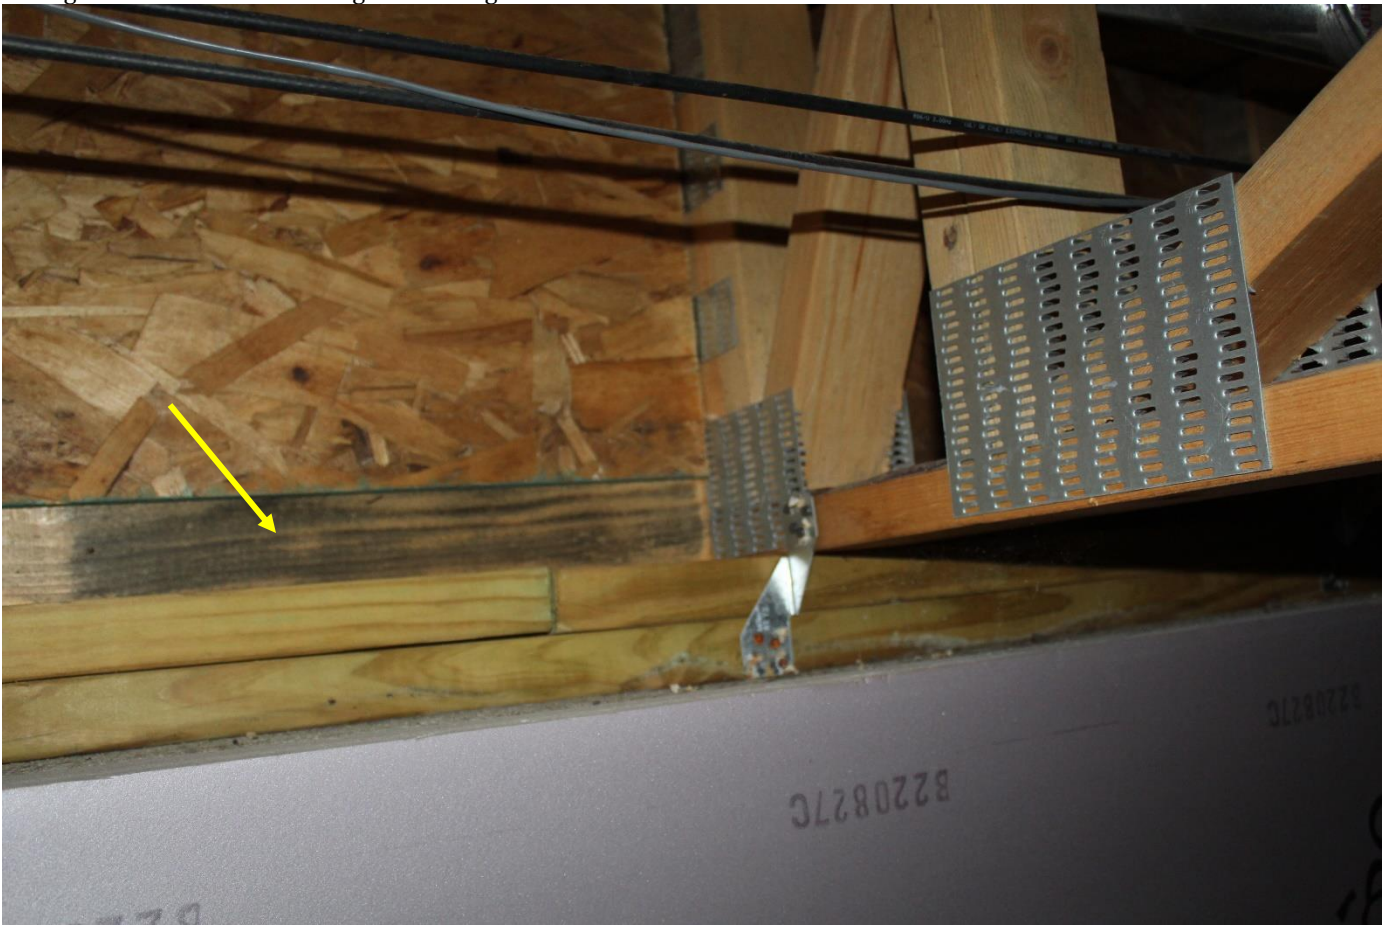
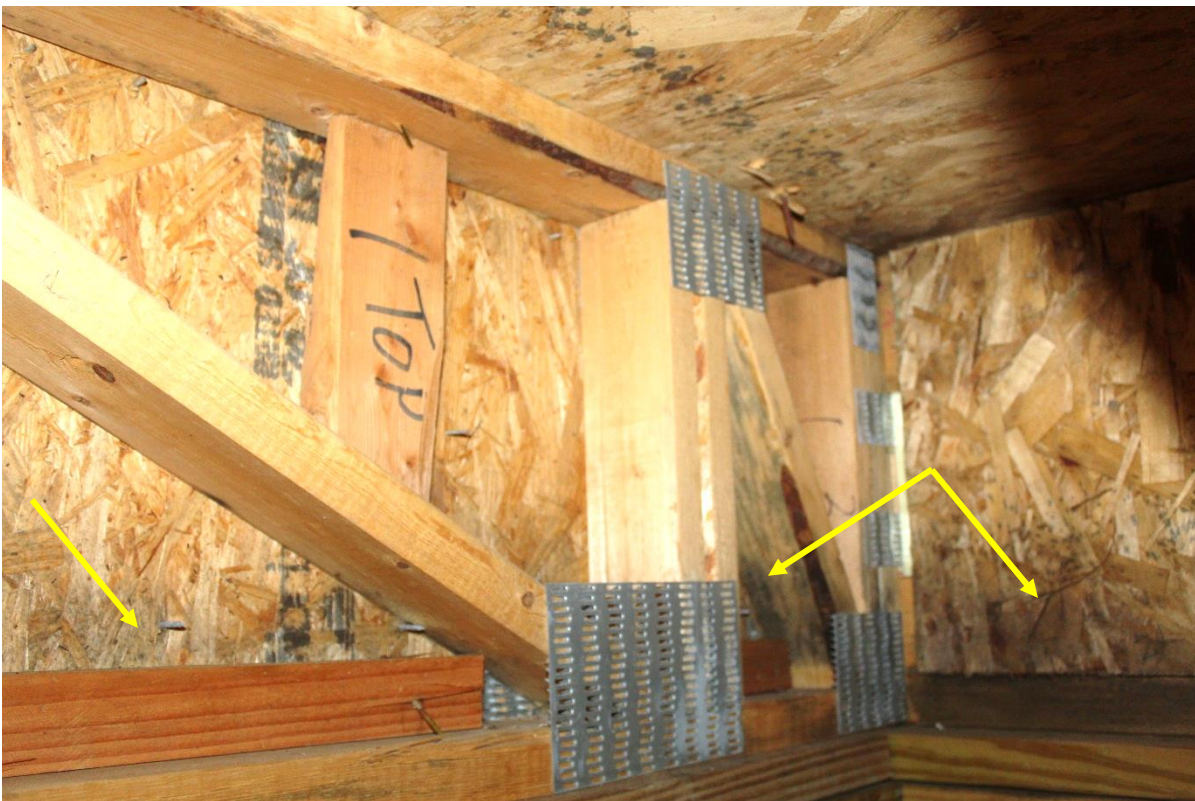
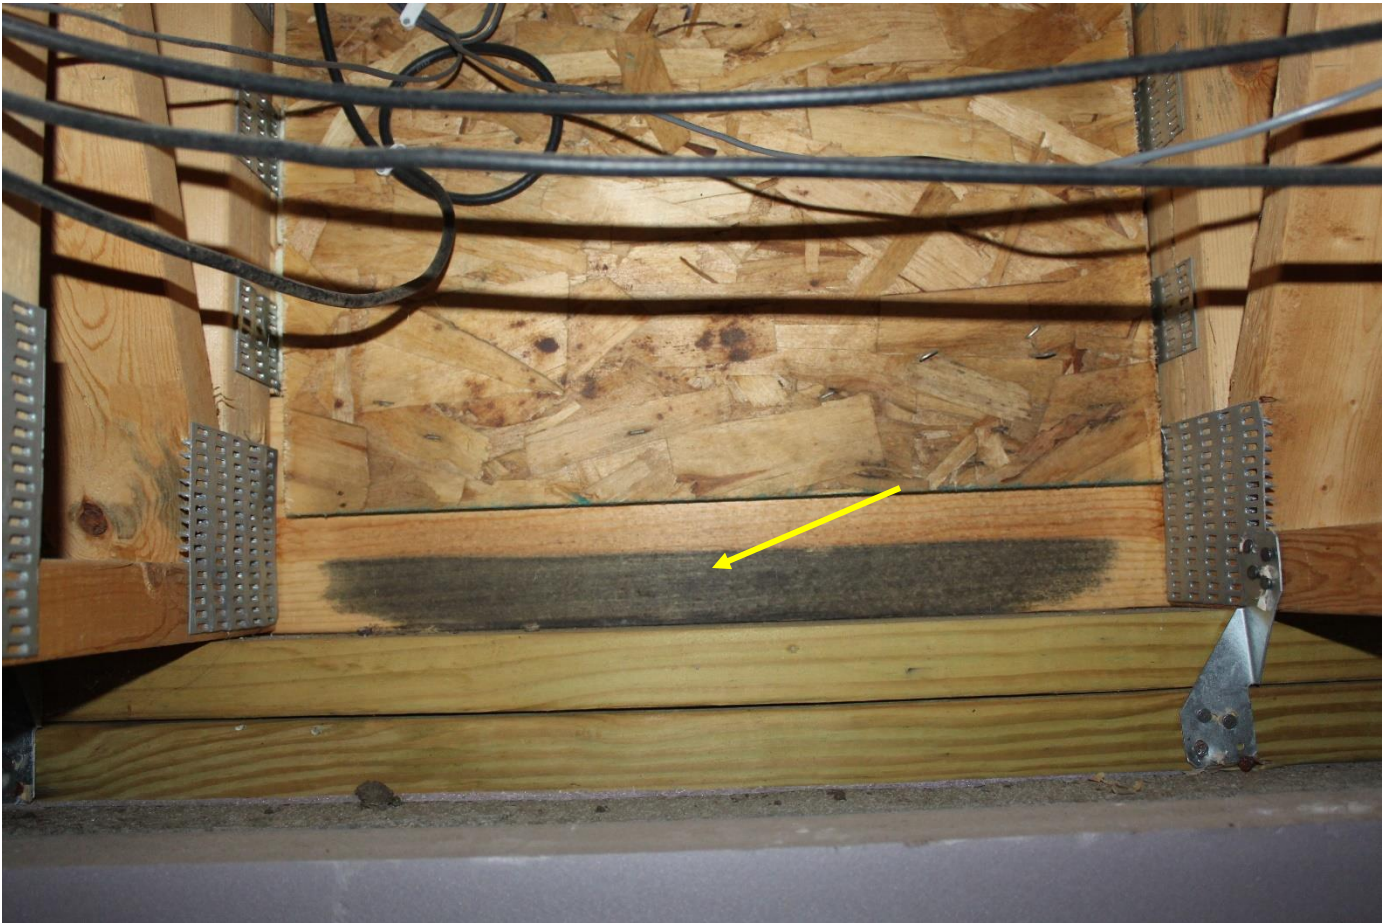
Mold growth on the wood framing & sheathing noticed in several areas.

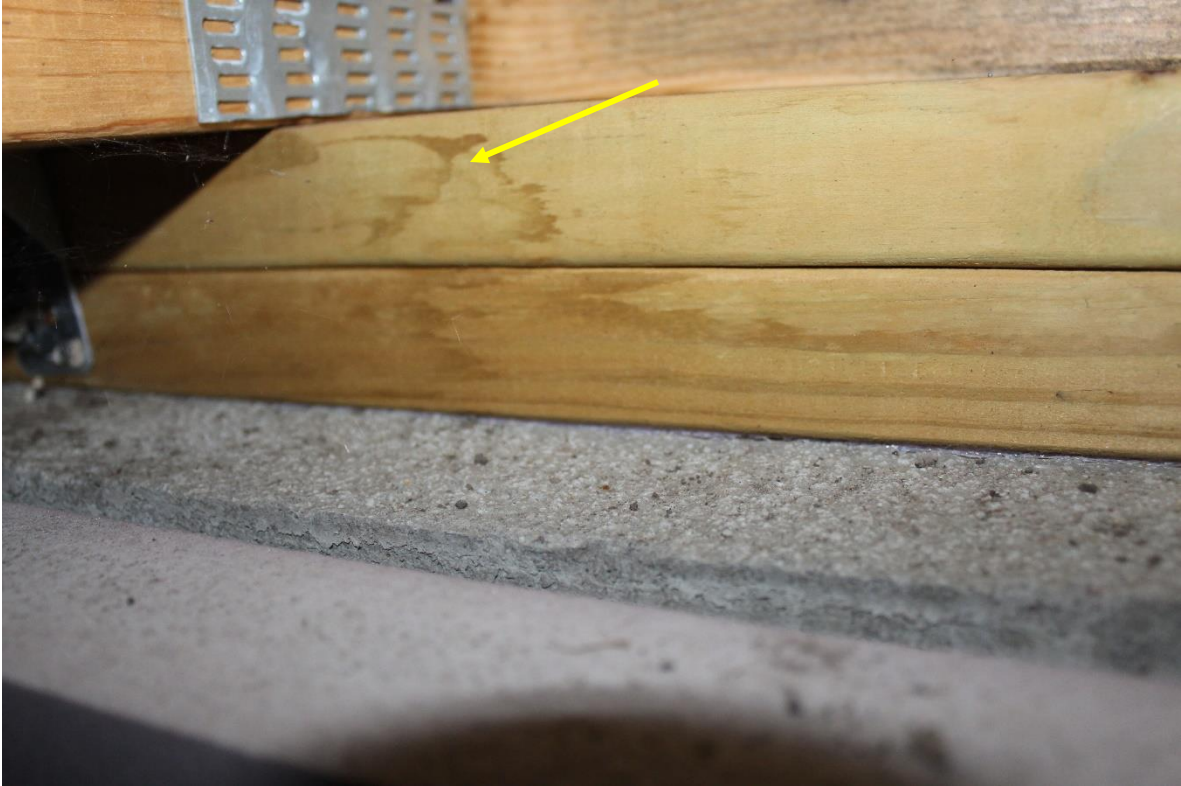
Water stains noticed on the wood framing.

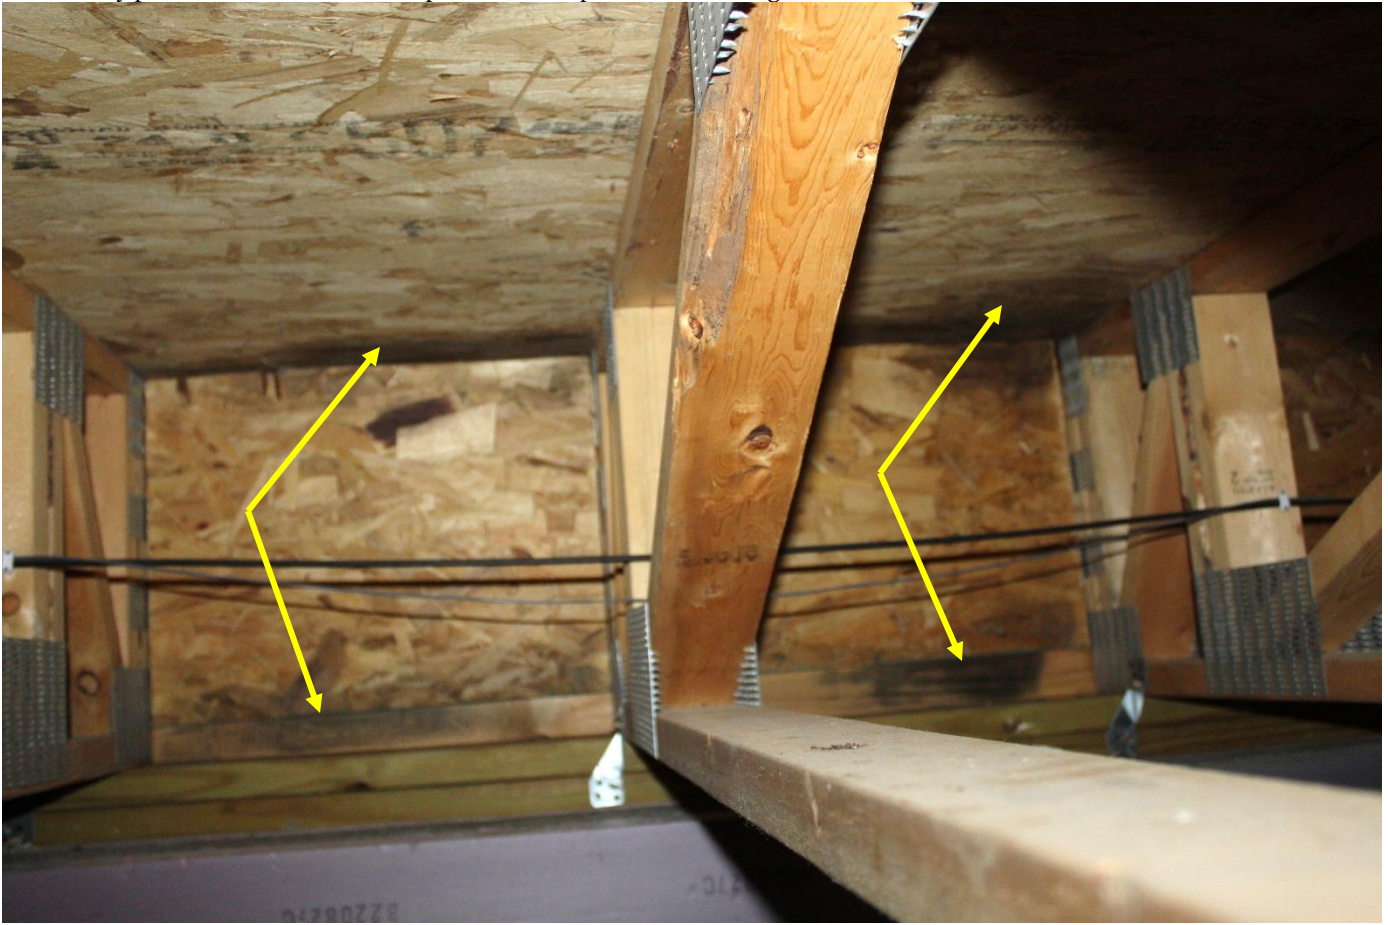
Water entry points noticed in the crawlspace due to unprofessional siding installation.

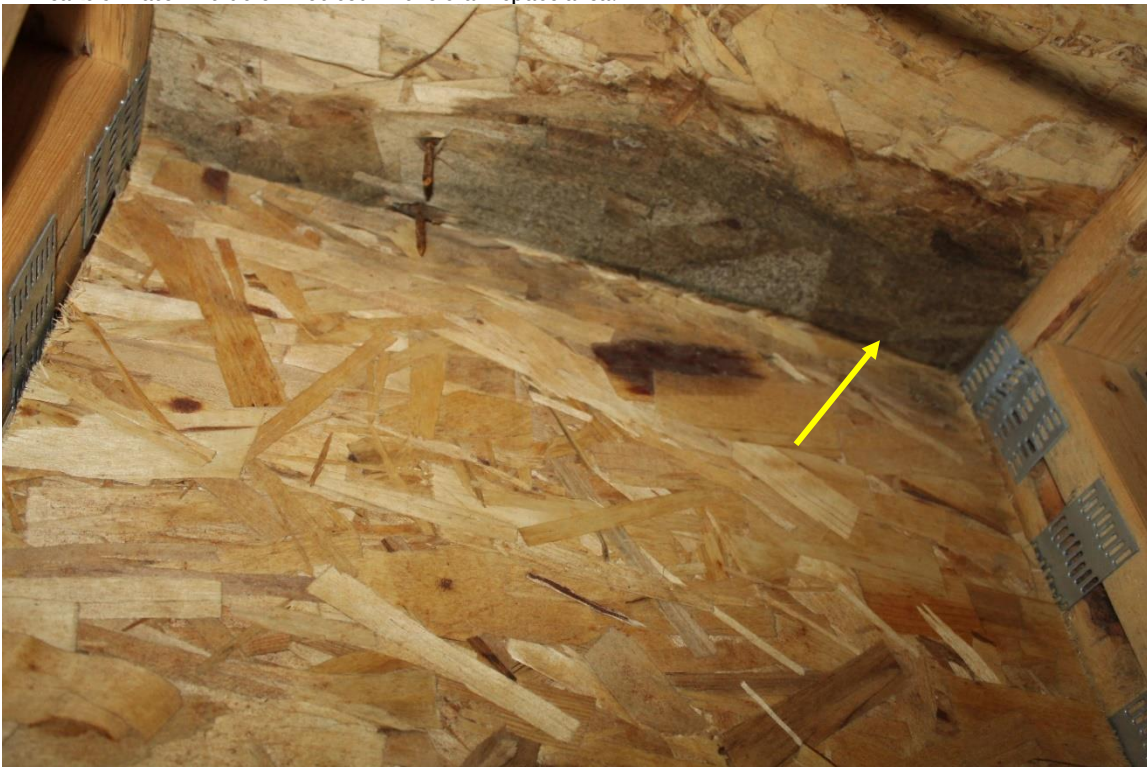
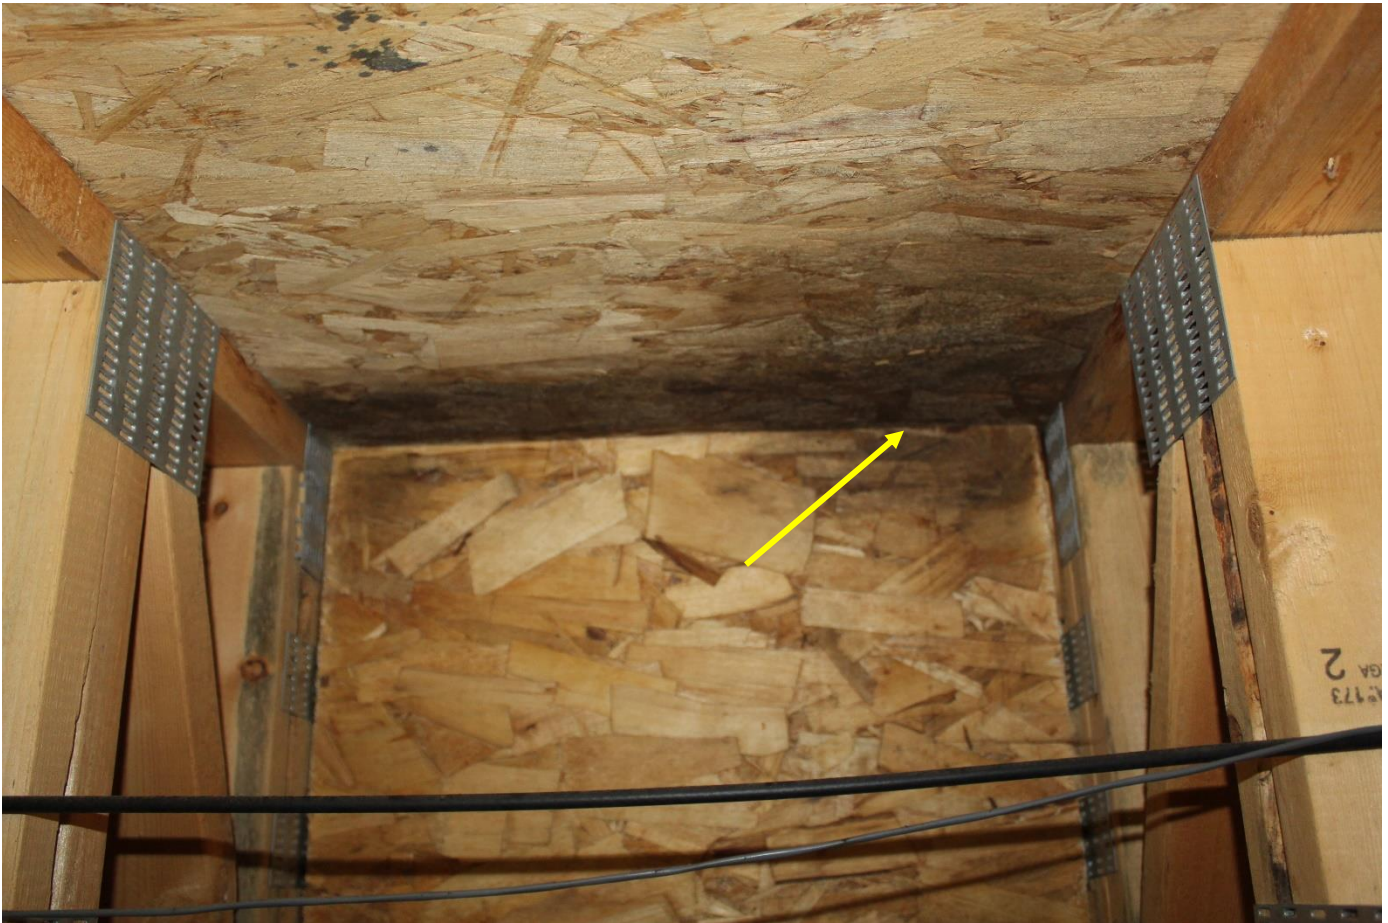
Air leaks & water intrusion noticed in the crawlspace area.

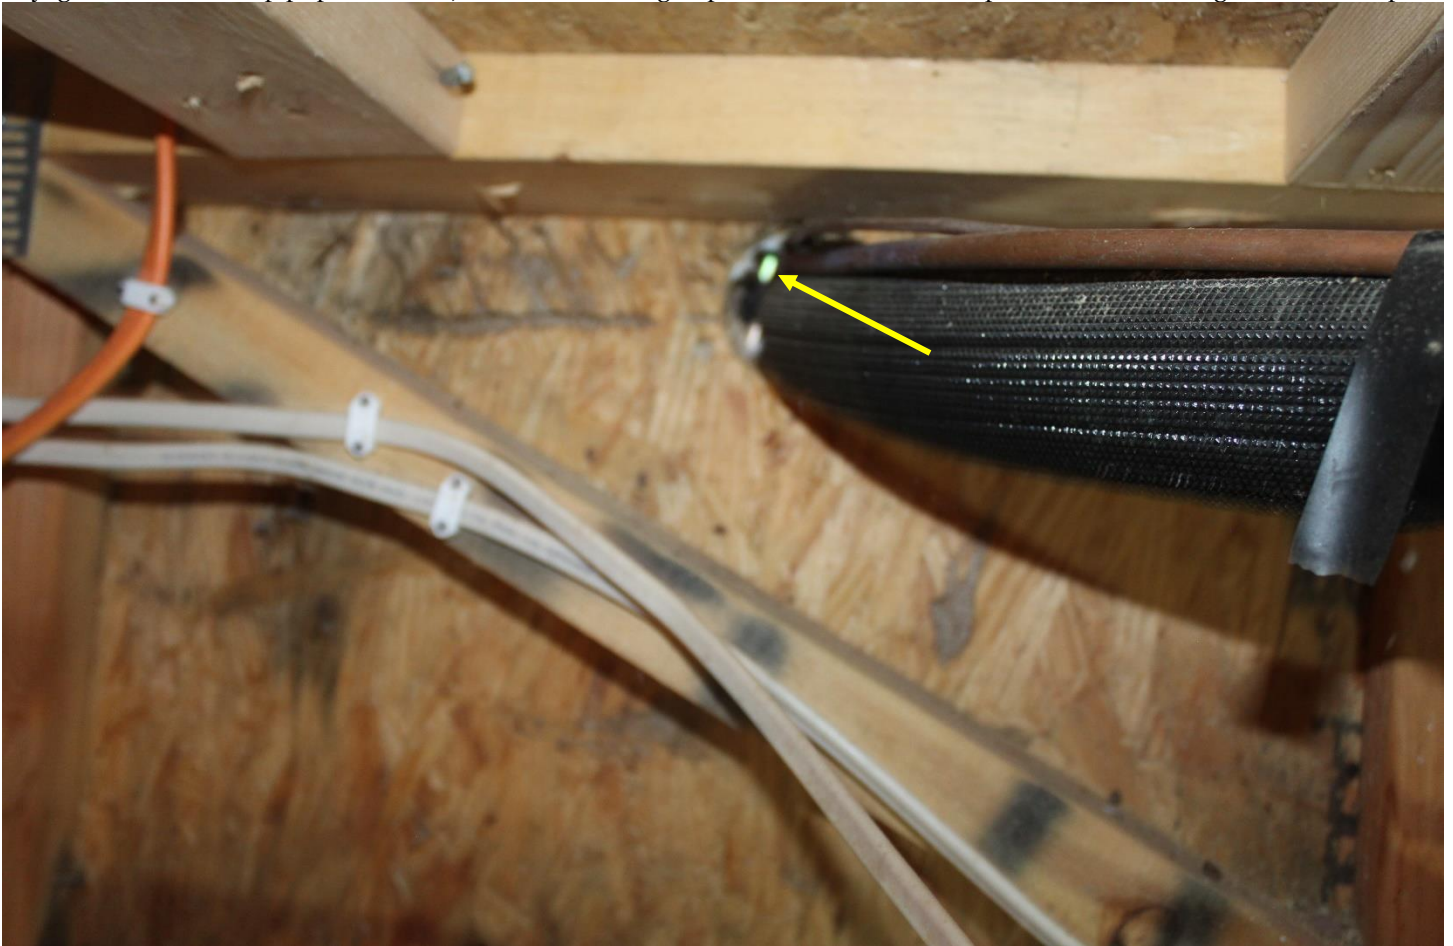
Daylight noticed around pipe penetrations, recommend sealing all penetrations as needed to prevent water entering into the crawlspace.

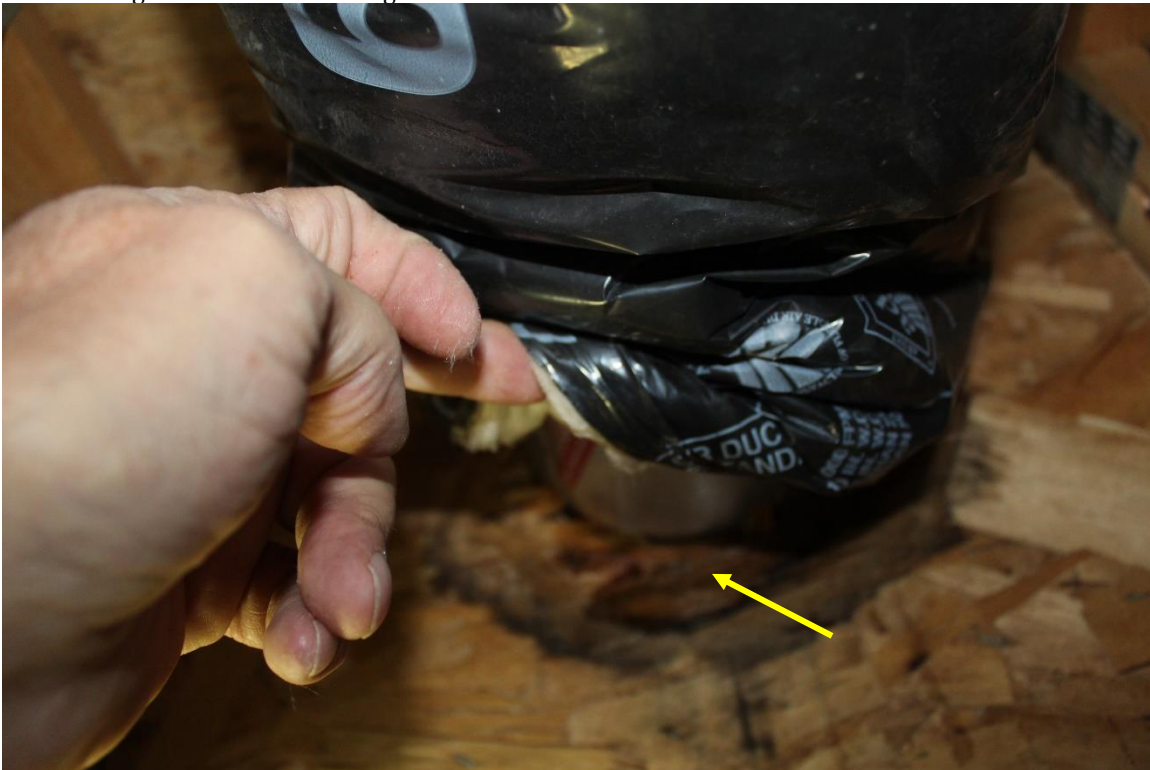
Water damaged OSB wood sheathing noticed.

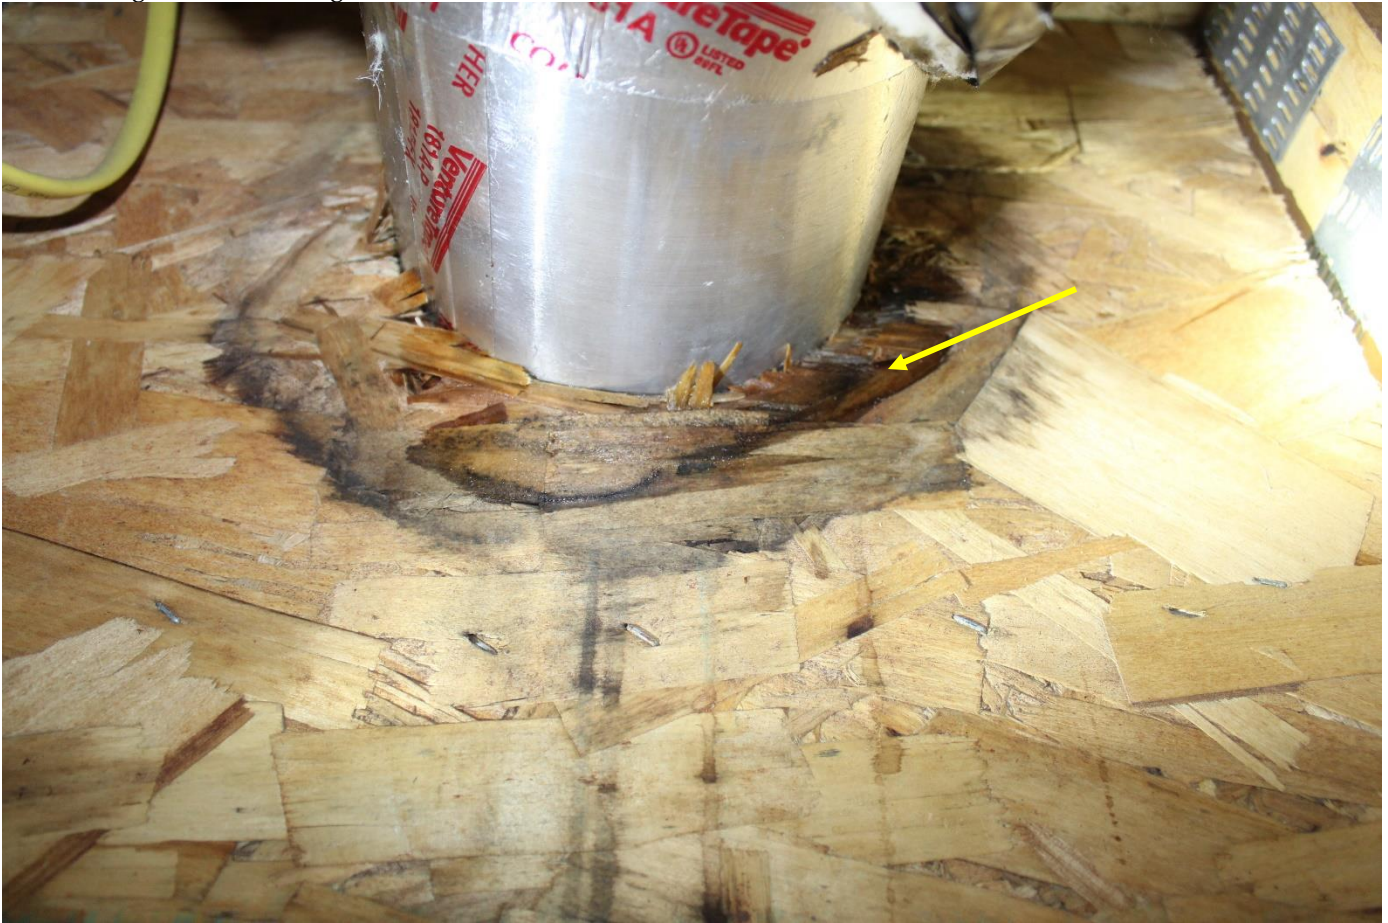
Water damaged wood sheathing noticed.

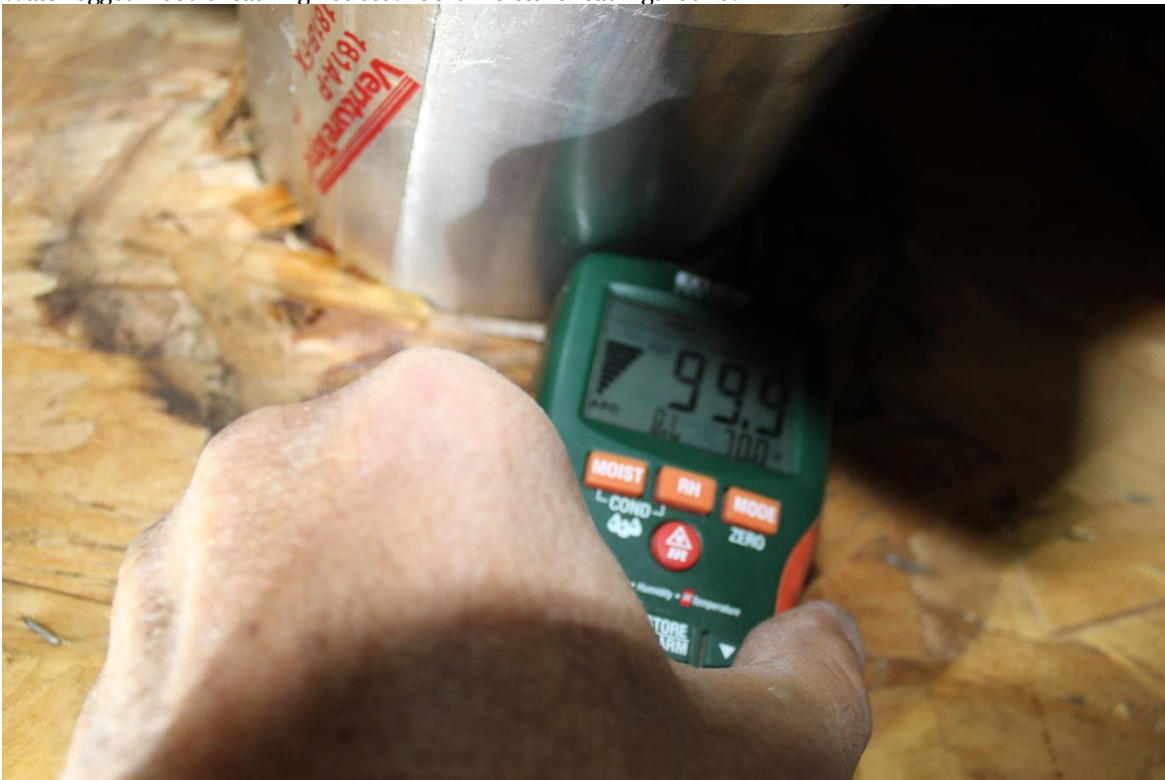
Waterlogged wood sheathing noticed. 100% moisture readings found.

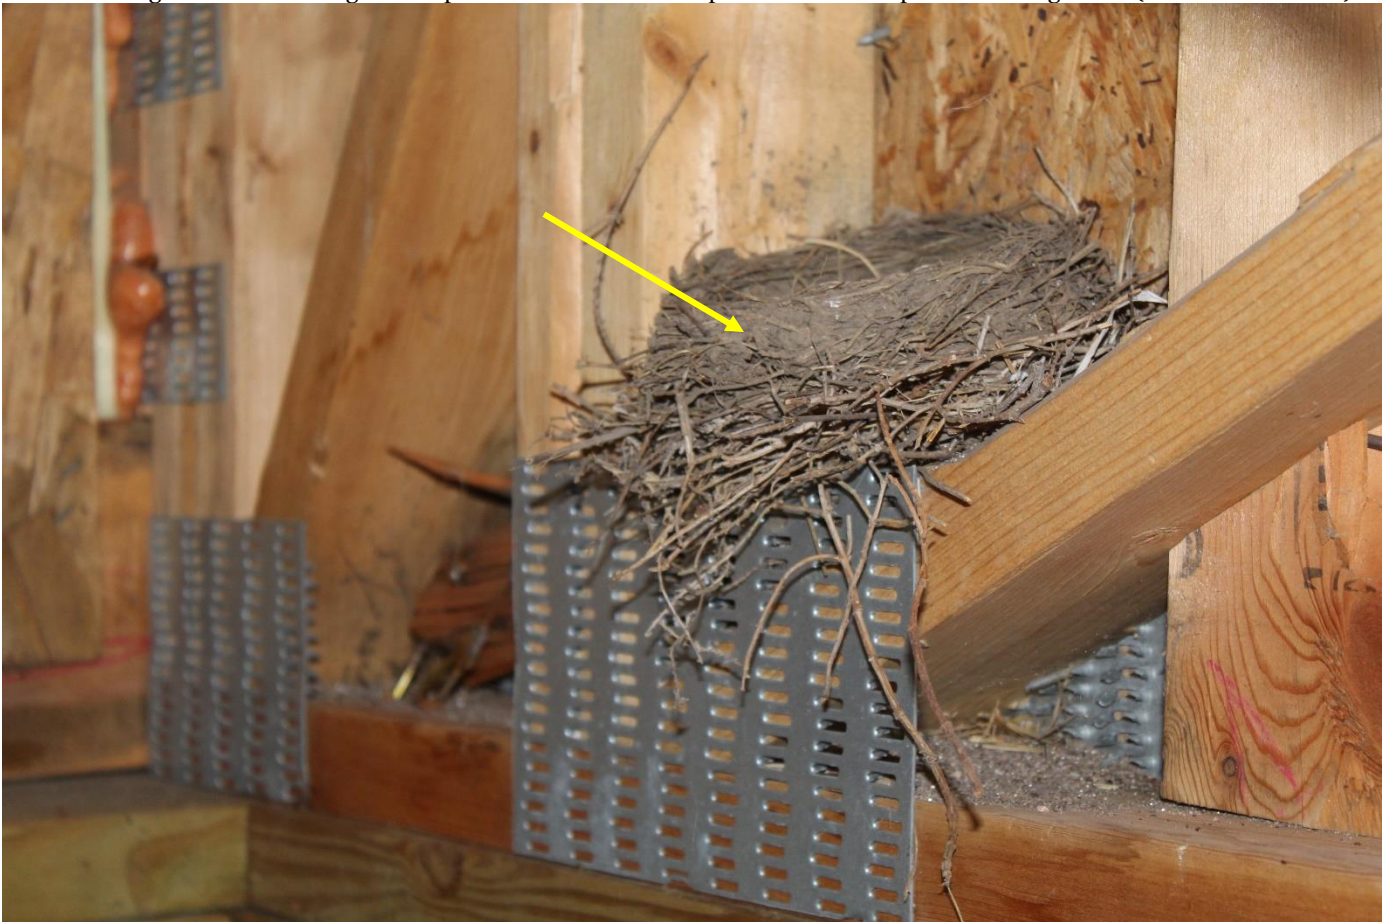
Remove all vegetation and biodegradable plant life from the crawlspace as needed to prevent mold growth. (Birds Nest Noticed)

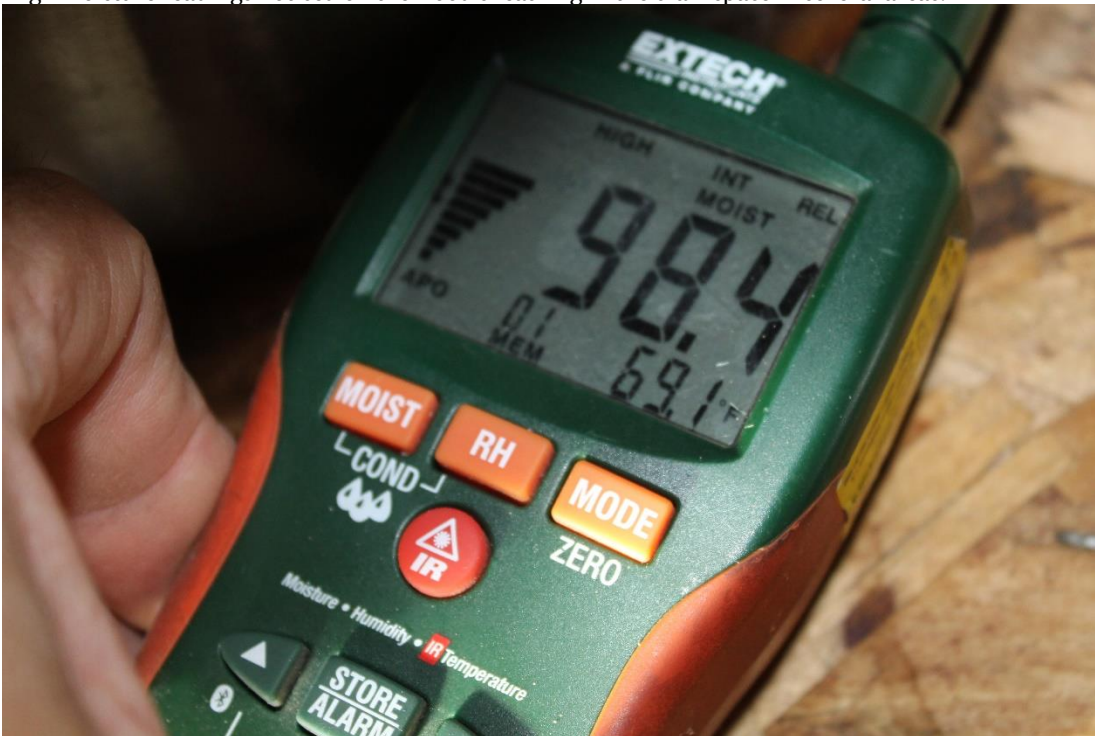
High moisture readings noticed on the wood sheathing in the crawlspace in several areas.
