# Black Hills Professional Home Inspections LLC®

### HOME INSPECTION

**Amber Cottman**  
605-219-6573  
6655 Greenfield Dr  
Rapid City, SD 57703  
[ampercottman@yahoo.com](mailto:ampercottman@yahoo.com)

**REPORT**  
11-1-23

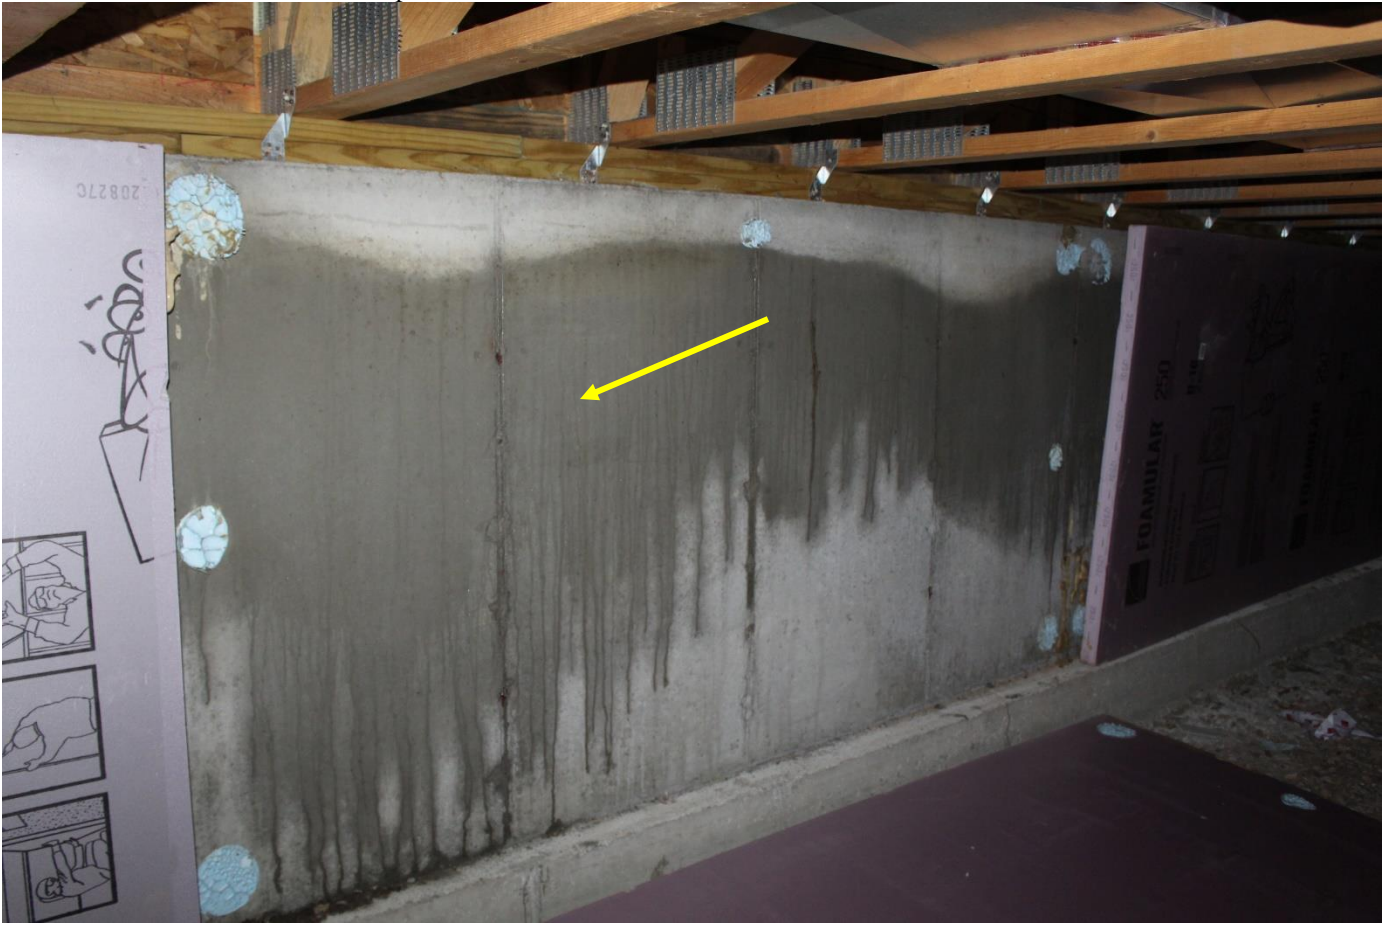
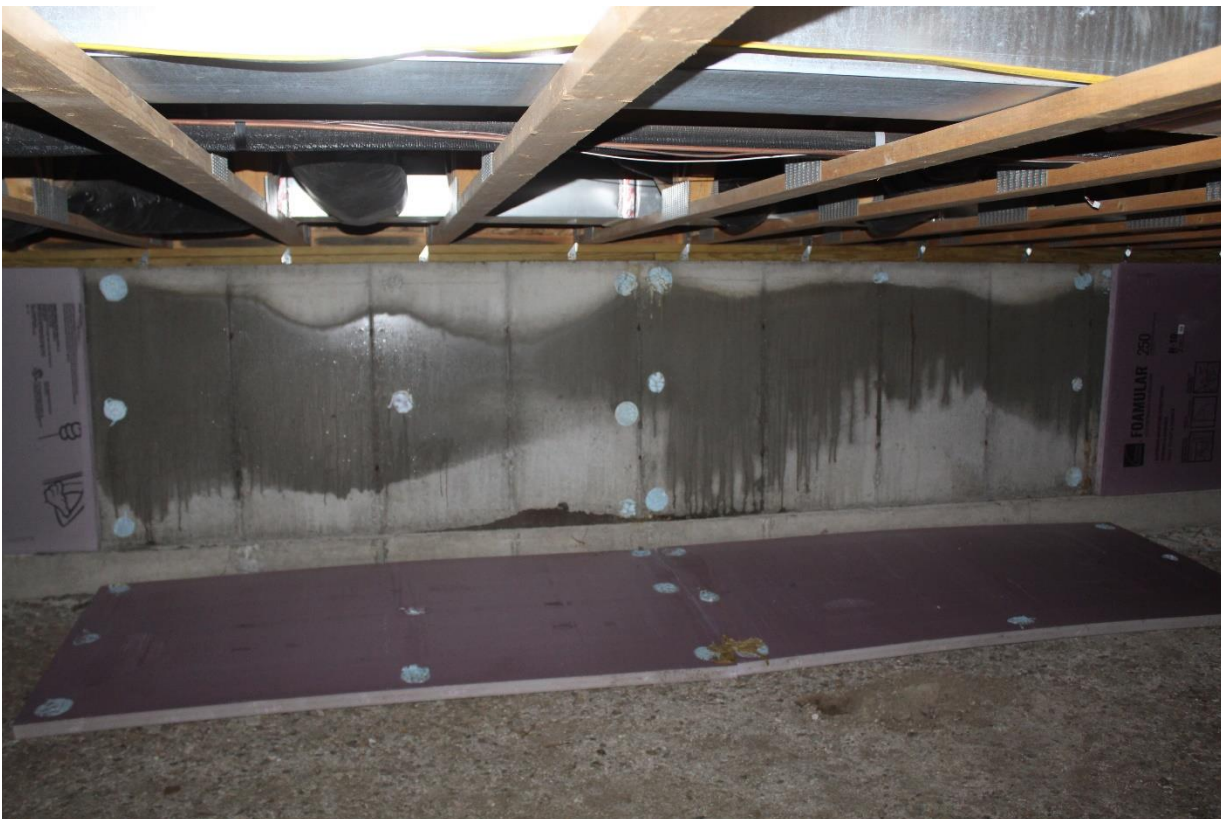
Water intrusion noticed in the crawlspace area. Soaked foundation walls noticed.

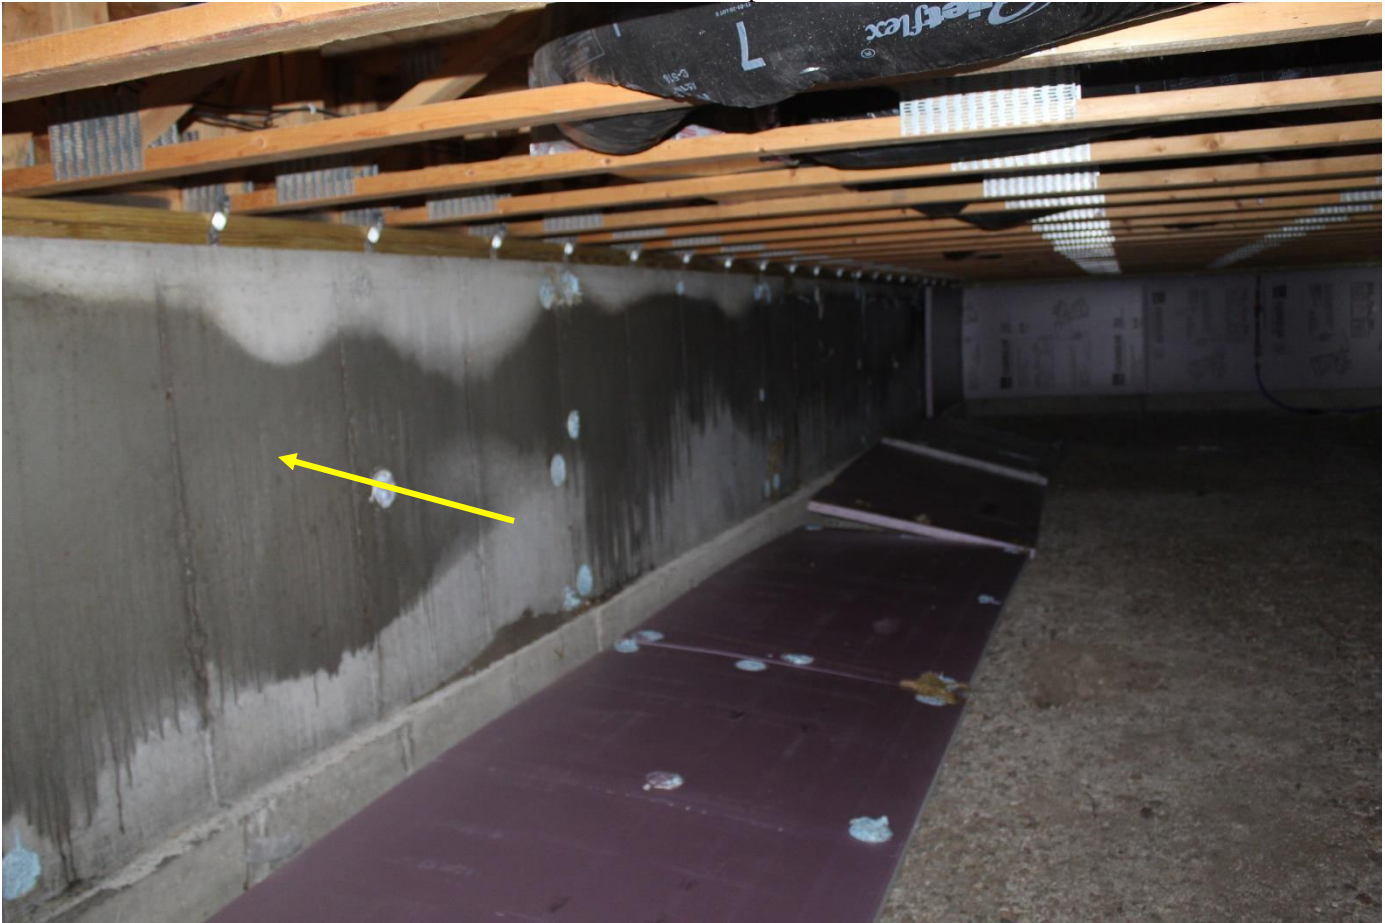
Water intrusion noticed on the foundation walls behind the insulation panels.

I recommend correcting the siding installation to prevent further water intrusion into the crawlspace, and highly recommend installing ventilation in the crawlspace as soon as possible to help relieve the moisture and condensation to prevent further mold issues. No ventilation was noticed in the crawlspace. The plans called for heat vents to be installed to make the crawlspace a conditioned area, no vents were noticed to be installed in the duct work at this time. High levels of moisture were noticed to be entering the crawlspace due to poorly installed siding, no venting, poor grading around the home and a lack of ventilation. I also noticed the exhaust from the heat recovery ventilator is not discharging condensation to the outside. All insulation panels should be removed help the concrete dry out, After the crawlspace has been dried out reinstall the insulation panels.

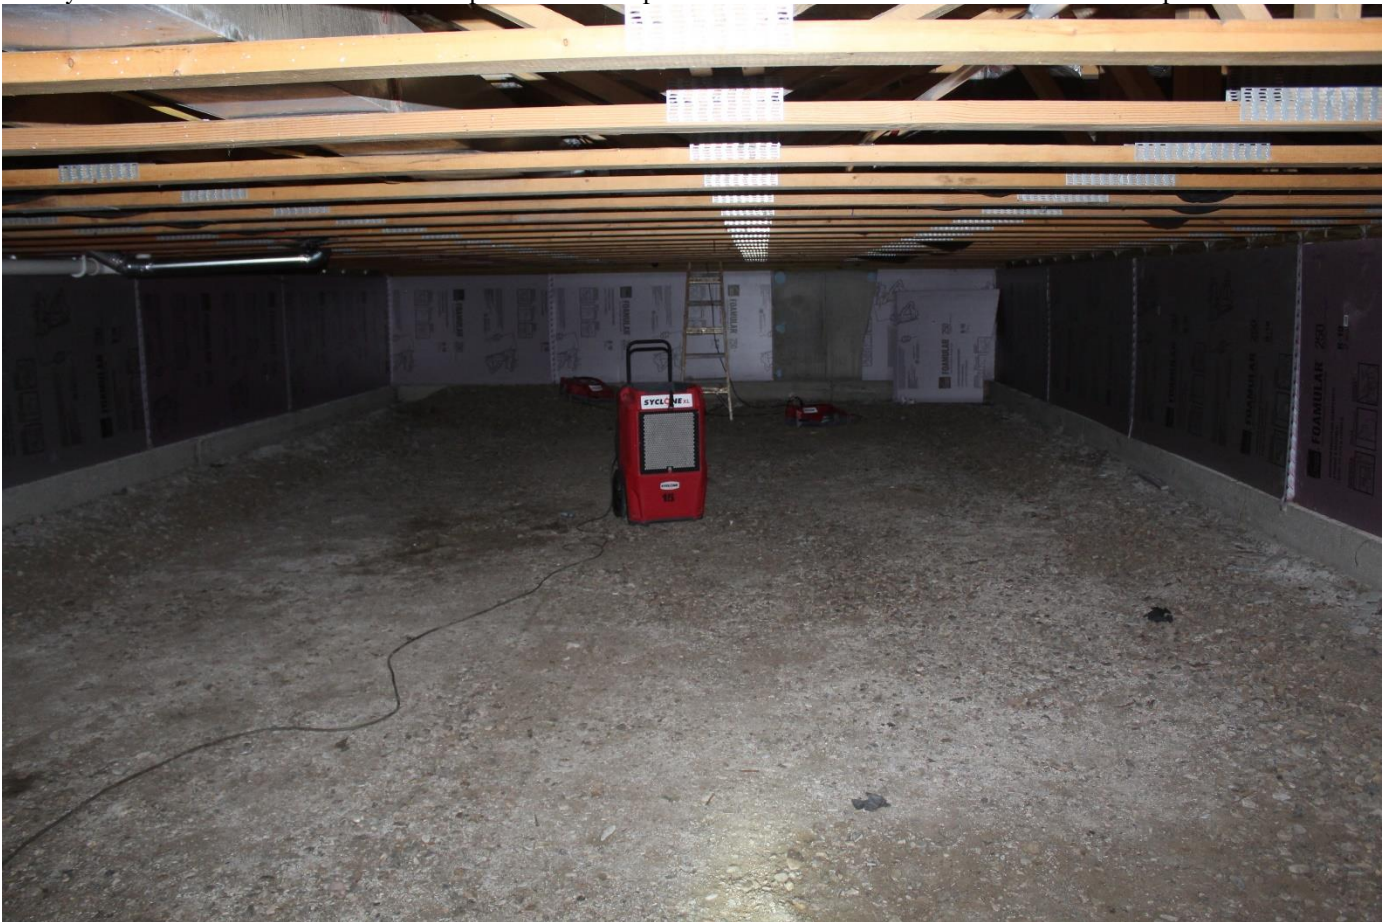
Muddy & wet dirt floor noticed in the crawlspace area. No vapor barrier noticed on the dirt floor in the crawl space.

I highly recommend installing a vapor barrier to the dirt floor in the crawl space after the moisture issues have been corrected and the area has been dried out. I do not recommend installing a vapor barrier until all water issues have been corrected and ventilation has been installed. You do not want to trap any moisture under the vapor barrier causing more mold issues. I also recommend treating the dirt floor and all wood areas for mold two or three times to kill all the mold within the crawlspace, I also recommend an air scrubber be set up in the crawl space to help remove mold spores from the air, and then do another air quality test after the crawl space has been dried out and treated for mold.

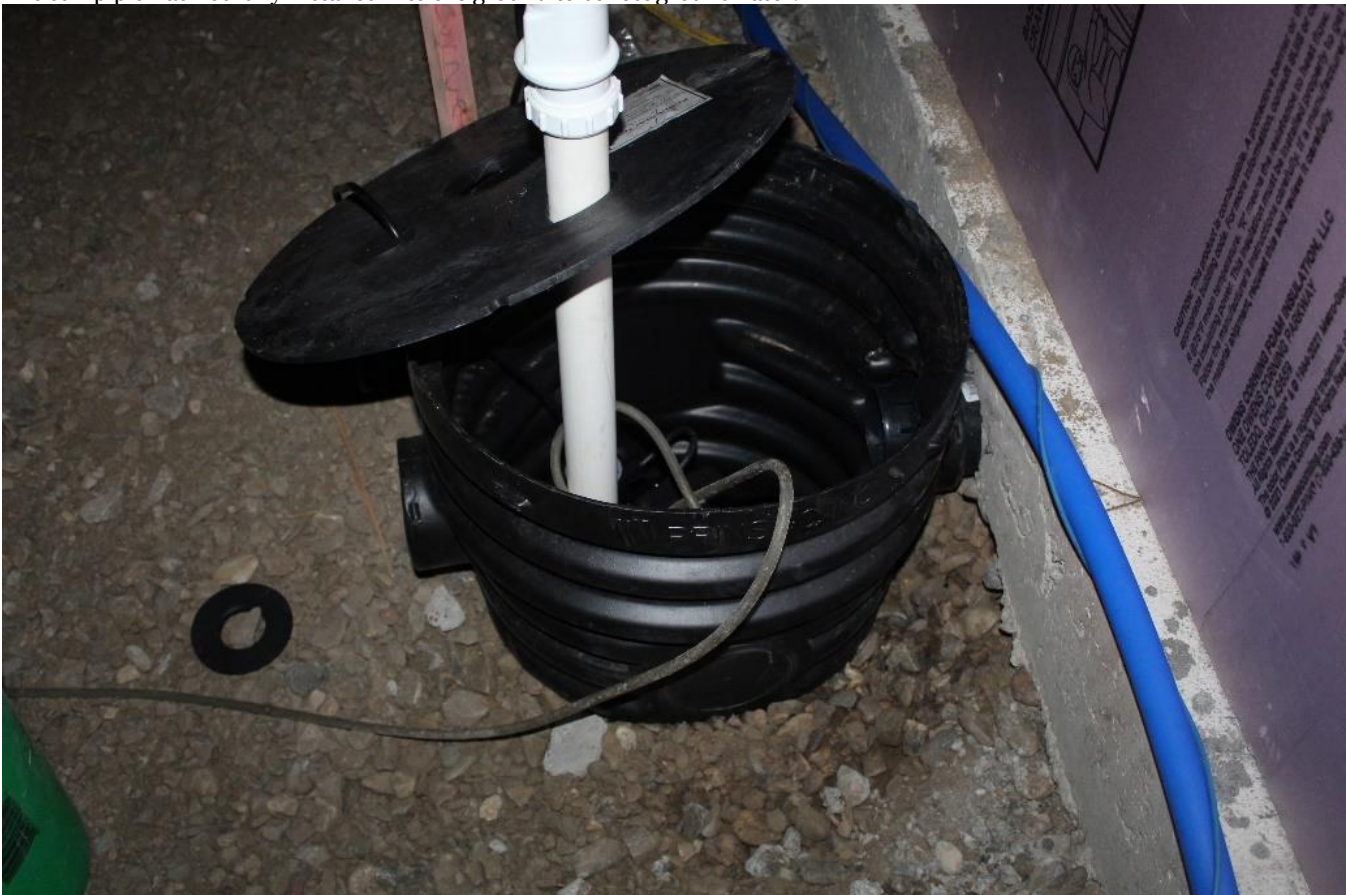
The sump pit was not fully installed into the ground to collect groundwater.

The sump pit casing was not installed properly to help relieve the moisture that was noticed in the dirt floor, the dirt floor is muddy in areas. The sump pit should have holes drilled in the bottom of the plastic pit casing to let ground water into the pit and then removed by the sump pump. I also noticed that the sump pit was not installed at the lowest portion of the ground. (Recommended) No interior drain tile was noticed to be installed leading to the sump pit. The only drain tile noticed was a pipe leading to the outside perimeter of the home. The quality of the installation of the drain tile is unknown at this time. A sewer line scope could be used to determine the quality of the installation of the exterior drain tile. There should be no hills & valleys in the drain tile for good drainage, the drain tile should be installed with a sock with 1" clean gravel on top & the bottom of the piping. When you are installing Drain Tile, it is important to slope the Pipe 1/8" per linear foot. This means that every 8 feet there will be a drop of 1" in the pipe. This is vitally important for the heavier rains.

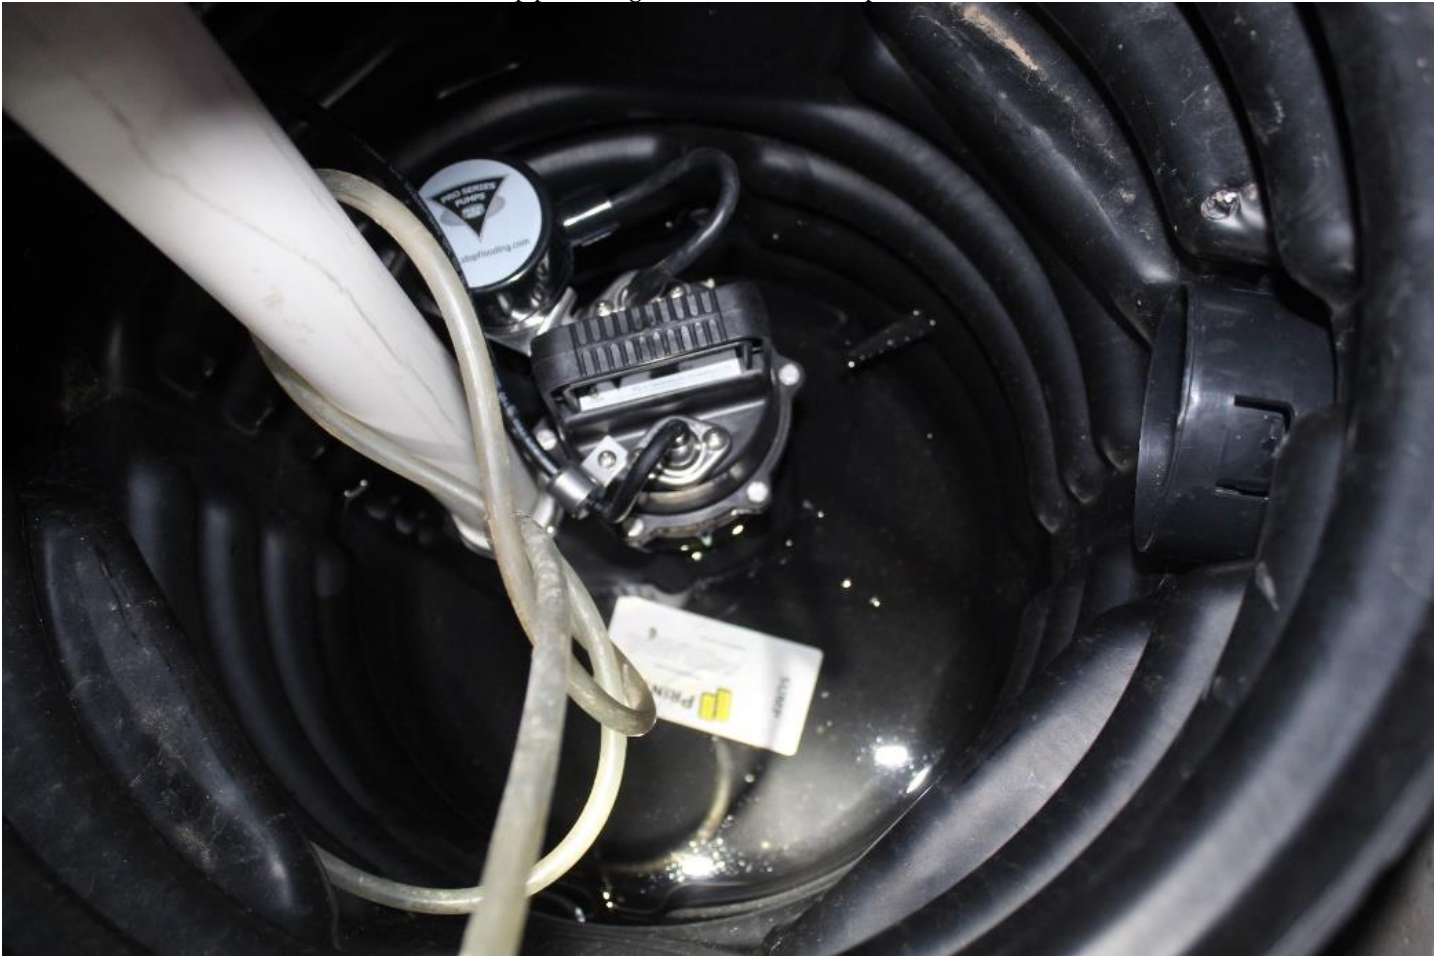
No holes were drilled into the bottom of the sump pit to let ground water into the pit.

Contractors usually drill holes in the bottom of the sump basin and around the sides to allow excess ground water to enter and prevent the basin from floating up. Make sure the holes are smaller than the "solids handling rating" of the pump (generally 1/4 in. to 3/4 inch in size) Clean gravel should be then installed around and at the bottom of the sump basin to help filter out silt & dirt before entering the sump basin. A fine mesh should then be installed on top of the clean gravel to further prevent soil & silt from entering into the sump basin and sump pump. (Highly Recommended)

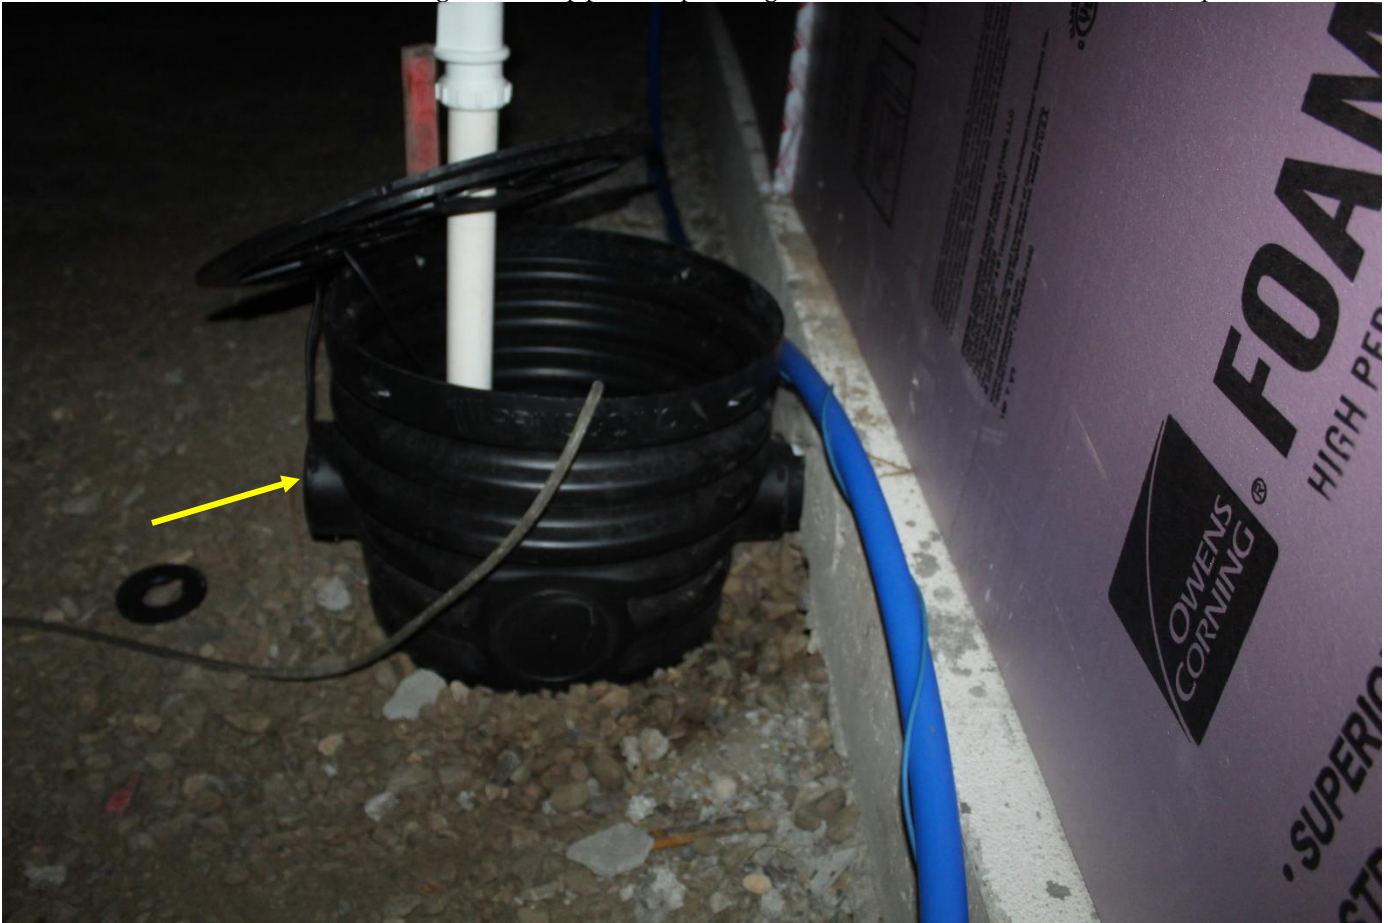
No interior drain tile was installed leading to the sump pit to help relive ground water from under the home as requested.

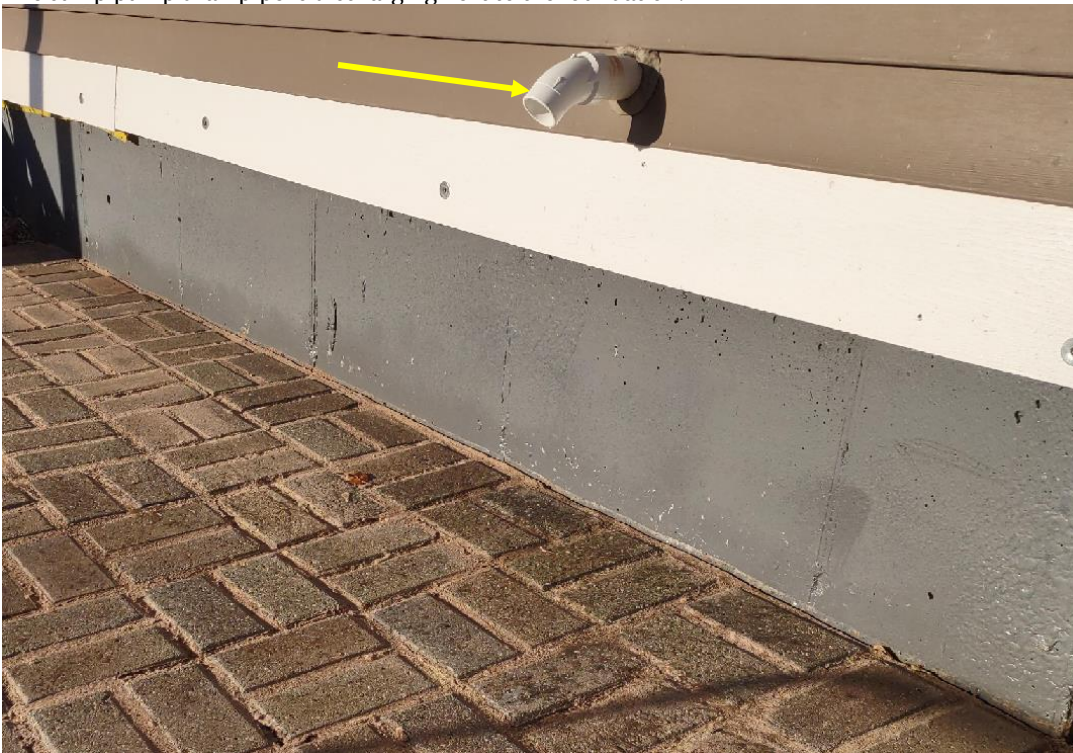
The sump pump drainpipe is discharging next to the foundation.

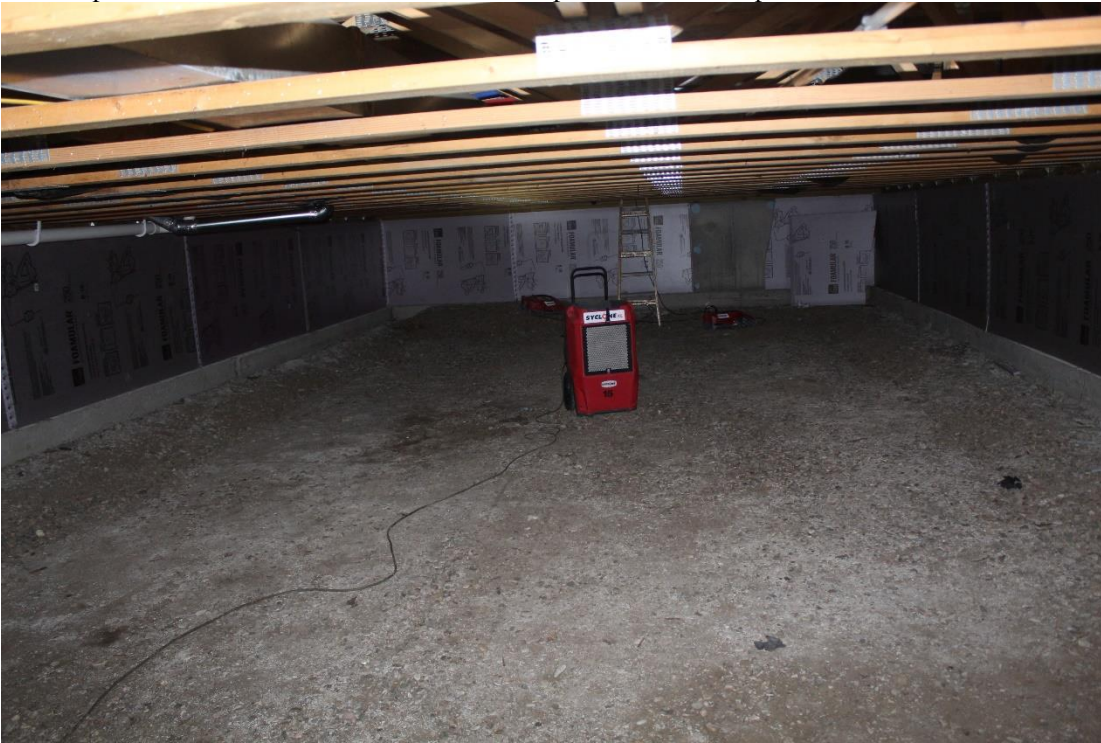
The sump pit should have been installed at the lowest point in the crawl space to be effective and was not.

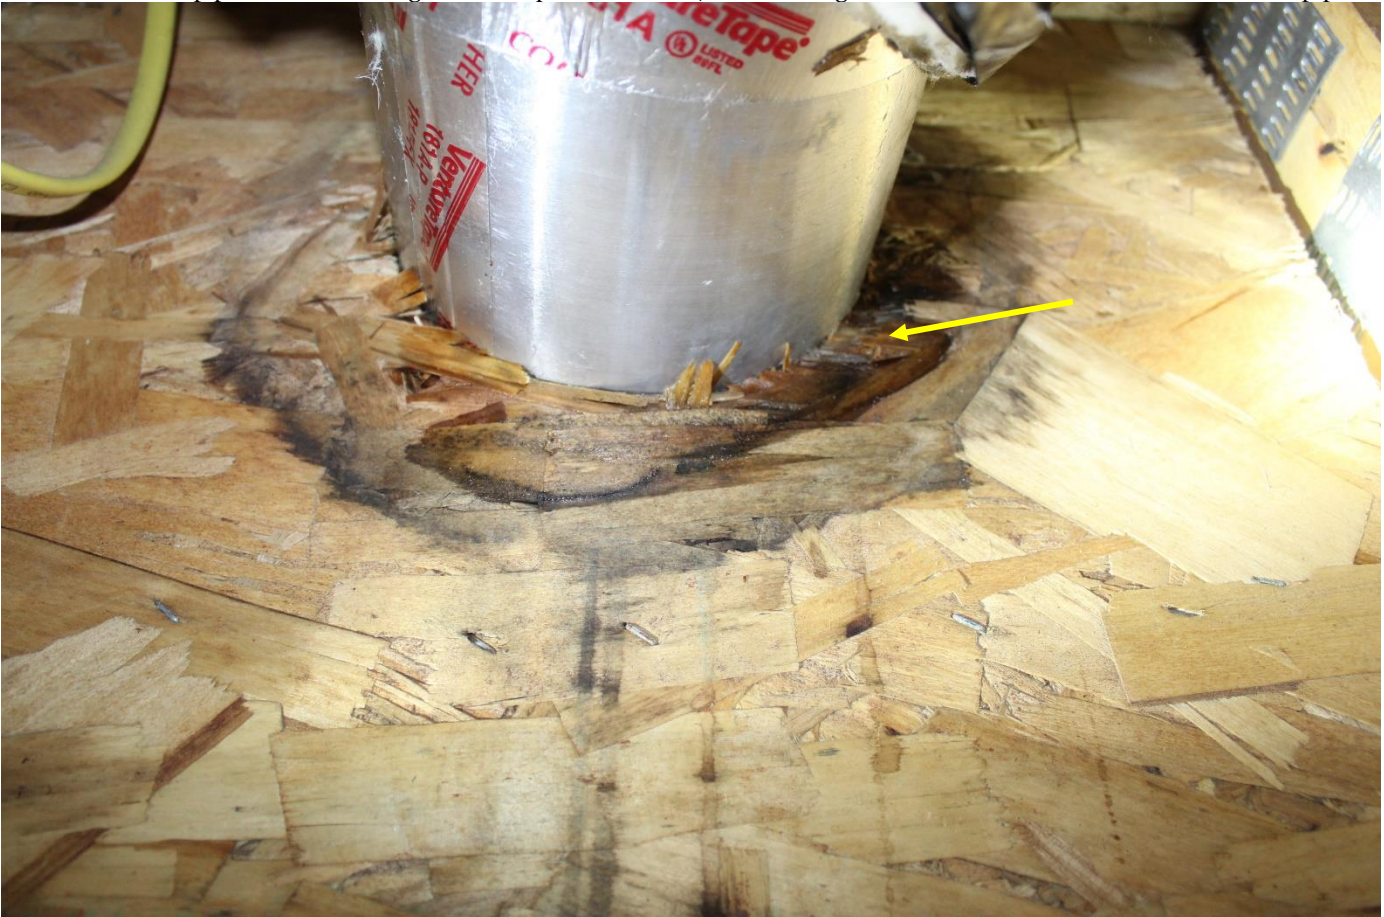
The HRV exhaust pipe has been leaking water for quite some time, water damaged noticed to the wood around the exhaust pipe.

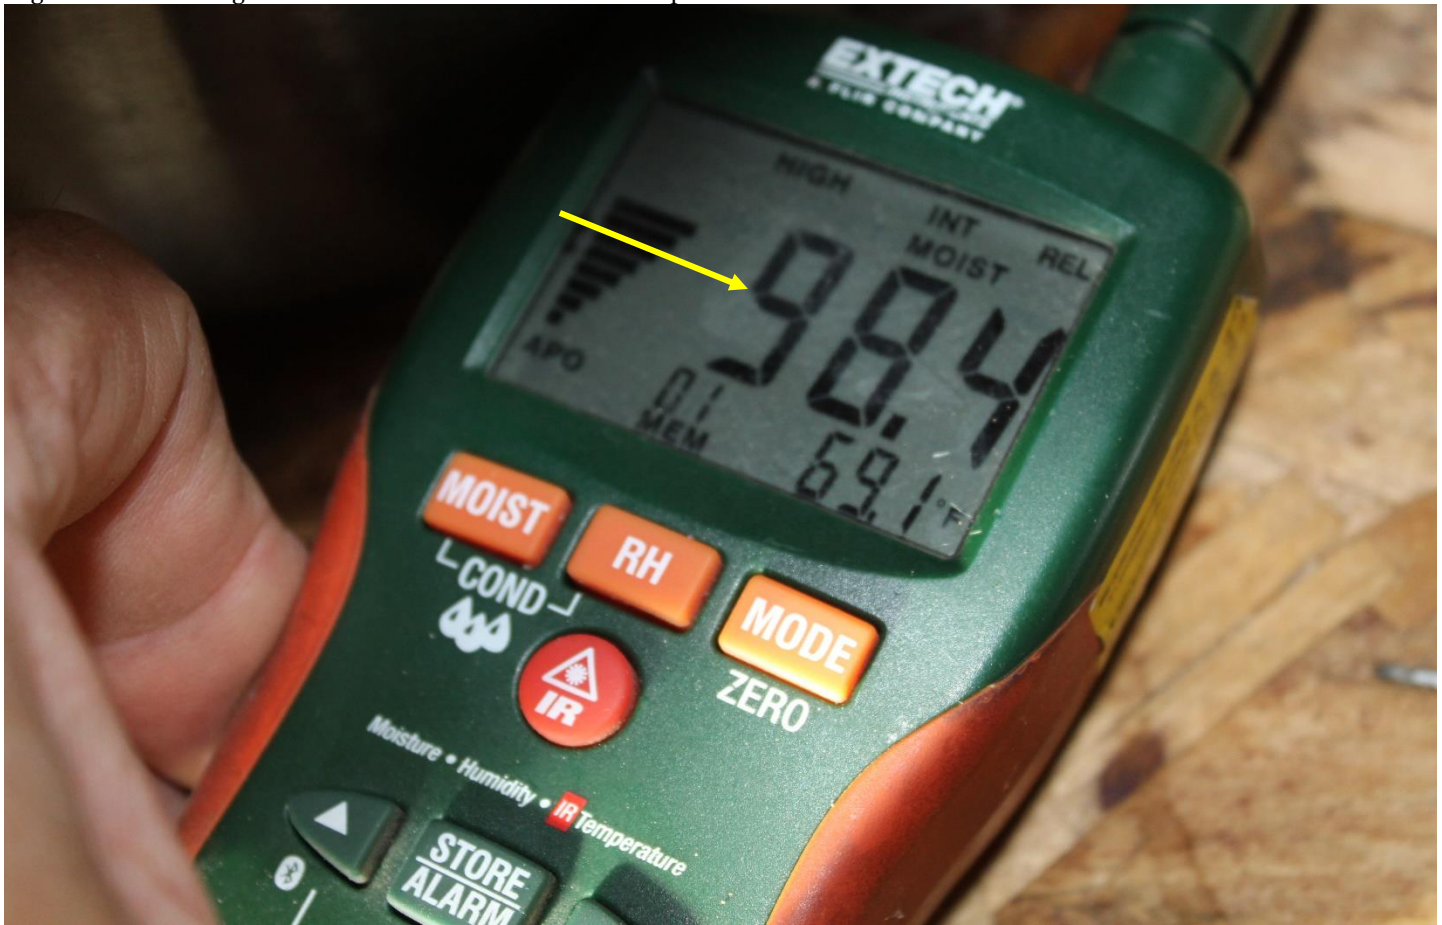
High moisture readings were taken & noticed within the crawlspace.

Dusty Johnson from Black Hills Inspection Services & Black Hills Professional Home Inspections LLC inspected the crawlspace on November 1<sup>st</sup> 2023 at or around 9:00 am and we found several concerns regarding moisture intrusion into the crawlspace. All moisture issues should be addressed and repaired, and have the crawlspace treated for mold. We highly recommend having vents be installed within the crawlspace as soon as possible to help dry out the crawlspace.

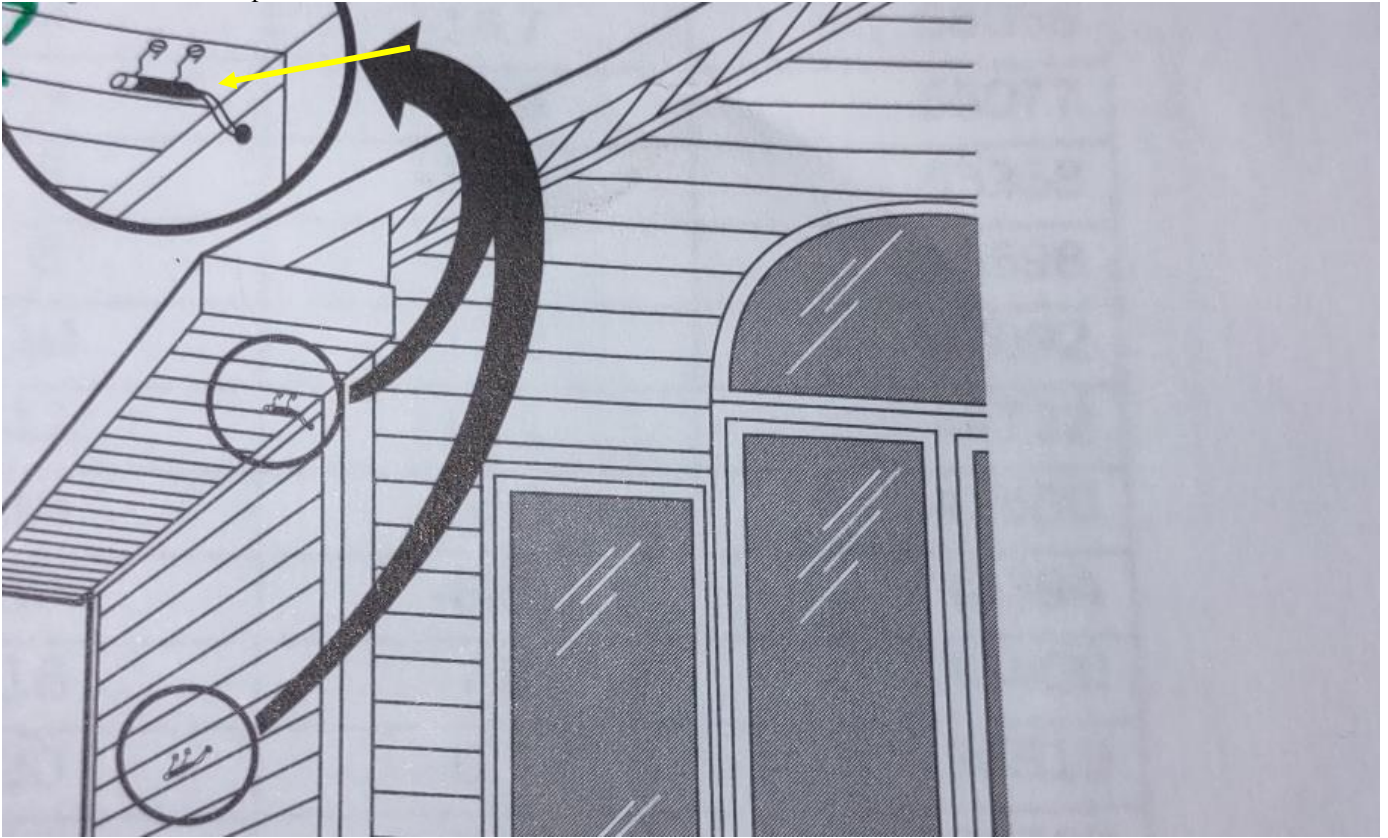
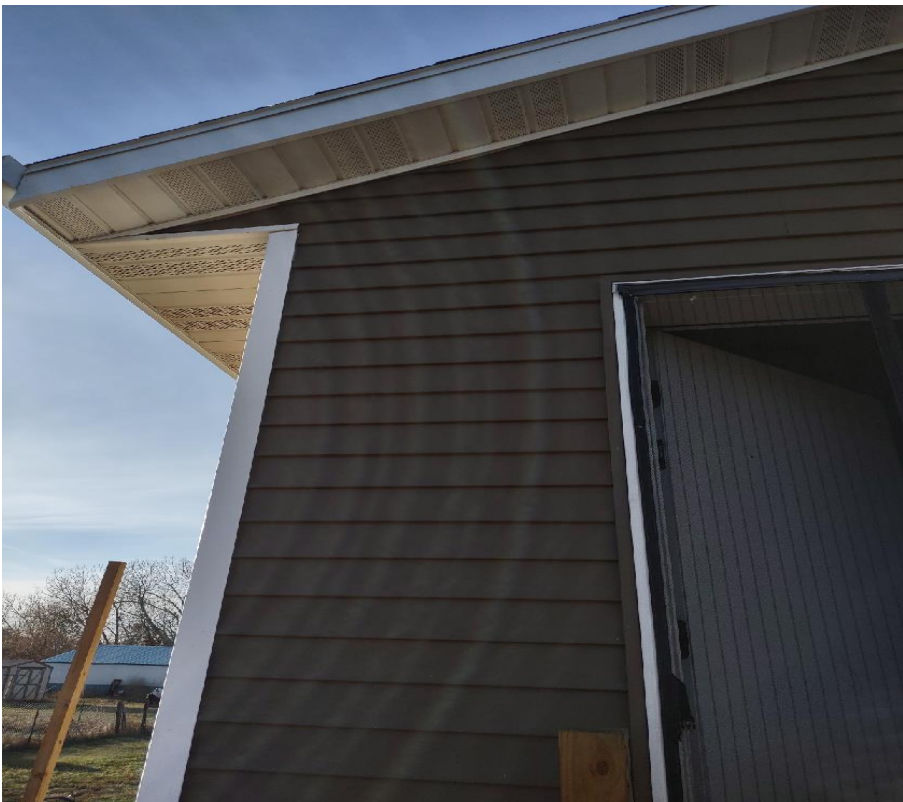
No remote outdoor temperature sensor was installed on the exterior of the home as stated.

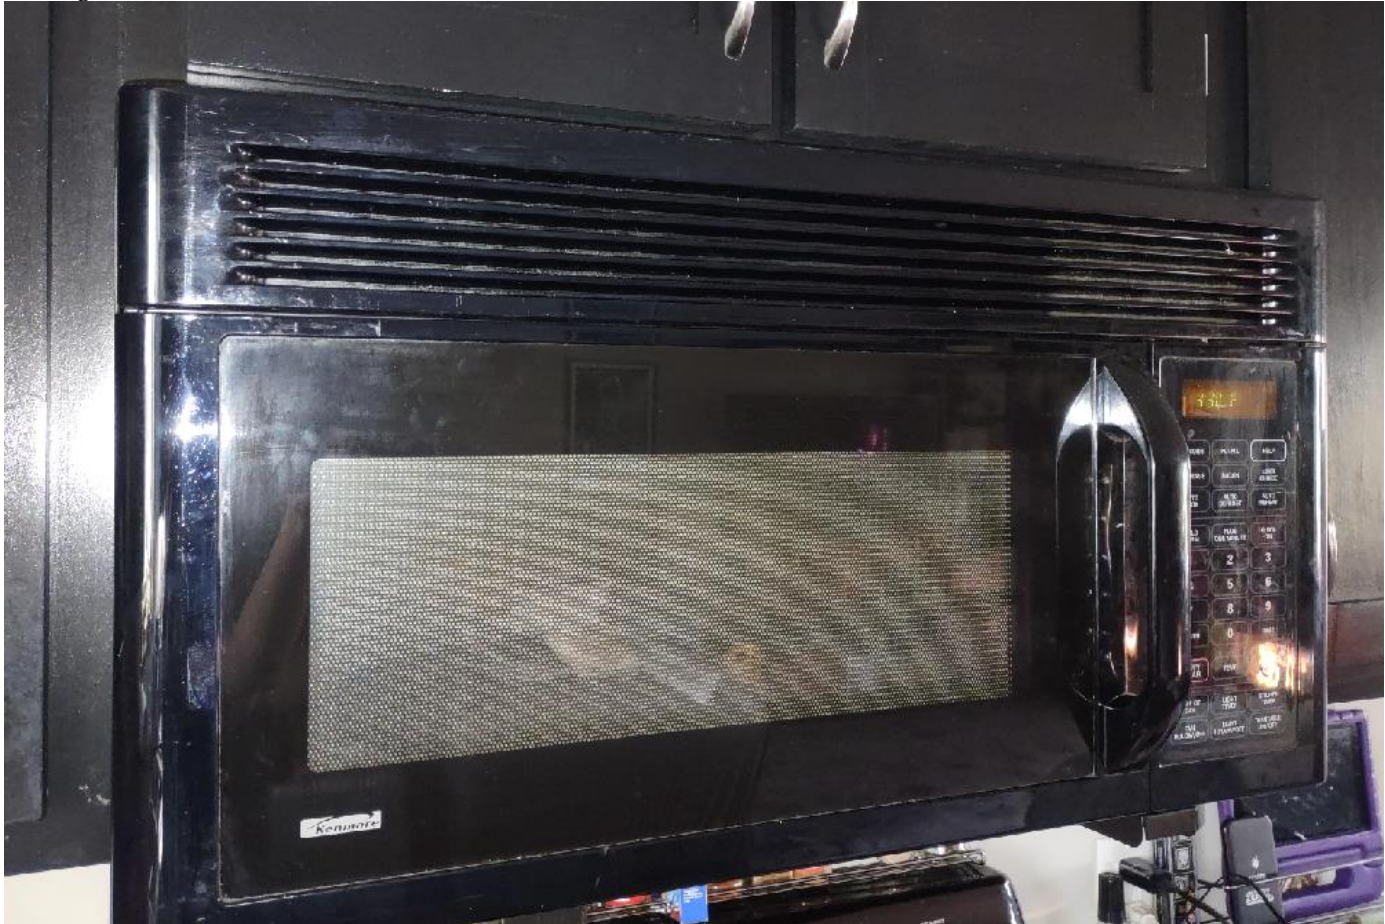
No rangehood was noticed to be installed.

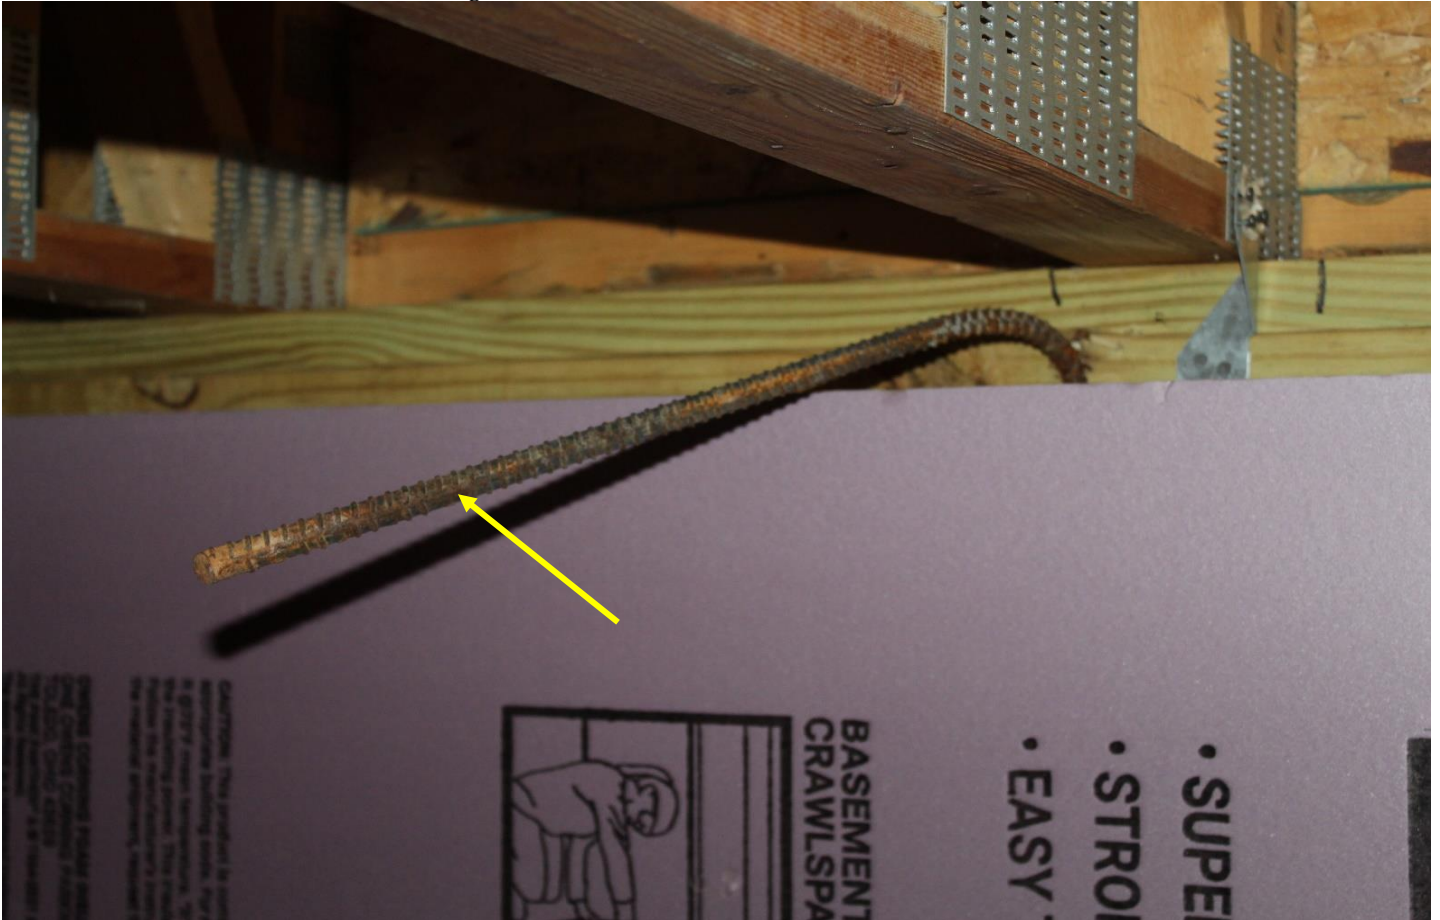
The ground rod that was installed in the foundation wall for grounding the electrical service appears not to have been utilized for grounding the system. Further investigations would be needed to see if the installed ground rod is being used. The grounding connection could be at the base of the foundation footing.
