Foundation Defect Discussion

- 1 Soil Test**
Soil Test in IRC, Soil test in Foundation Plans, Soil Test requested and Paid For by Amber Cottman. **Soil Test was not performed as requested by Amber Cottman**
- 2 Expansive Soils**
IRC and IBC requirements Expansive soils, Engineered Fill. **Code Requirements were not followed for the presumed Expansive Soils.**
- 3 Elevation of Foundation**
No elevation survey conducted to determine foundation elevation.
- 4 Crawl Space Floor**
Wrong Elevation, Improper Grading, No Base Course, Lead to flooding of the crawlspace

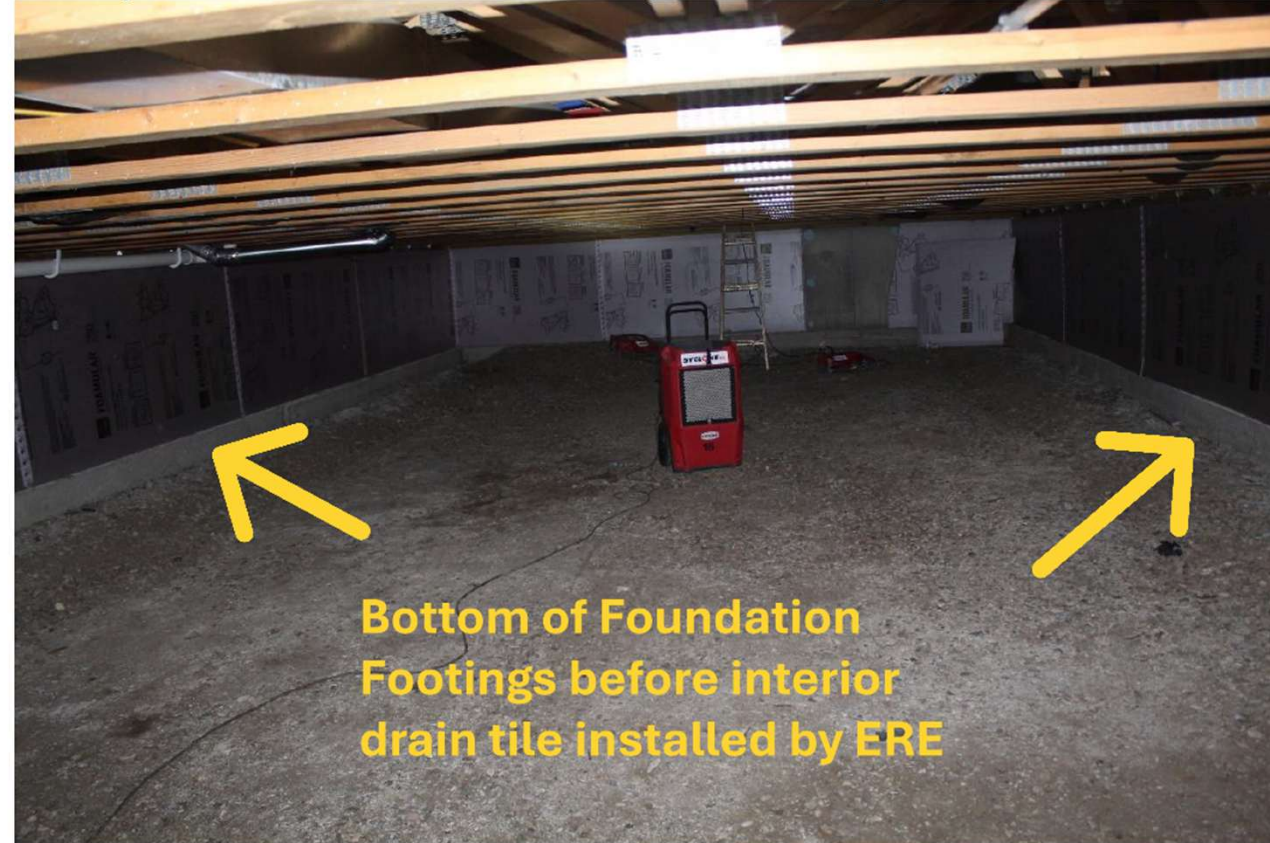
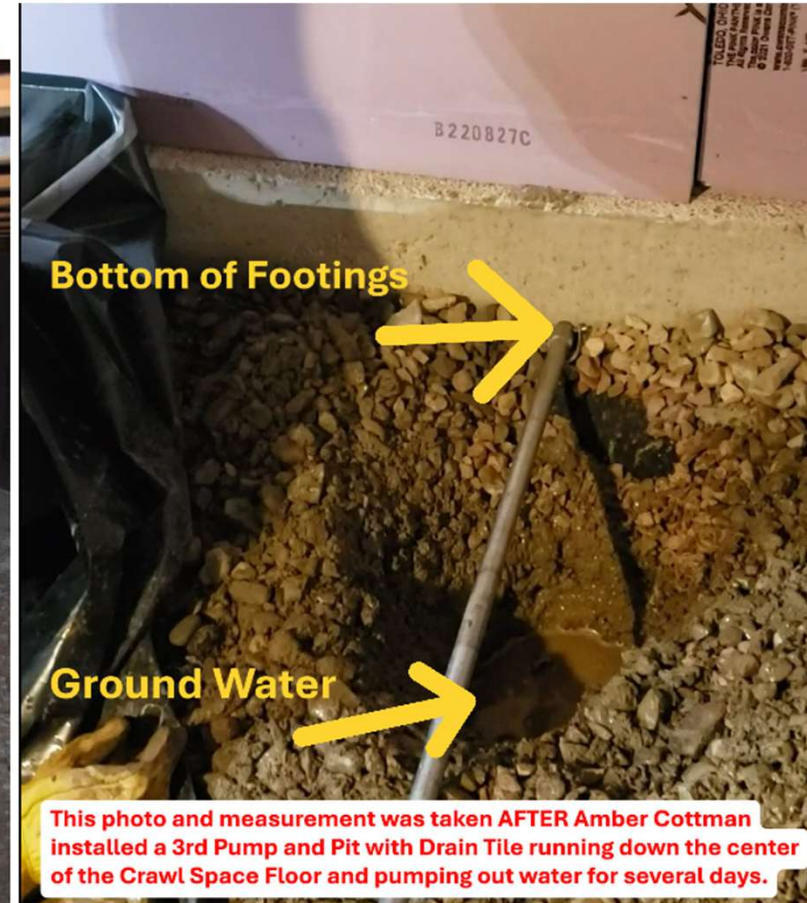
Pictures of Crawlspace Floor

The sump pit should have been installed at the lowest point in the crawl space to be effective and was not.

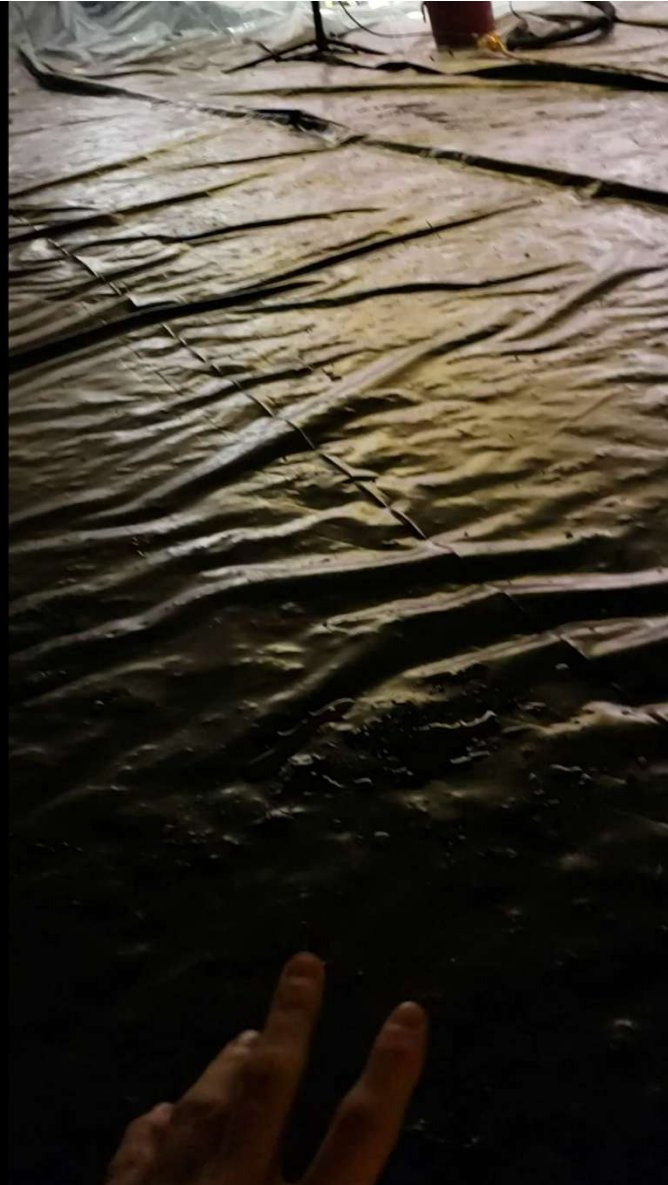
Video of Flooding

Flooding of crawlspace occurred due to contractor negligence.

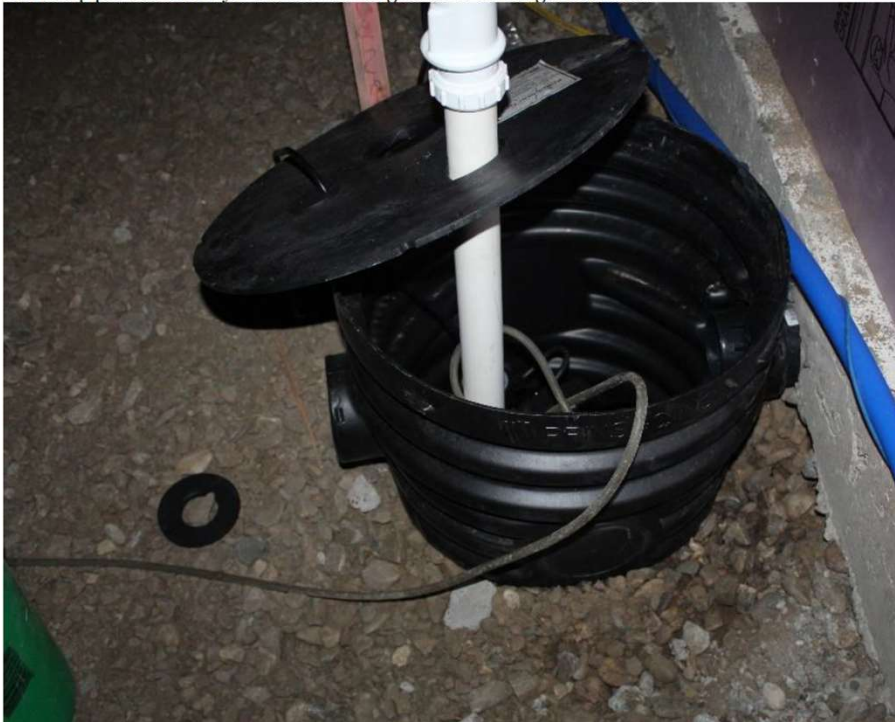
The sump pit was not fully installed into the ground to collect groundwater.

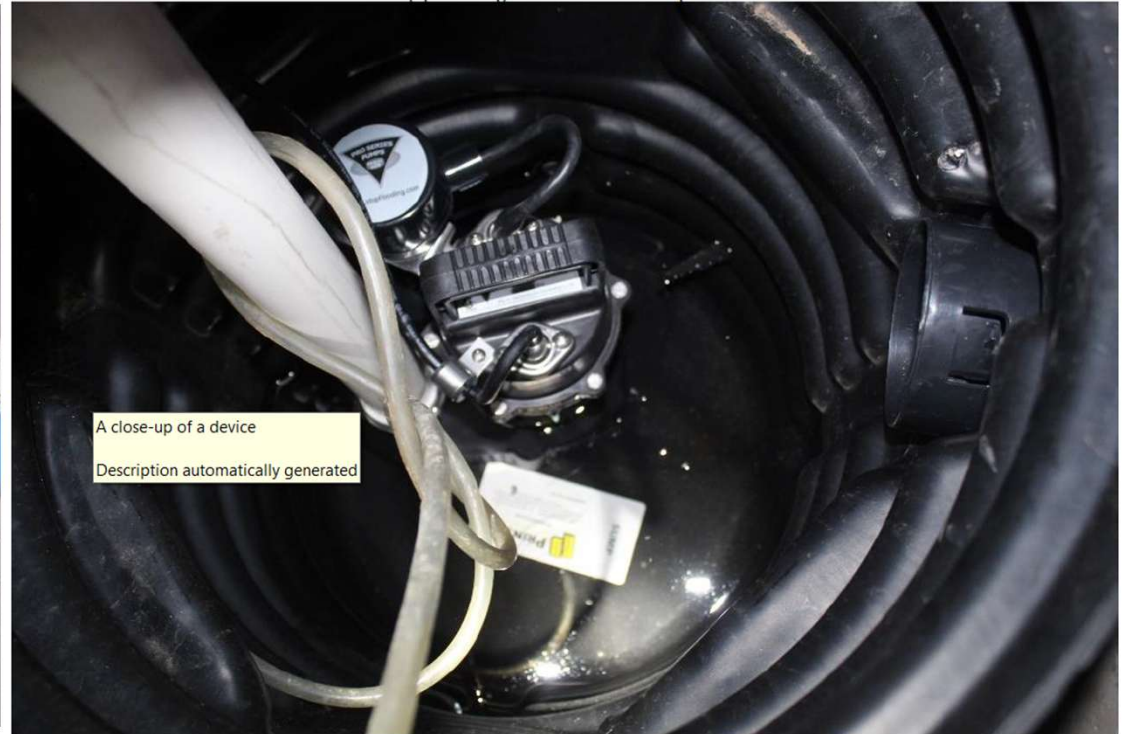
No holes were drilled into the bottom of the sump pit to let ground water into the pit.

The Sump pit was not fully installed into ground to collect ground water; No Holes drilled into the bottom of the sump pit to let ground water into basin. This is the wrong type of basin for this application.

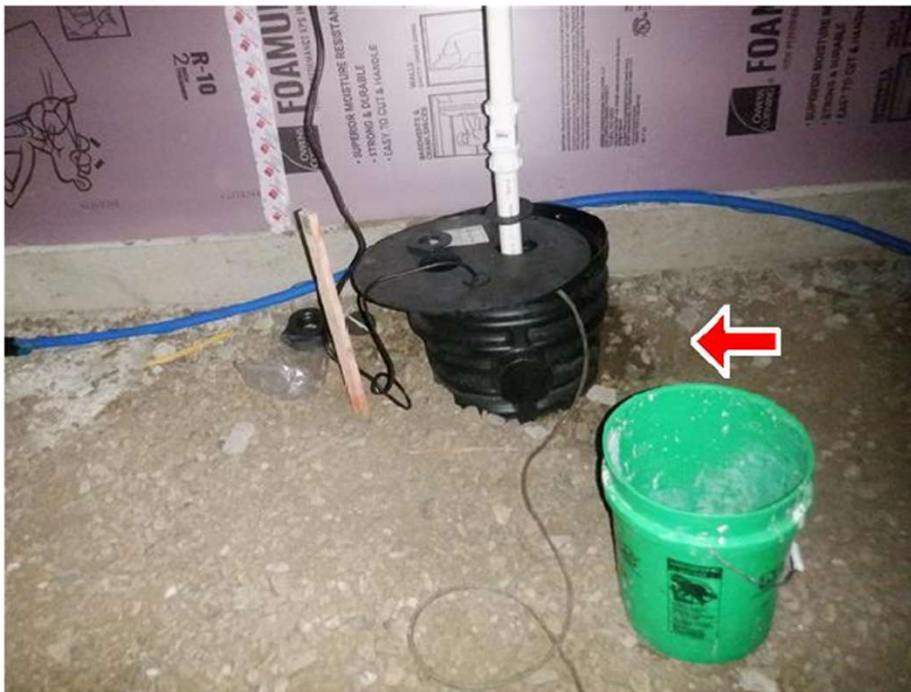
Picture from Inspection Services LLC, Dusty Johnson (P122)

(5) Sump pump for exterior drain tile. Add another pit and pump or drop pit and add holes and or drain tile for interior moisture

This is a recommendation from Dusty Johnson

This recommendation was never acknowledged by Mike Walker and was never in Mike Walkers plan to remedy

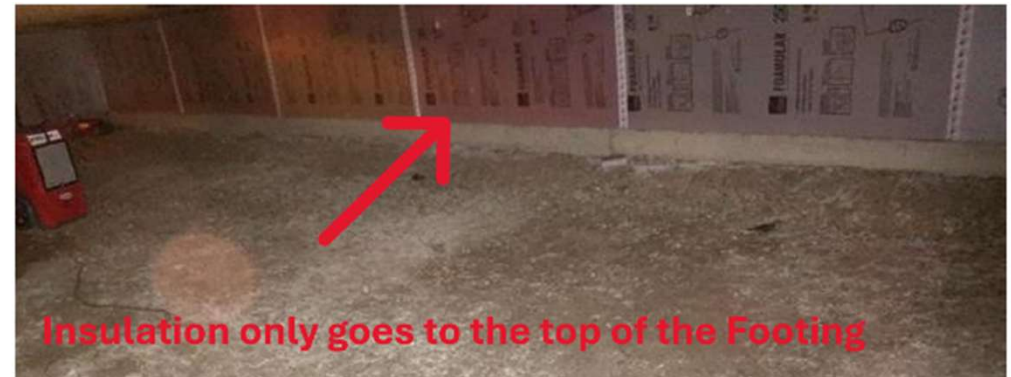
Insulation only reaches the top of the footings. IRC states that it shall extend downwards to the floor of the finished grade and then extend vertically or horizontally and addition 24 inches.

Insulation only goes to the top of the Footing

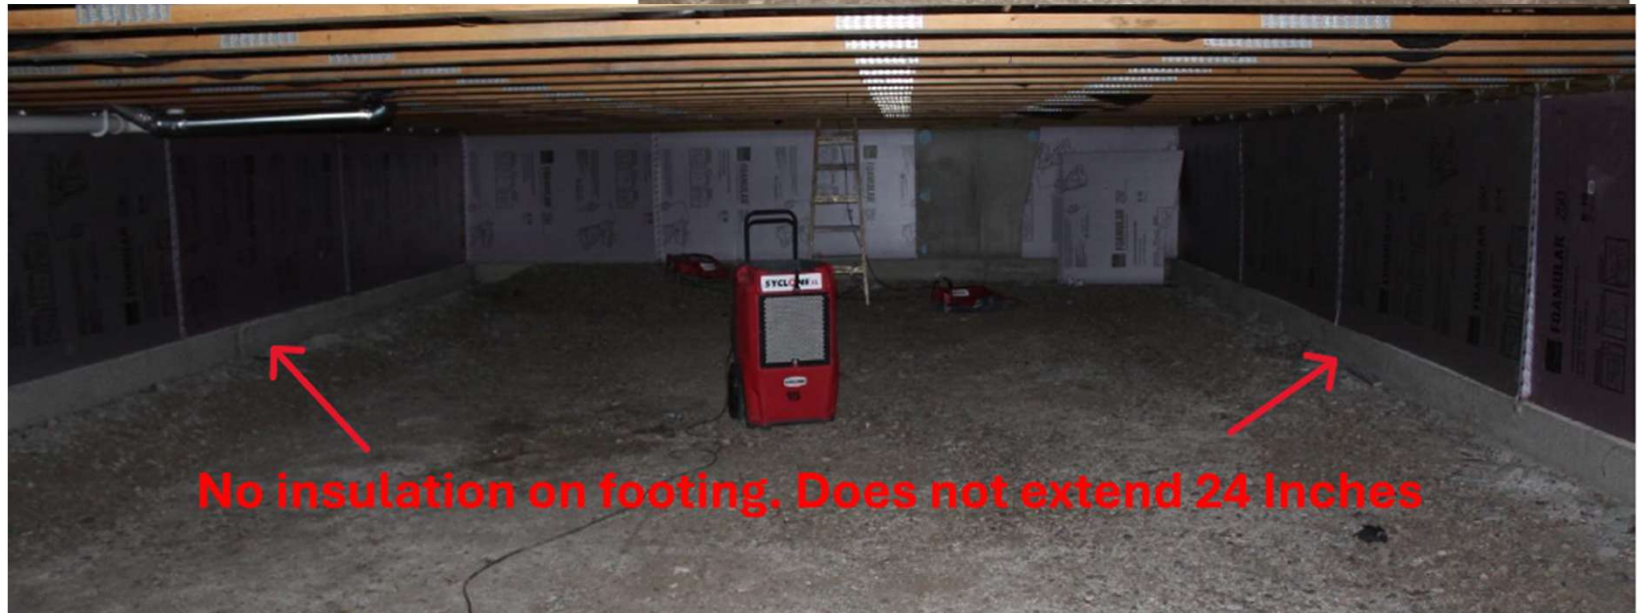
No insulation on footing. Does not extend 24 Inches

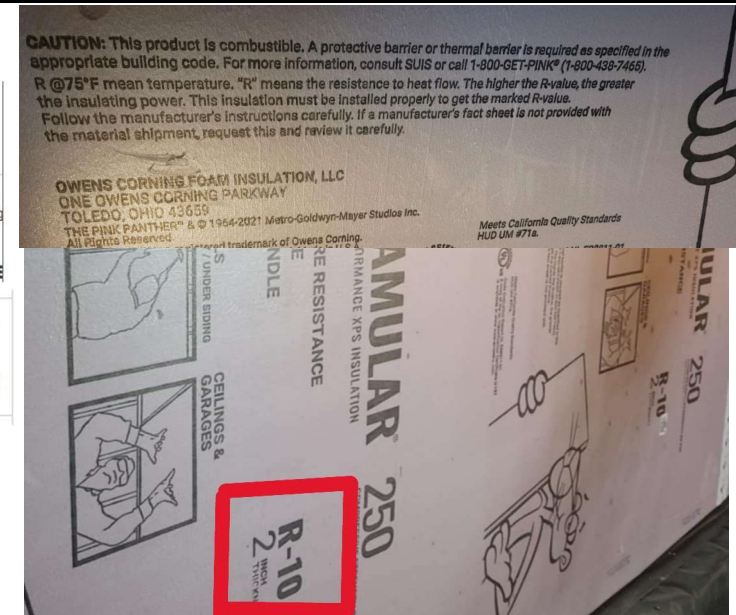
Installed is R-10 and does not meet IRC

These are pictures of the Insulation glued to the stem wall of the foundation.

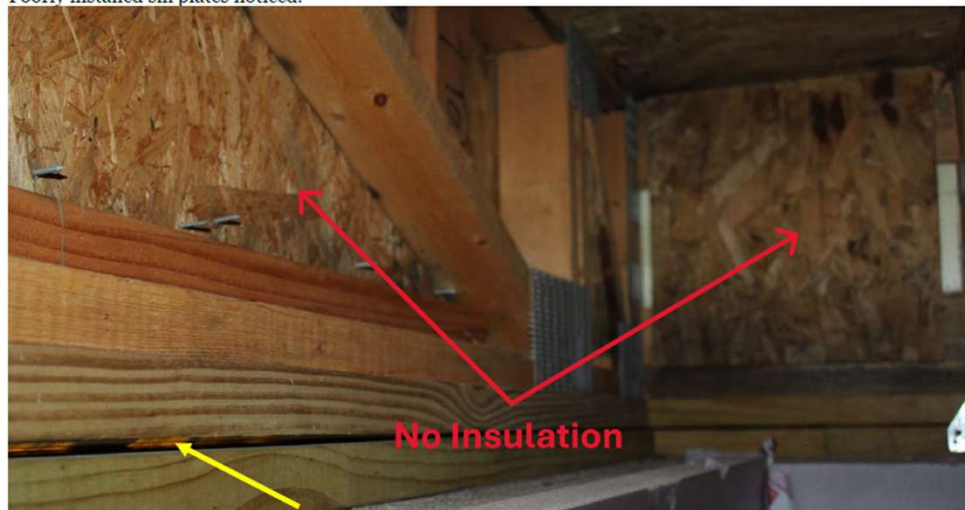
Poorly installed sill plates noticed.

Picture shows no insulation.

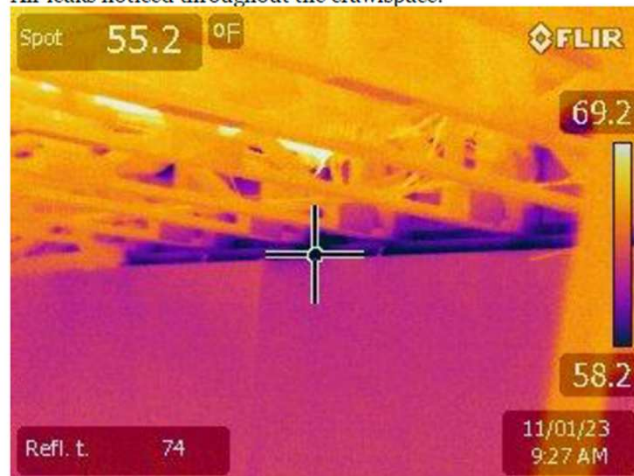
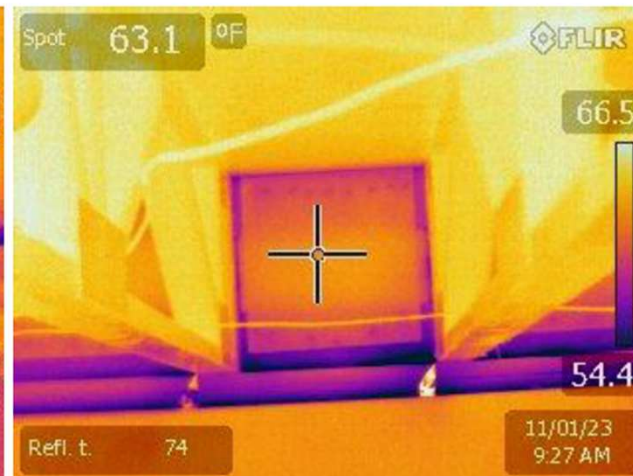
Air leaks noticed throughout the crawlspace.

Thermal Imaging from Home Inspection heat loss. The Dark Purple is areas with extreme temperature differences. These are areas that will lose heat or cooling due to lack of proper insulation.

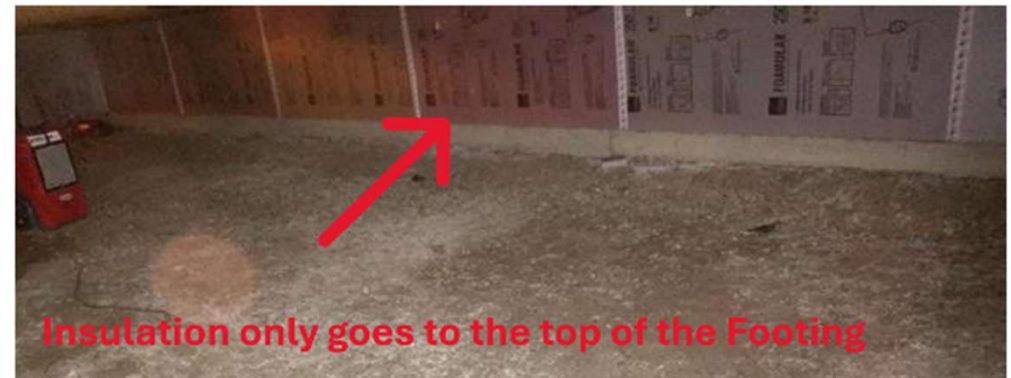
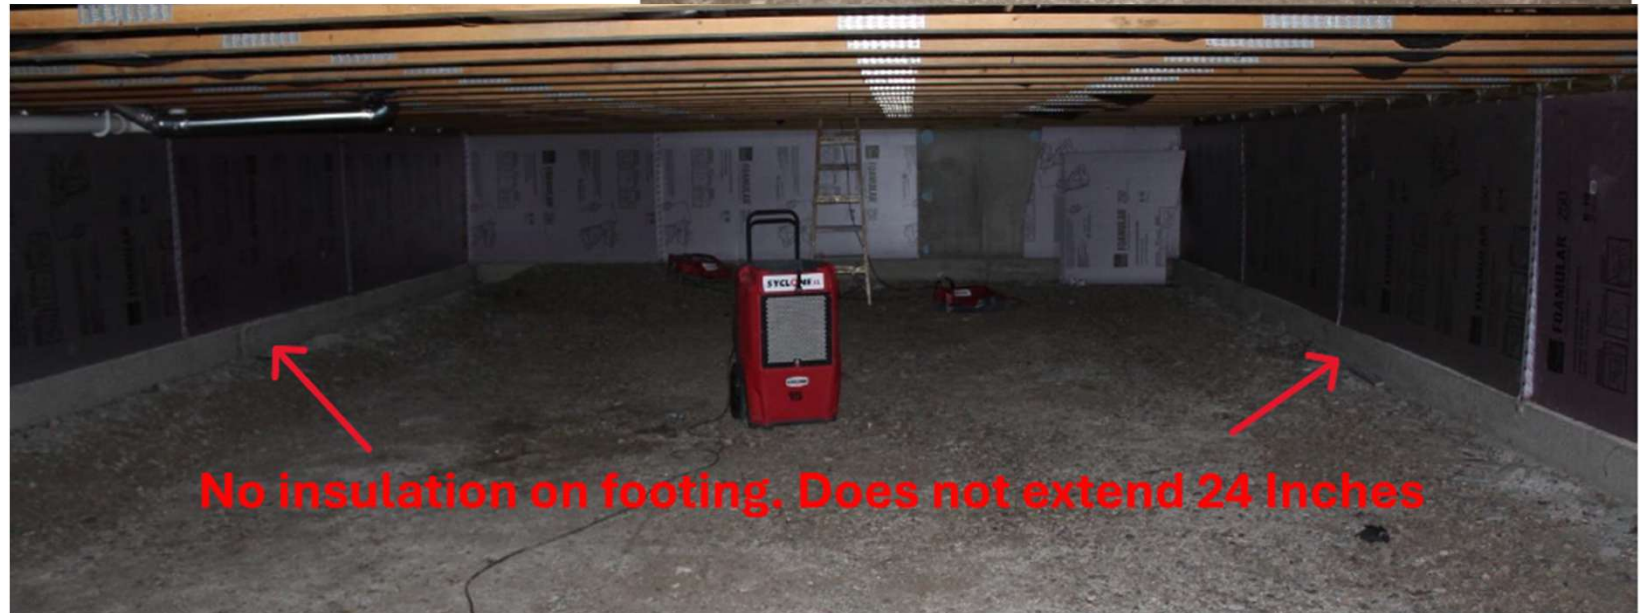
Pictures from Professional Inspection Reports

No Vapor Barrier installed on the crawlspace floor

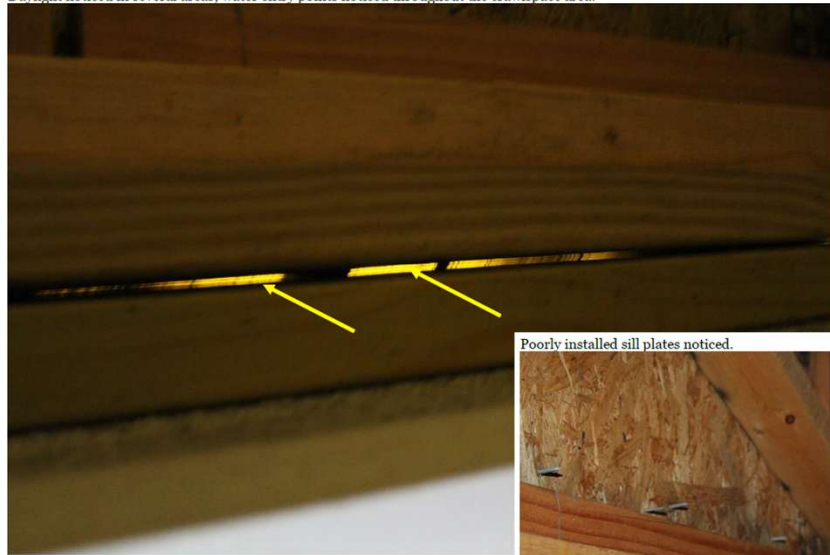
Daylight noticed in several areas; water entry points noticed throughout the crawlspace area.

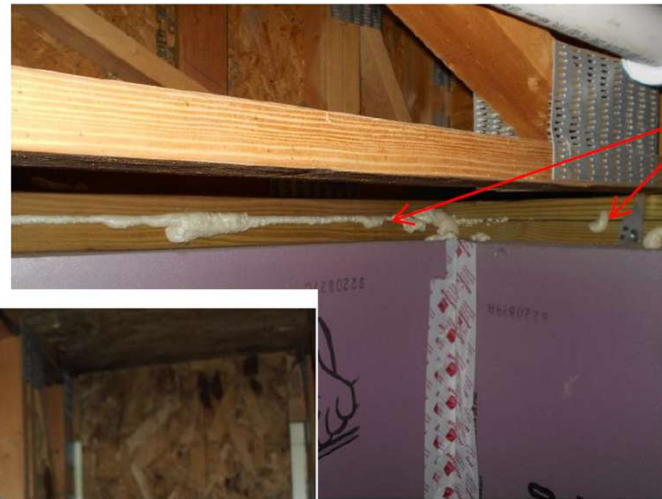
Double Sill Plate on West Wall

Attempts were made to close the gap in this corner with use of spray-foam insulation. Spray foam has no structural capacity and is not considered a structural repair of the gapping observed.

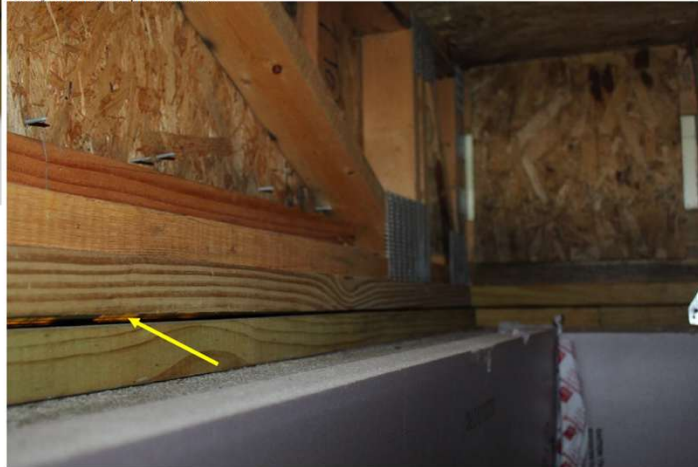
Poorly installed sill plates noticed.

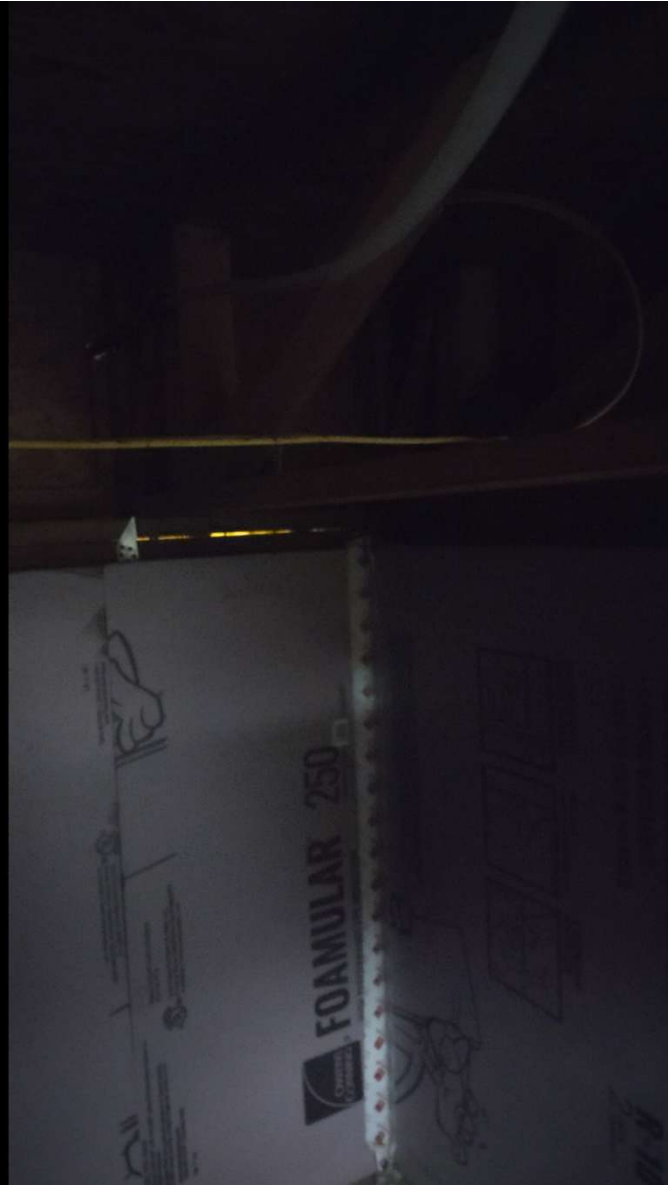
Video Showing
Sunlight coming
through the 2 Sill
Plates into
crawlspace.

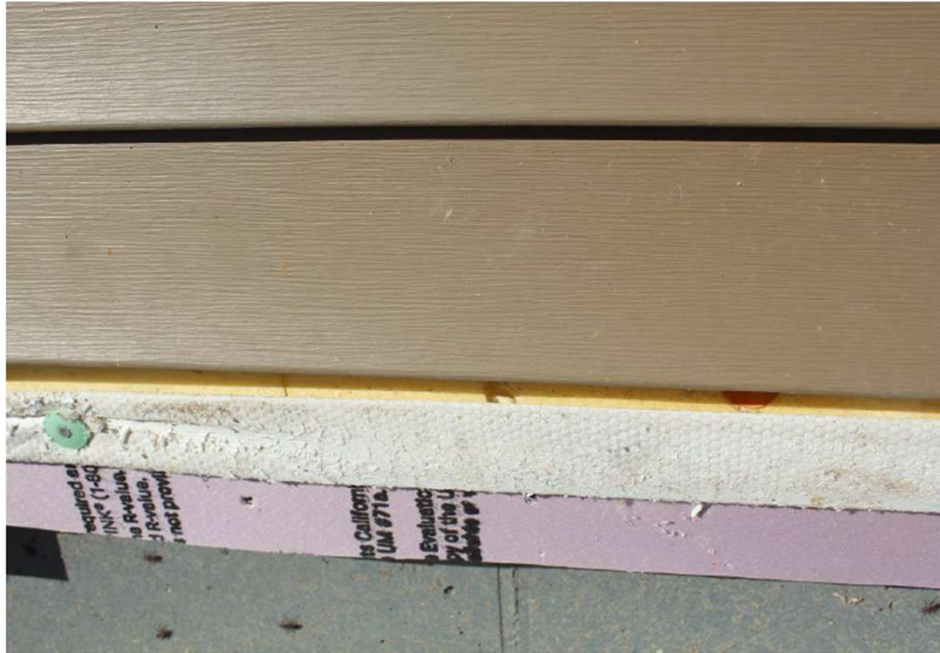
The house wrap was rolled upward, any water getting behind the siding will leak along the whole top of the foundation wall and into the crawlspace and down the foundation wall. (Uncommon Practice)

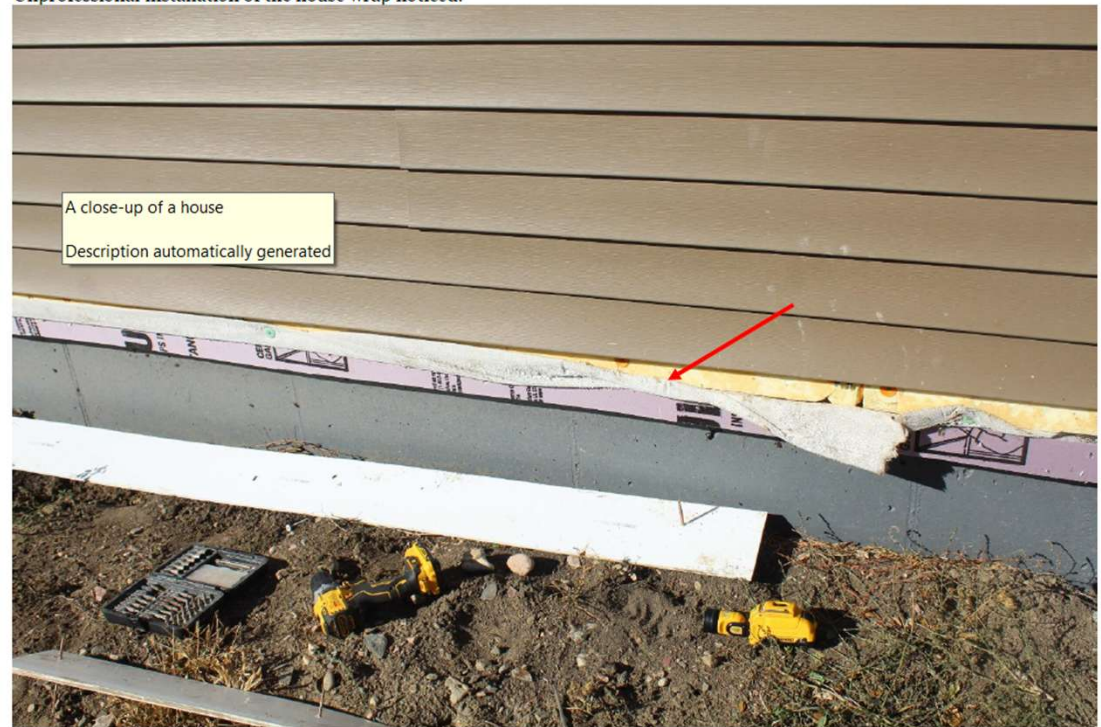
Unprofessional installation of the house wrap noticed.

The house wrap was rolled upward, any water getting behind the siding will leak along the whole top of the foundation wall and into the crawlspace and down the foundation wall. (Uncommon Practice)

House Wrap from SDH is pinned up for transport. It was not correctly installed by contractor. House wrap rolled upward will trap water and direct it into the un-flashed sill plate and into crawlspace.

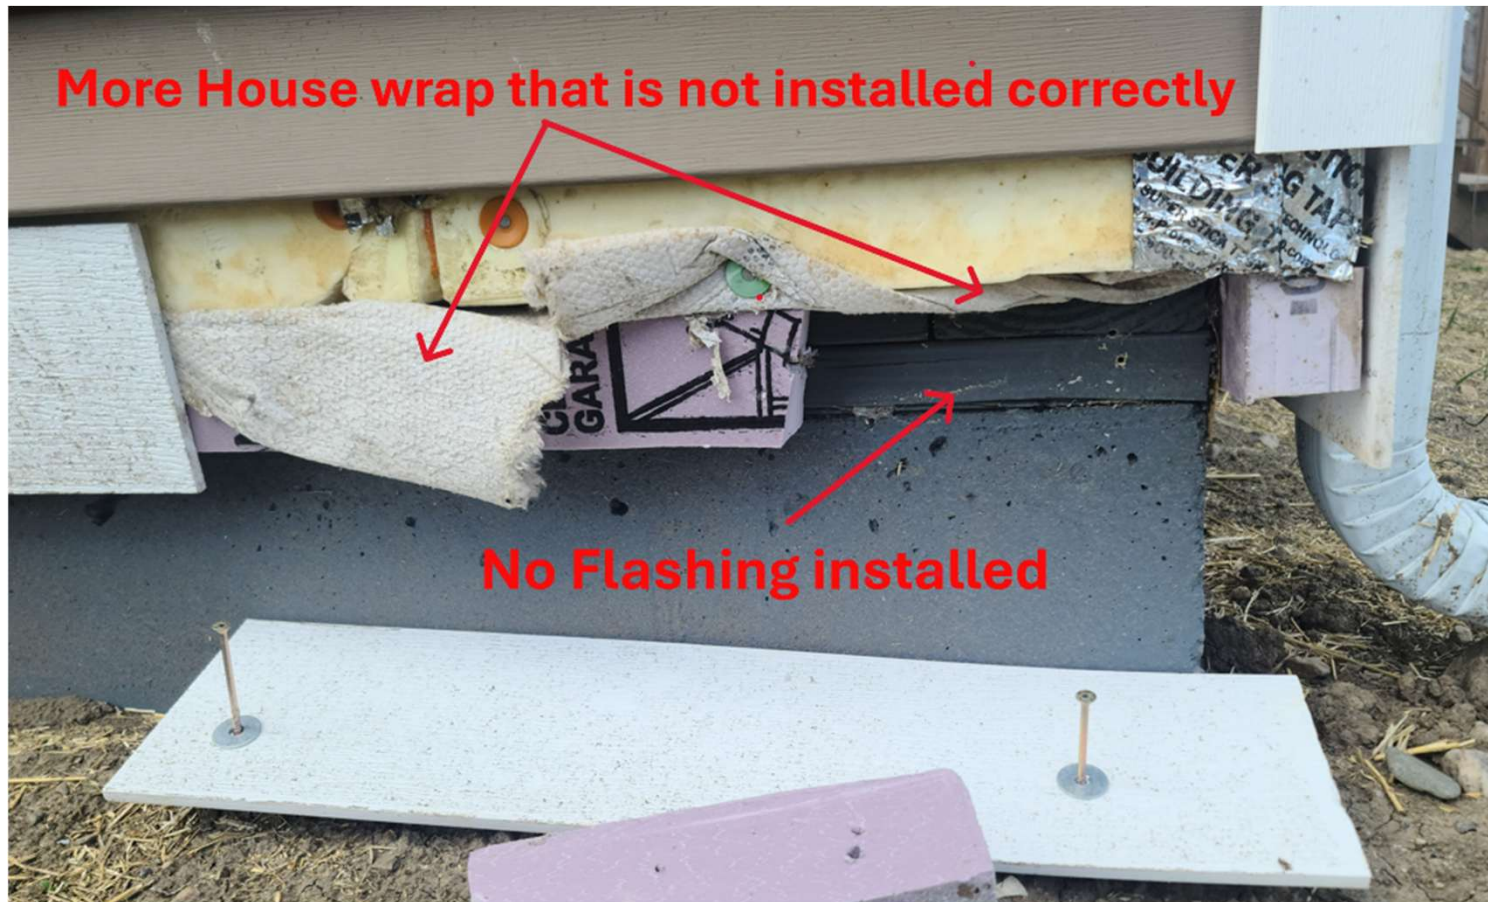
A metal Sill Cover or Flashing was installed around the perimeter of the home.

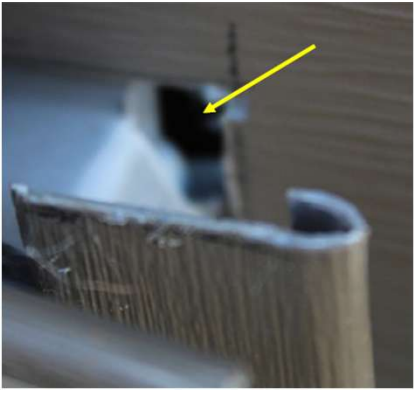
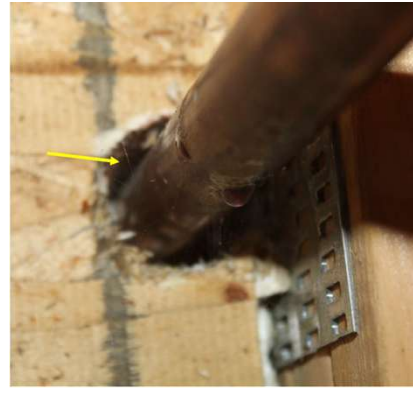
A tape for roof joints and seams was applied to sill plate and concrete connection. The tape quickly released from the concrete created and intrusion point for air, water and insects throughout the entire perimeter of home.

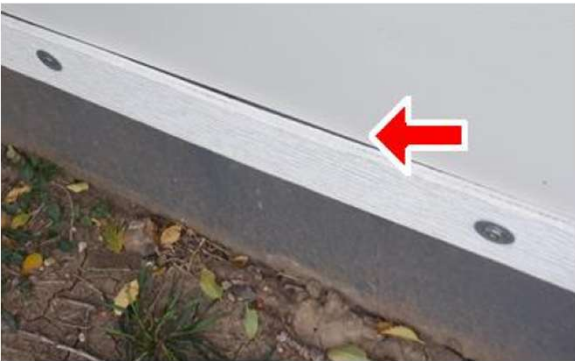
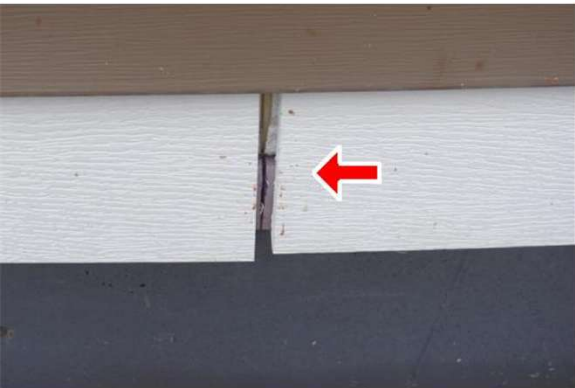
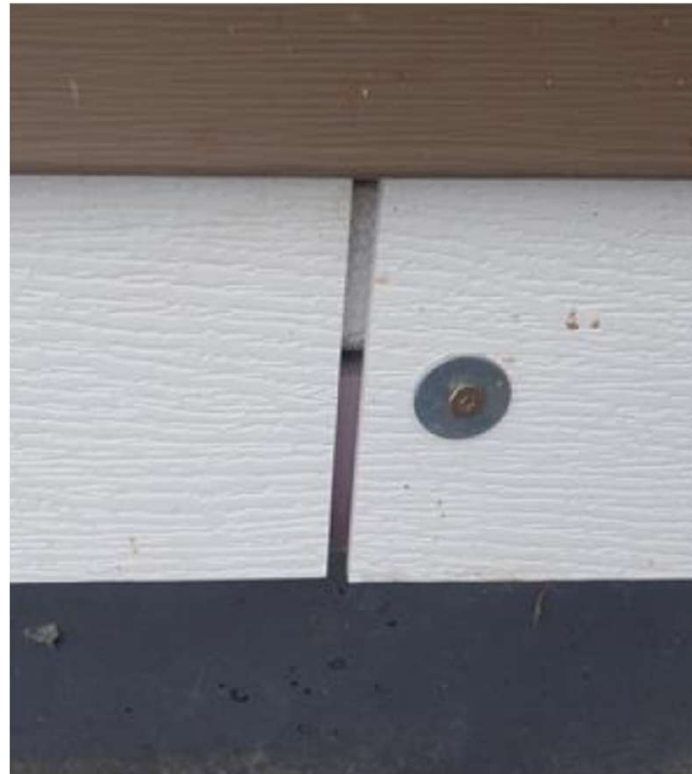
- **Several intrusion points found in professional inspections. See Report for complete list. Intrusion points were not sealed by contractors after completing their scope of work.**

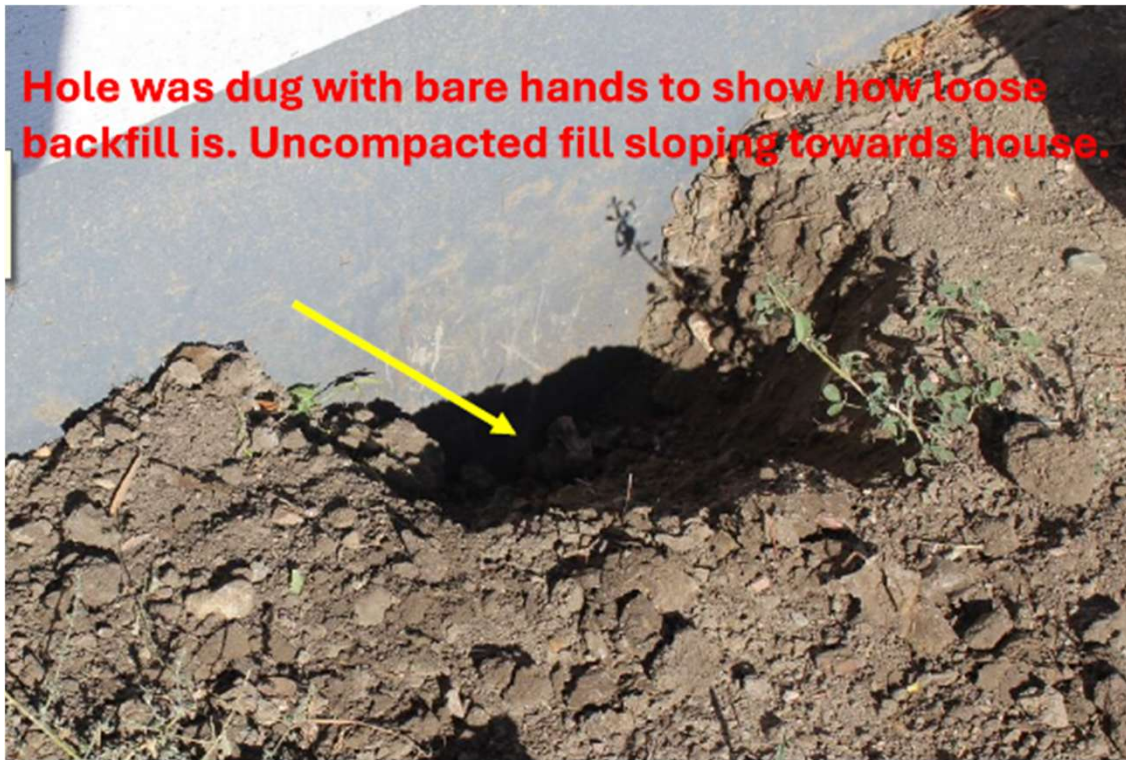
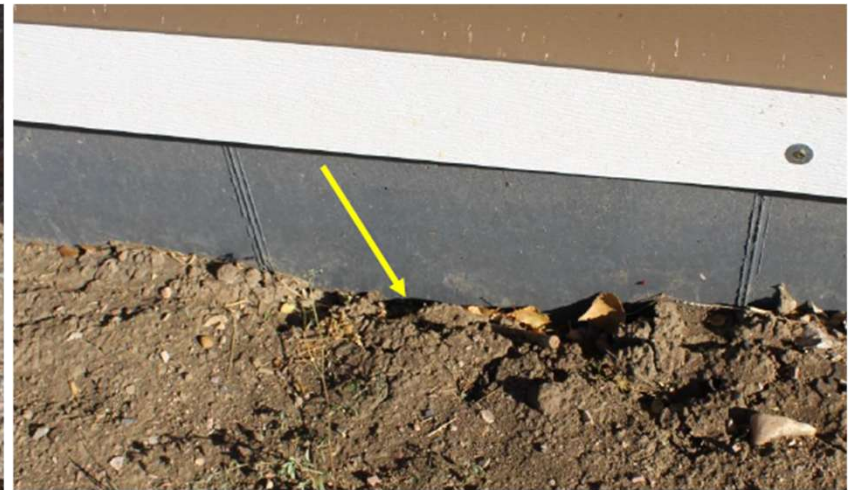
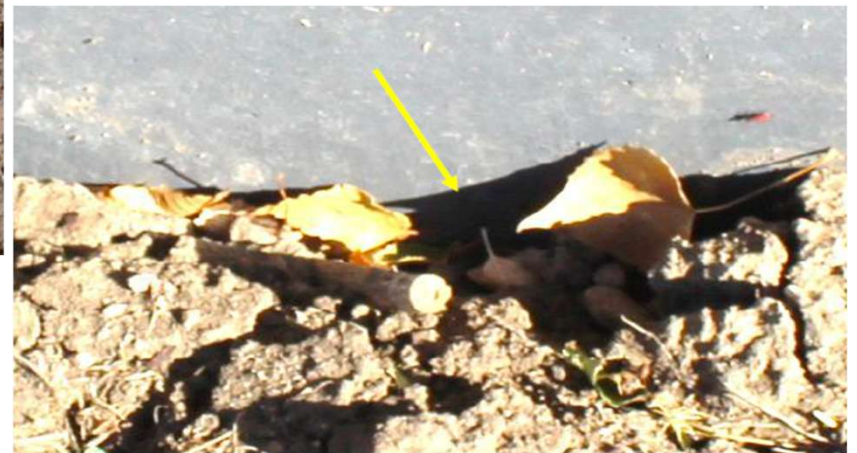
Backfill and Grading around the perimeter of foundation sloped towards the house in several locations and was not sufficiently compacted. Hole was dug with bare hands to show how loose backfill is.

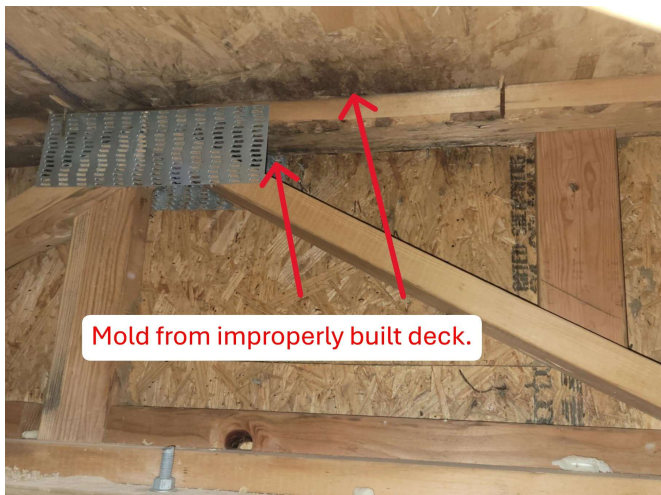
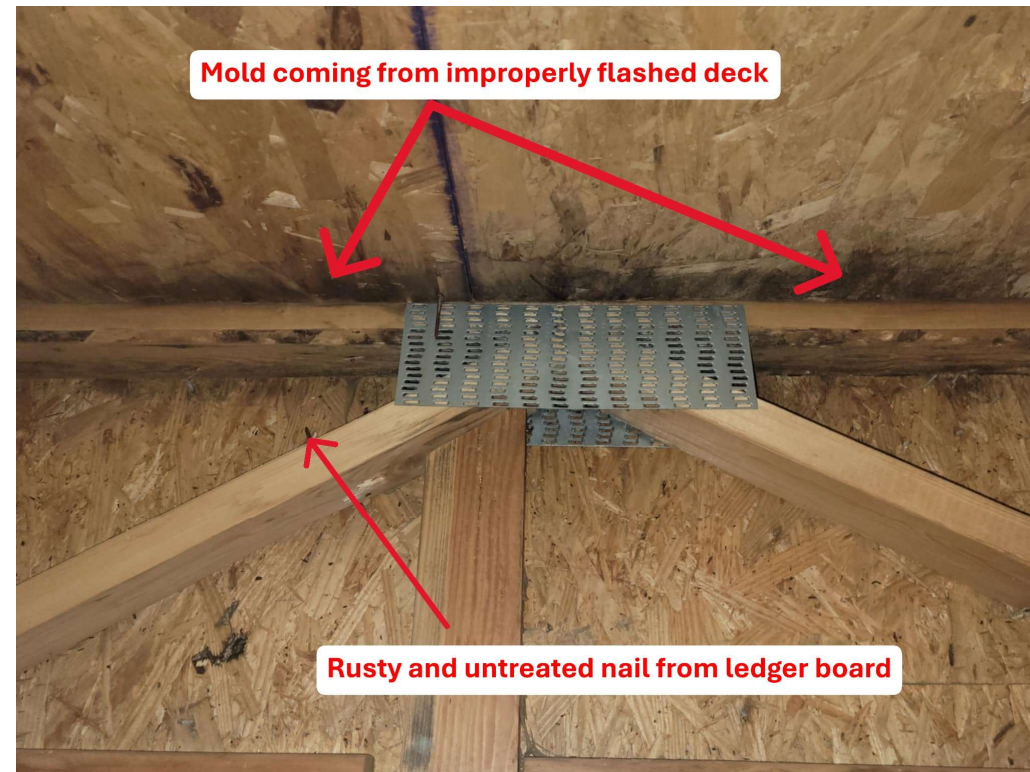
Interior of crawlspace where decks are attached- Pics from Plaintiff

These are picture of where the ledger board of the deck is fastened to the house. You can see a significant amount of water stained and moldy wood. The deck was improperly fastened and without proper flashing.

This led to concerns from the Home Inspector and Amber about the damage to exterior sheathing, insulation and vapor barrier. It became a point of contention when Amber wanted the Decks pulled back and the bottom row of the siding removed to review full scope of the damage.

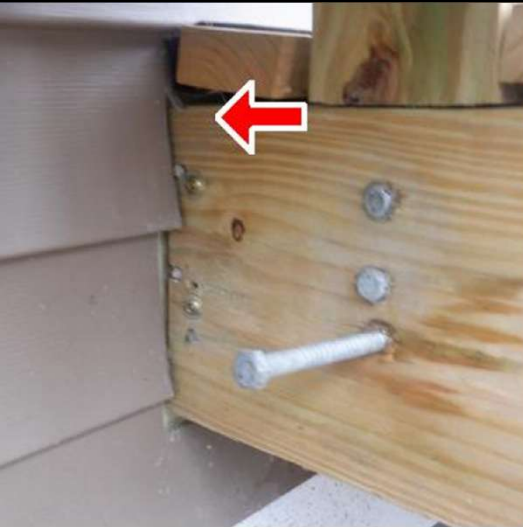
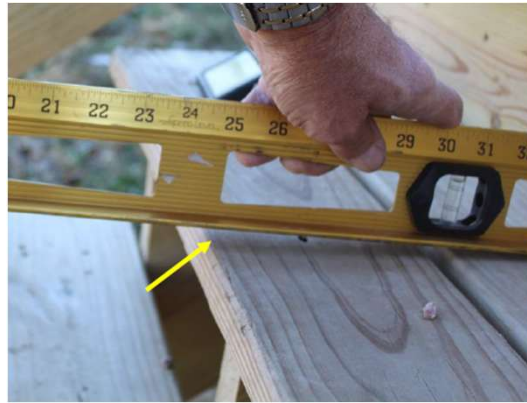
The support posts are resting in the dirt.

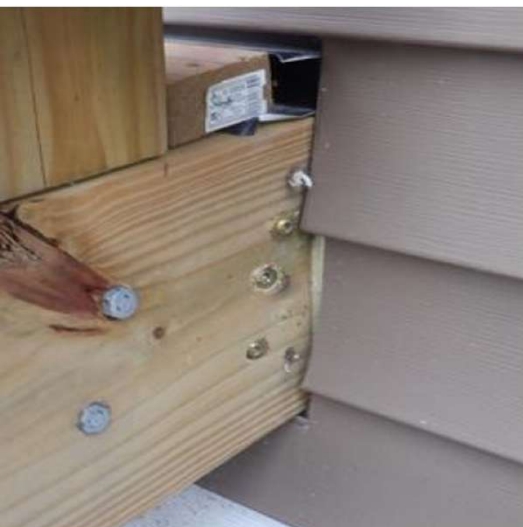
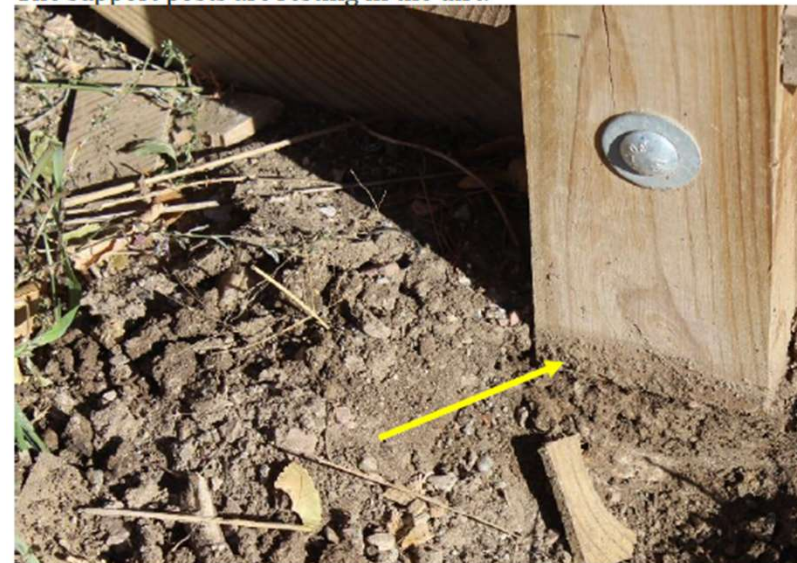
Deck was not properly built.

No counterflashing on Ledger board/Intrusion points.

Missing Fasteners.

Sloped away from house creating a major safety hazard.

Post falling away from concrete supports

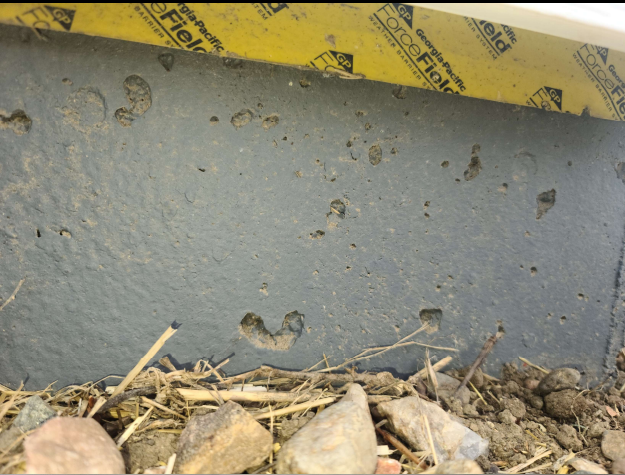
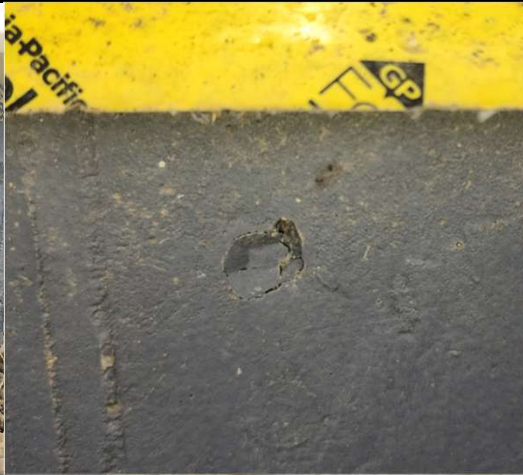
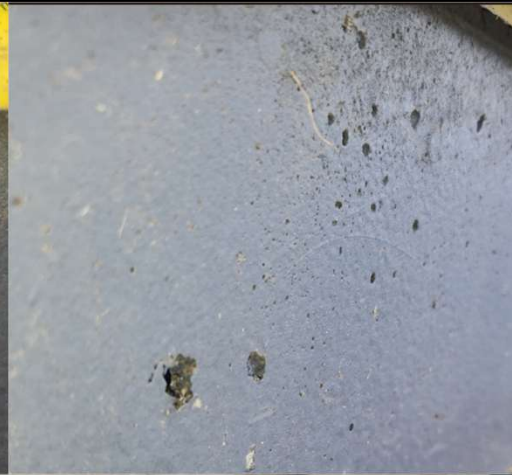
Pictures show pitting of concrete and the inadequate moisture control barrier applied to foundation wall.

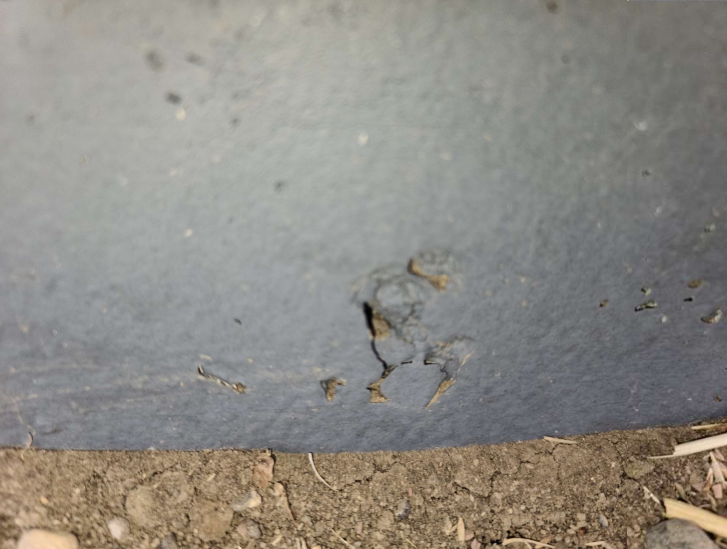
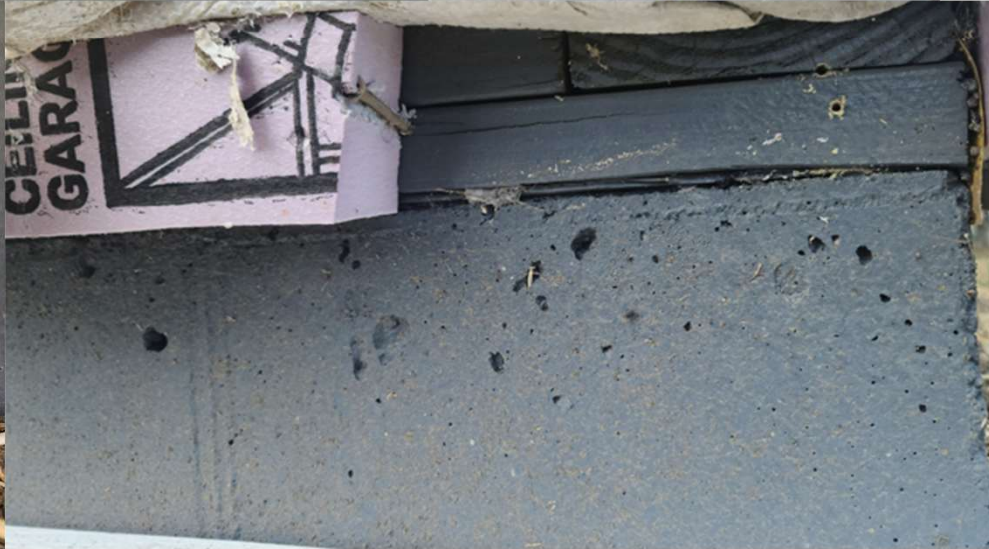
Note from Albertson Engineering Inc

1. Based on visual observation, it appears that waterproofing on the exterior face of foundation wall is in question. We would recommend waterproofing of the exterior face of foundation wall be investigated and verified. If found that the waterproofing is missing, then the waterproofing should be installed per the Foundation Details. Note this would require excavation around the entire perimeter of the house and replacement of backfill. Care should be taken during this operation to ensure that the exterior perimeter foundation drain tile is not damaged.

Exterior Water Moisture Control Barrier and concrete pitting around entire perimeter is compromised. Full depth of pitting and moisture control is unknown due to it mostly being under backfill.

Water can enter foundation wall through applied moisture barrier into pitting in concrete. Due to the lack of insulation and proximity to frost line, water will freeze, expand and contract. This will lead to a much faster degradation of foundation wall.
