Foundation Defect Discussion

- 1 Soil Test**
Soil Test in IRC, Soil test in Foundation Plans, Soil Test requested and Paid For by Amber Cottman. **Soil Test was not performed as requested by Amber Cottman**
- 2 Expansive Soils**
IRC and IBC requirements Expansive soils, Engineered Fill. **Code Requirements were not followed for the presumed Expansive Soils.**
- 3 Elevation of Foundation**
No elevation survey conducted to determine foundation elevation.
- 4 Crawl Space Floor**
Wrong Elevation, Improper Grading, No Base Course, Lead to flooding of the crawlspace

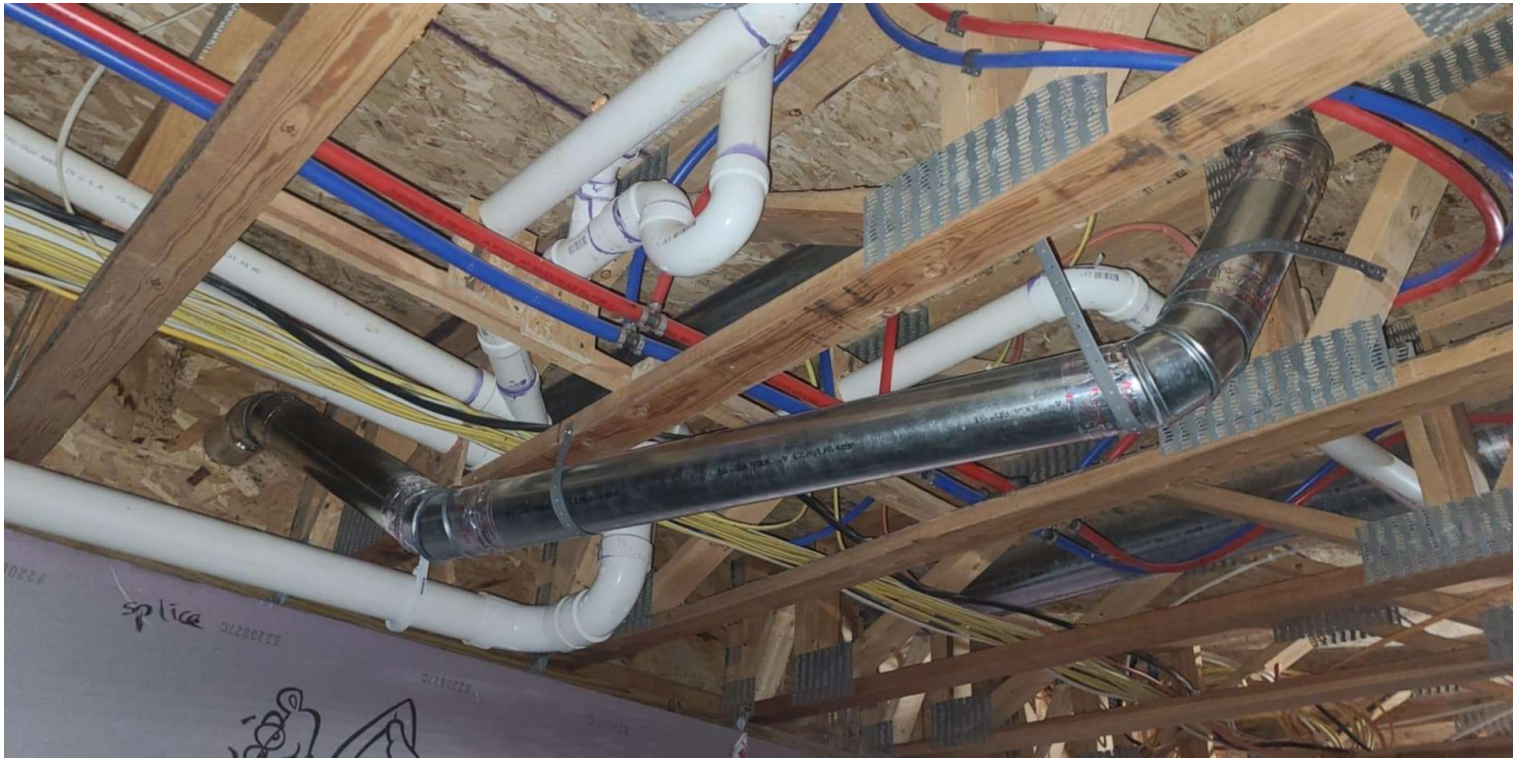
Picture of the dryer vent installed by Street Heat and contracted by NDHR. The vent is sill not to code. Low spots in the vent will collect moisture. NEED TO RESEARCH THIS ONE MORE.
