# Black Hills Professional Home Inspections LLC®

### HOME INSPECTION

**Amber Cottman**  
605-219-6573  
6655 Greenfield Dr  
Rapid City, SD 57703  
[ampercottman@yahoo.com](mailto:ampercottman@yahoo.com)

**REPORT**  
11-1-23

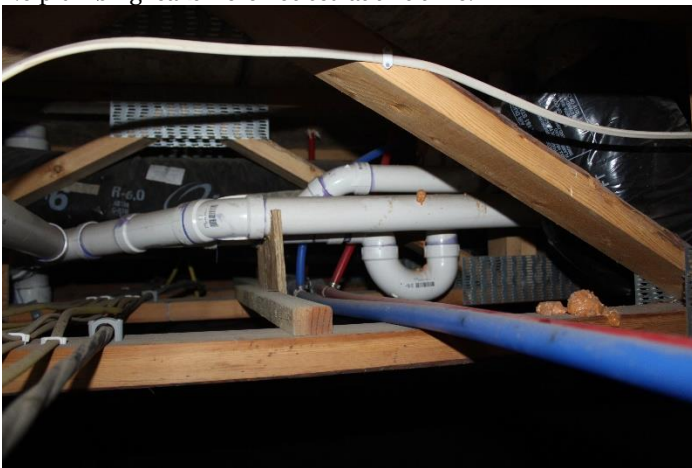
No plumbing leaks were noticed at this time.

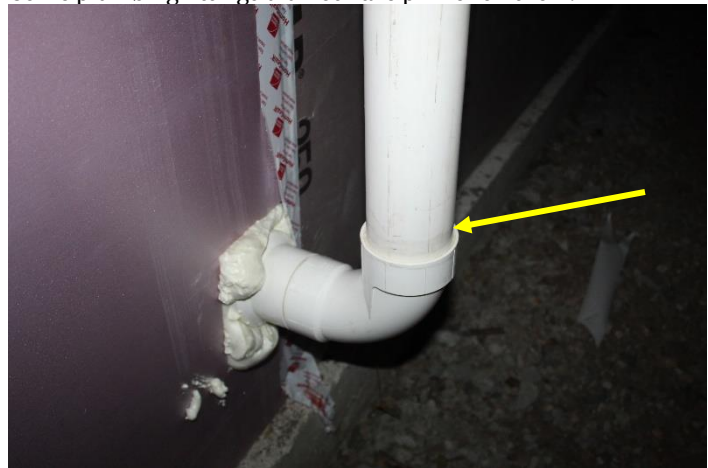
Some plumbing fittings did not have primer on them.
