Foundation Defect Discussion

- 1 Soil Test**
Soil Test in IRC, Soil test in Foundation Plans, Soil Test requested and Paid For by Amber Cottman. **Soil Test was not performed as requested by Amber Cottman**
- 2 Expansive Soils**
IRC and IBC requirements Expansive soils, Engineered Fill. **Code Requirements were not followed for the presumed Expansive Soils.**
- 3 Elevation of Foundation**
No elevation survey conducted to determine foundation elevation.
- 4 Crawl Space Floor**
Wrong Elevation, Improper Grading, No Base Course, Lead to flooding of the crawlspace

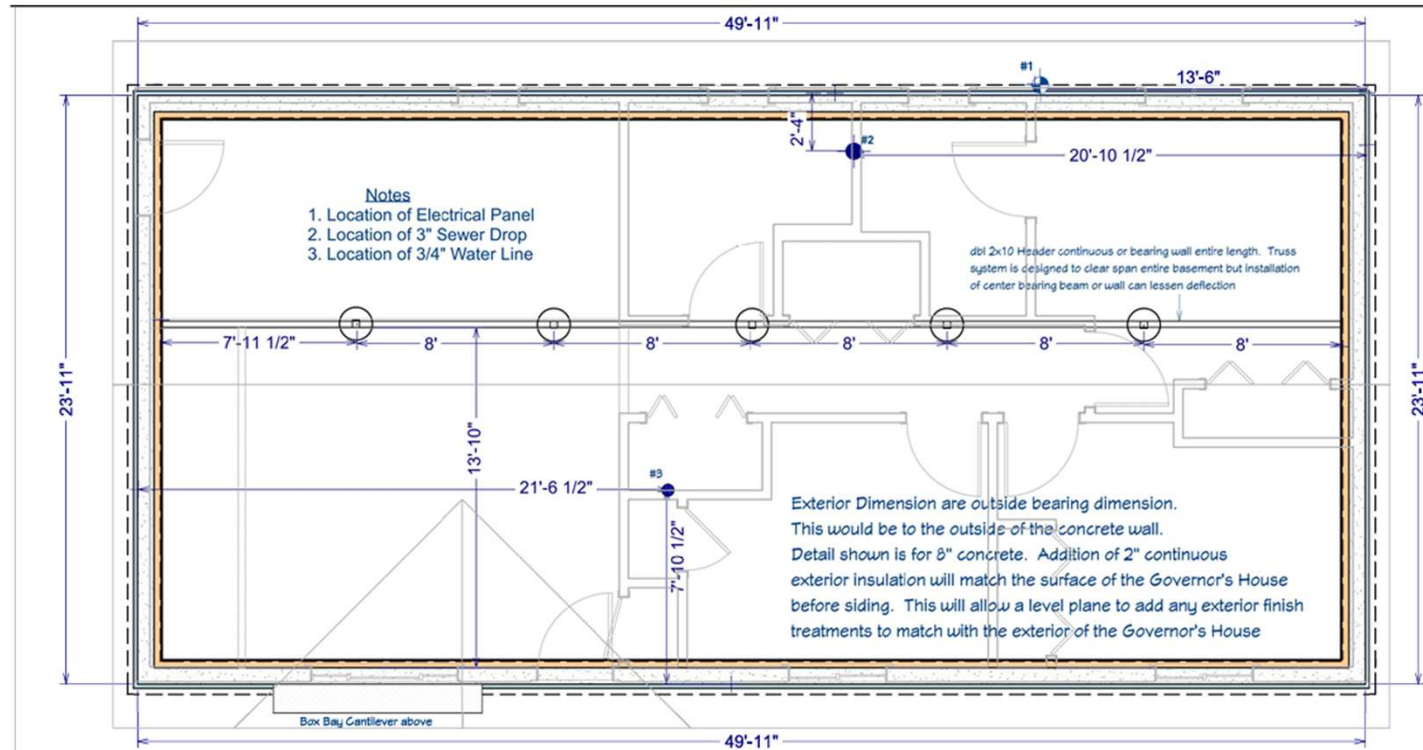
SDH Foundation Plans – (P30)

South Dakota Housing states to verify soil conditions prior to beginning work.

The verification of soil conditions requirement was **NOT** followed by Contractors.

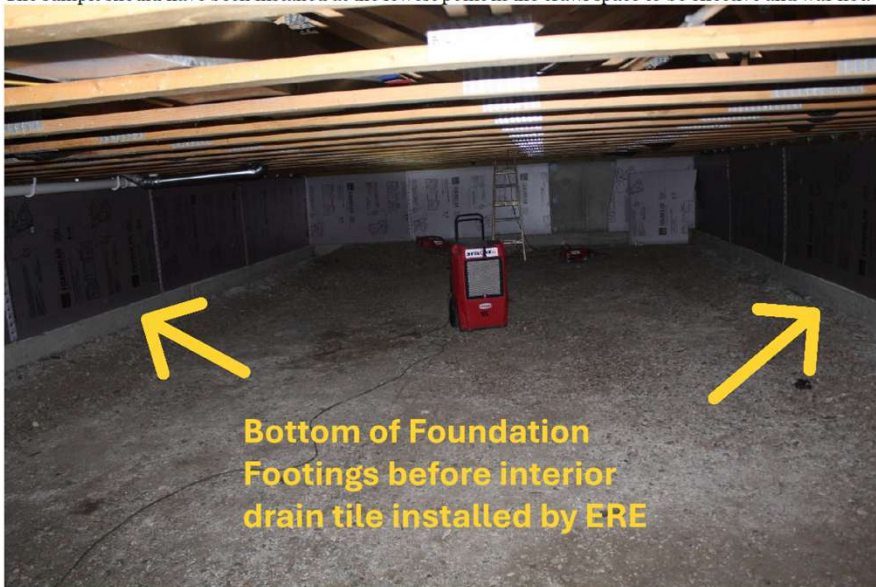
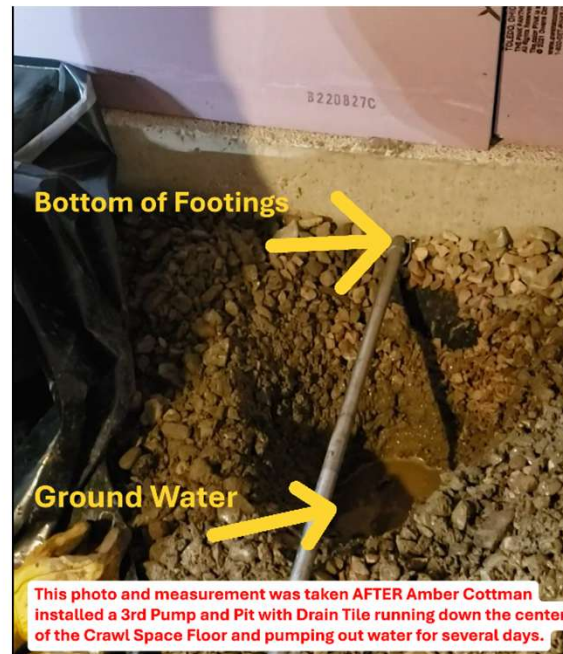
Screen Shot of ERE's Estimate provided my Neighborworks (P8)

The sump pit should have been installed at the lowest point in the crawl space to be effective and was not.

ERE was contracted to Import 1" of clean rock for the foundation floor. Place and grade 6" of base course on interior floor of foundation.

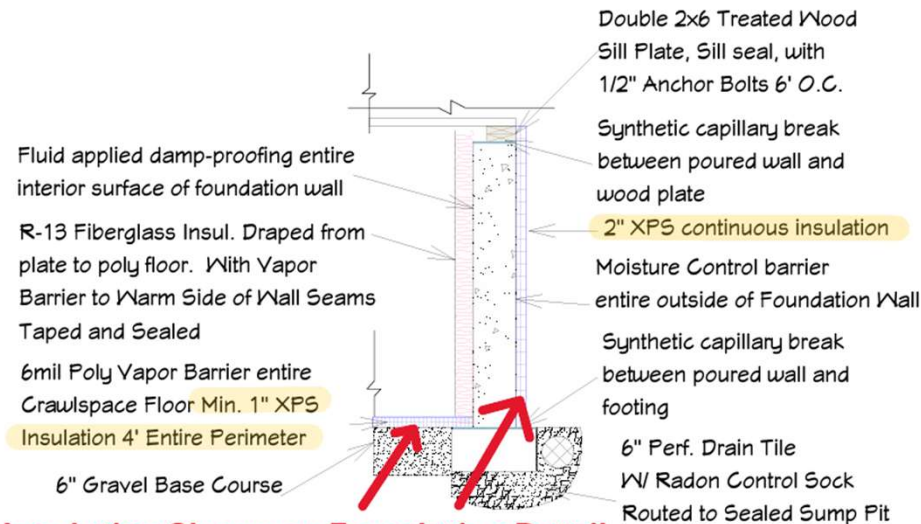
Insulation Shown on Foundation Detail

Insulation in the SDH Foundation Plan shows a detail that meets IRC Requirements. It reaches the floor and extends an additional 4 feet (only 2 feet needed to meet IRC)

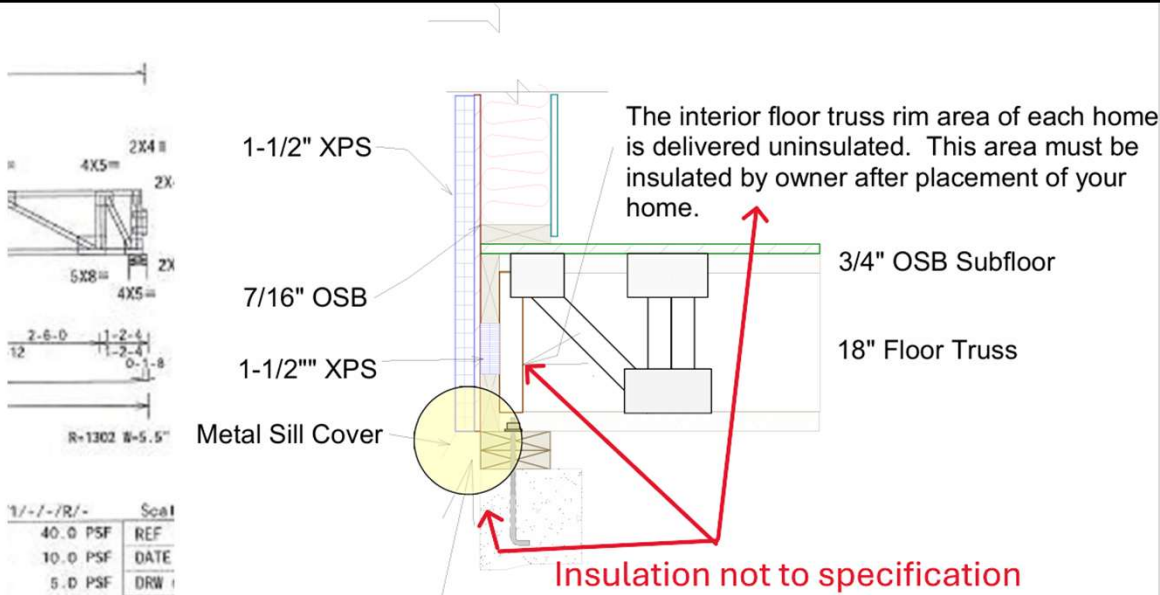
SDH Foundation Plans -

Insulation in the SDH Foundation Plan shows a detail for Insulation to be installed by Homeowner. Homeowner was charged for insulation, and insulation was never installed to Spec.

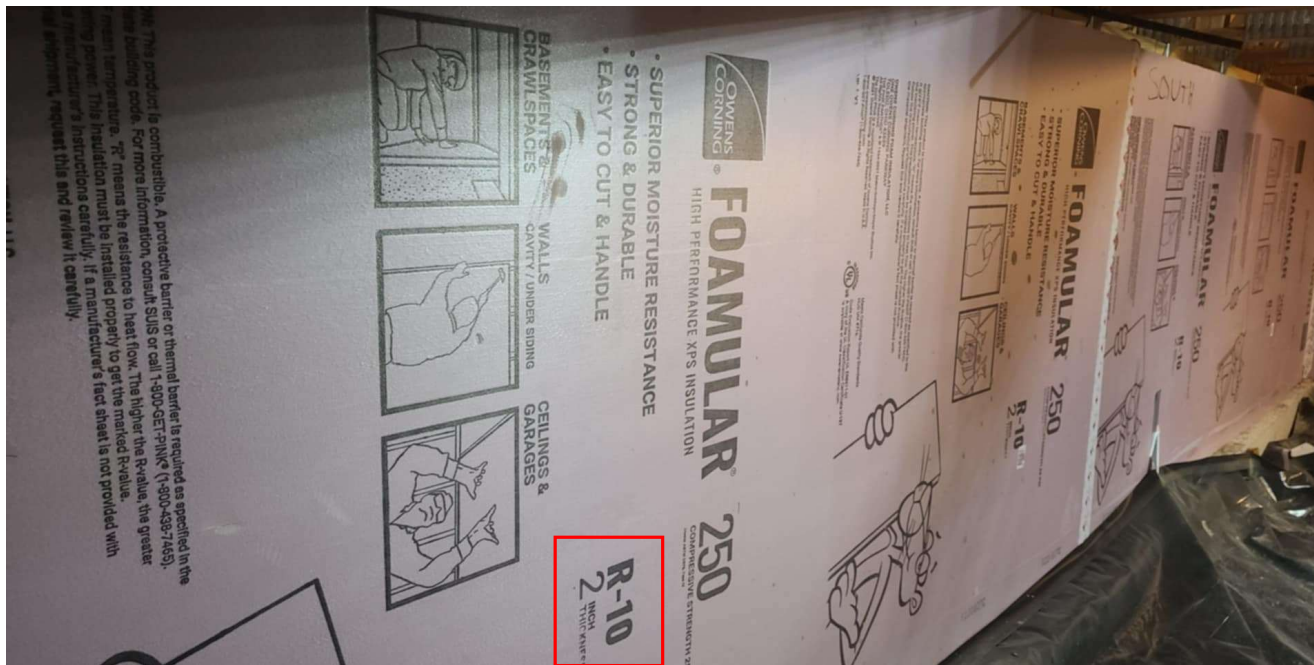
SDH Foundation Plans -

SDH States that R-15 is The IRC requirement for continuous insulation on Concrete Walls

NWDHR installed R-10 on the inside wall only.

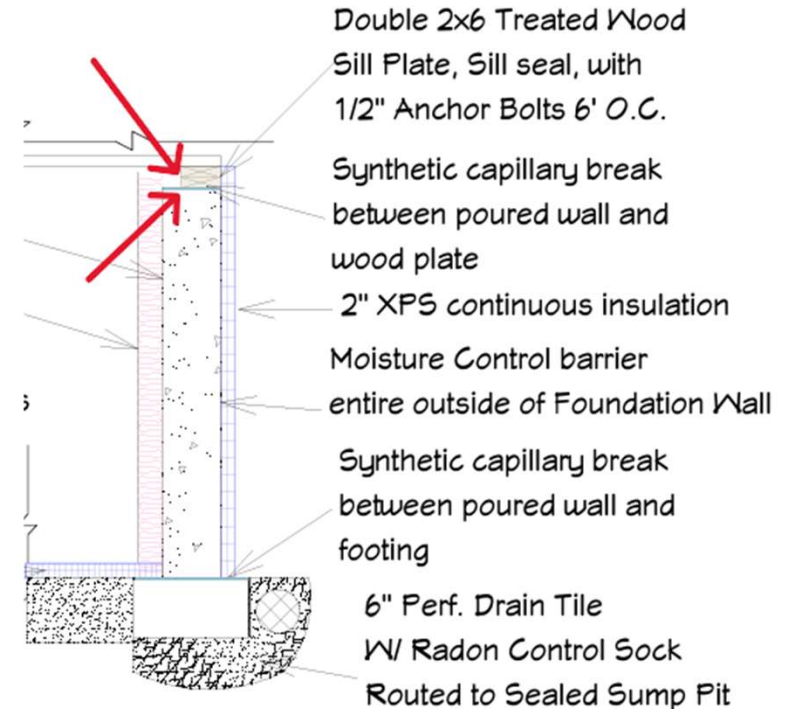
SDH Foundation Plans – (P30)

Sill Seal needed to be between concrete foundation AND between the Double 2x6 Sill Plates.

Sill Seal was never installed and resulted in cupping and deformation of the sill plate along with a major water intrusion point causing mold.

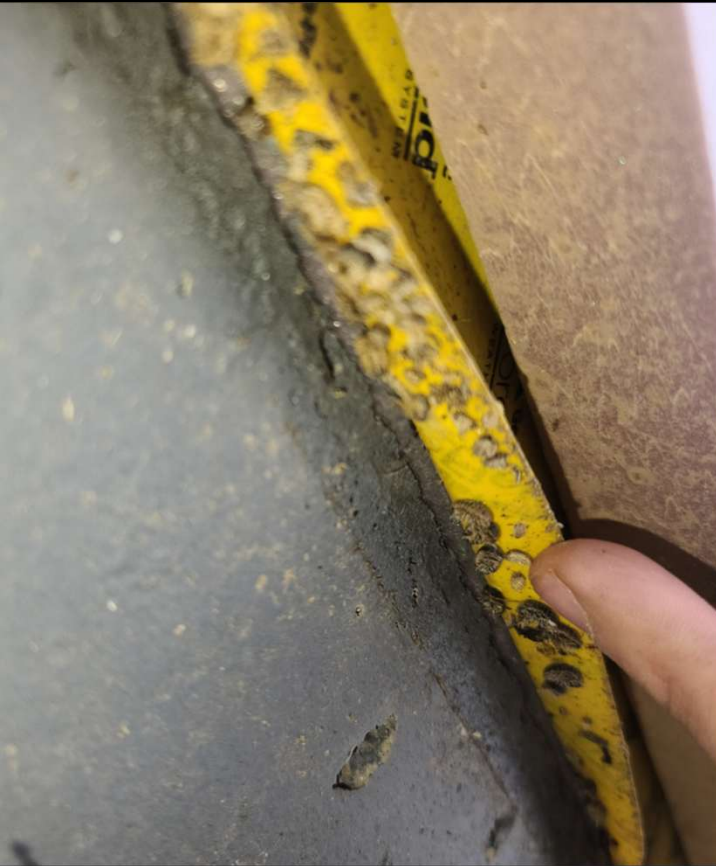
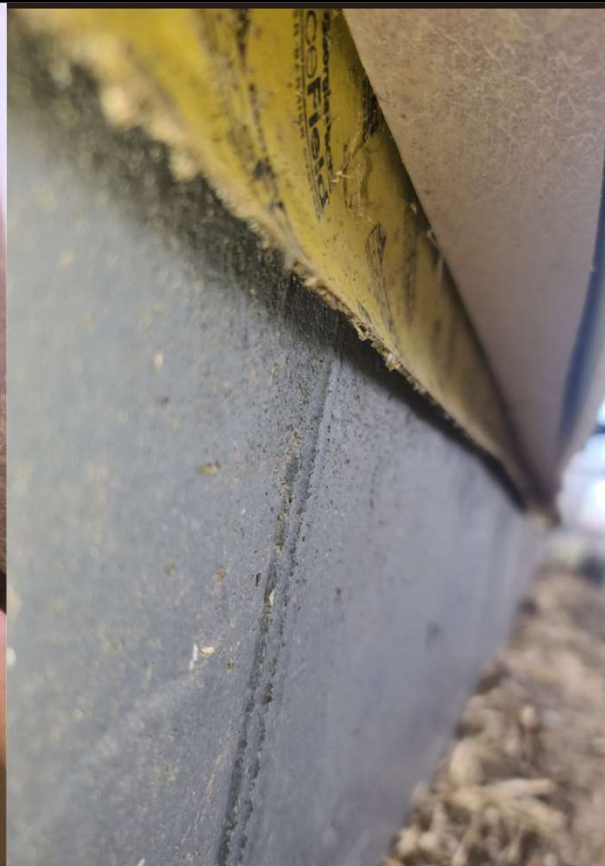
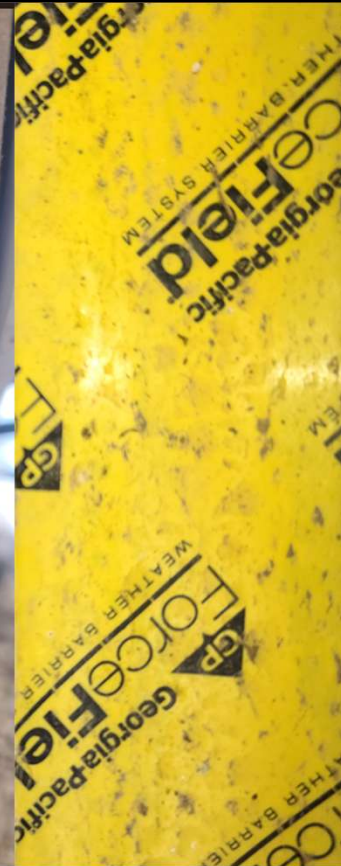
Pictures from Homeowner

A metal Sill Cover or Flashing was installed around the perimeter of the home.
