# Black Hills Professional Home Inspections LLC®

### HOME INSPECTION

**Amber Cottman**  
605-219-6573  
6655 Greenfield Dr  
Rapid City, SD 57703  
[ampercottman@yahoo.com](mailto:ampercottman@yahoo.com)

**REPORT**  
11-1-23

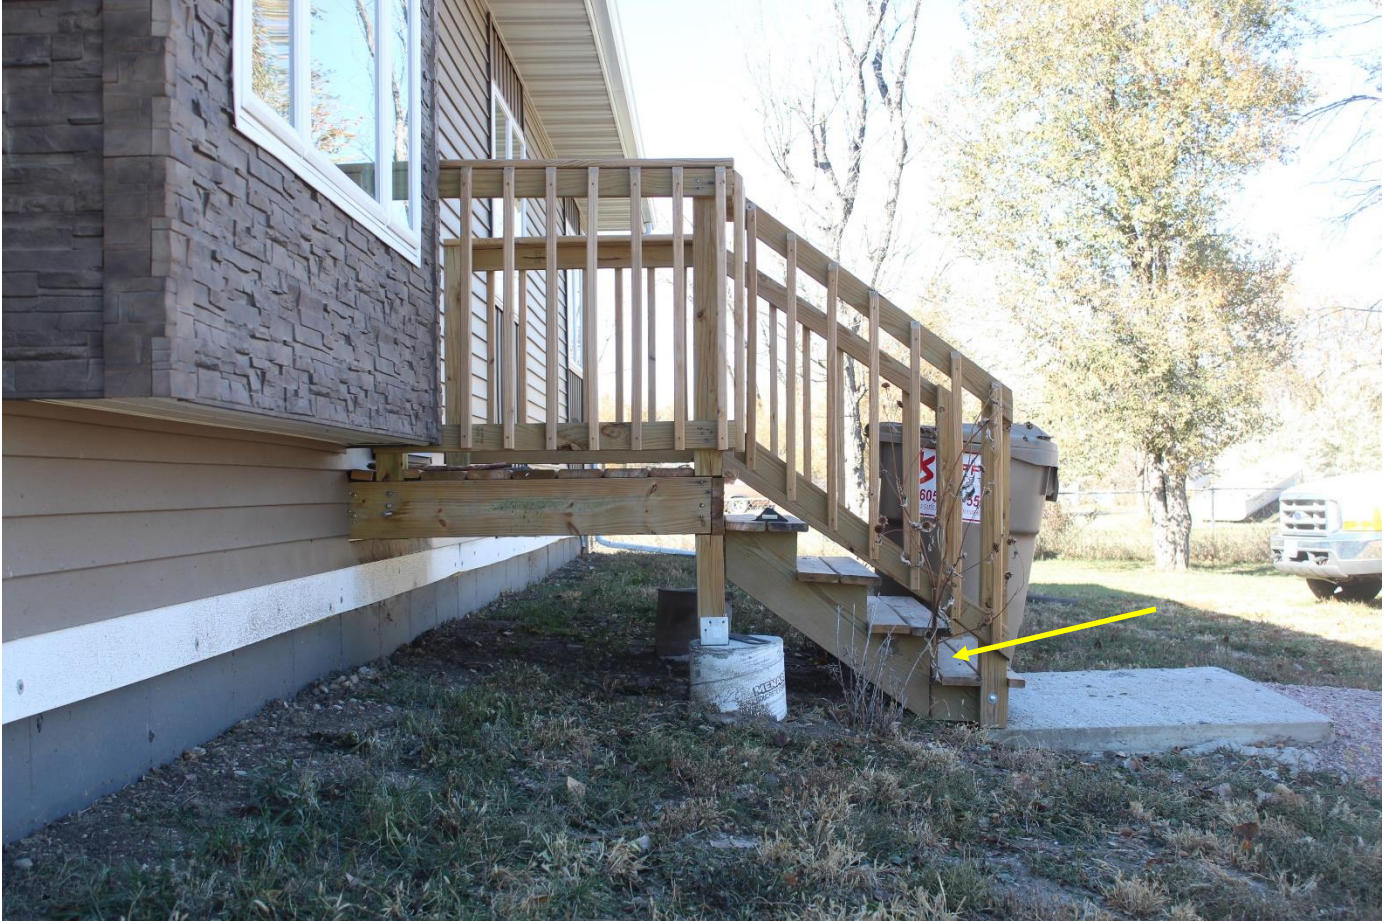
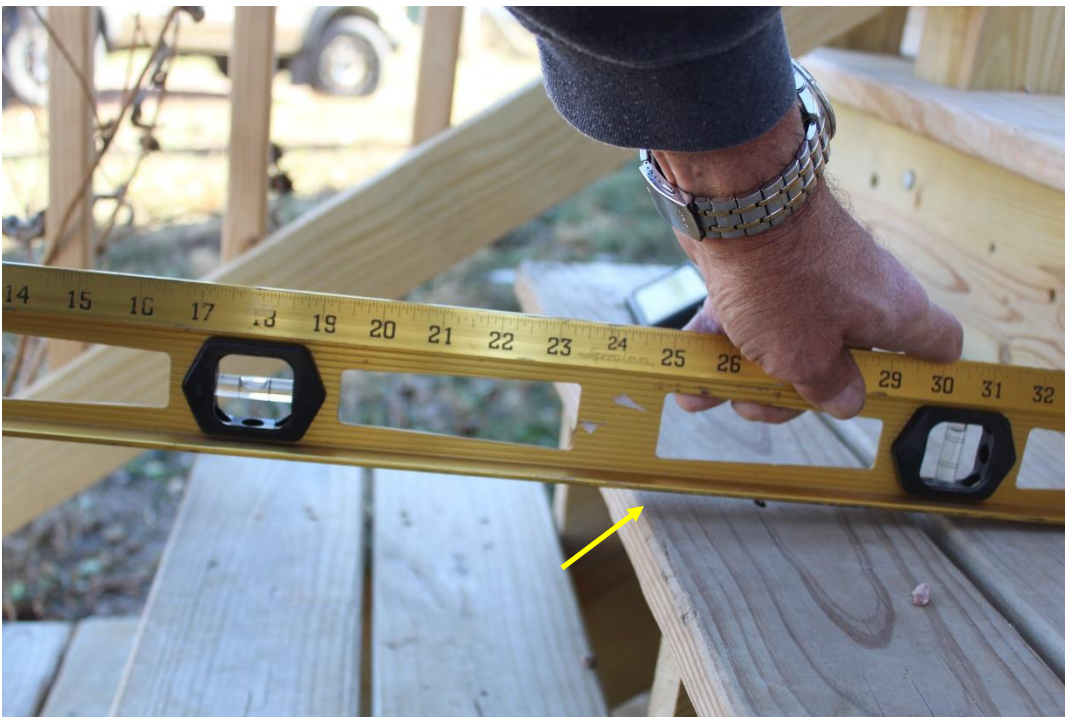
The deck stairs are leaning forward, level as needed.

**SAFETY ISSUE:** The stairs should not be sloping downhill forcing you down the stairs.

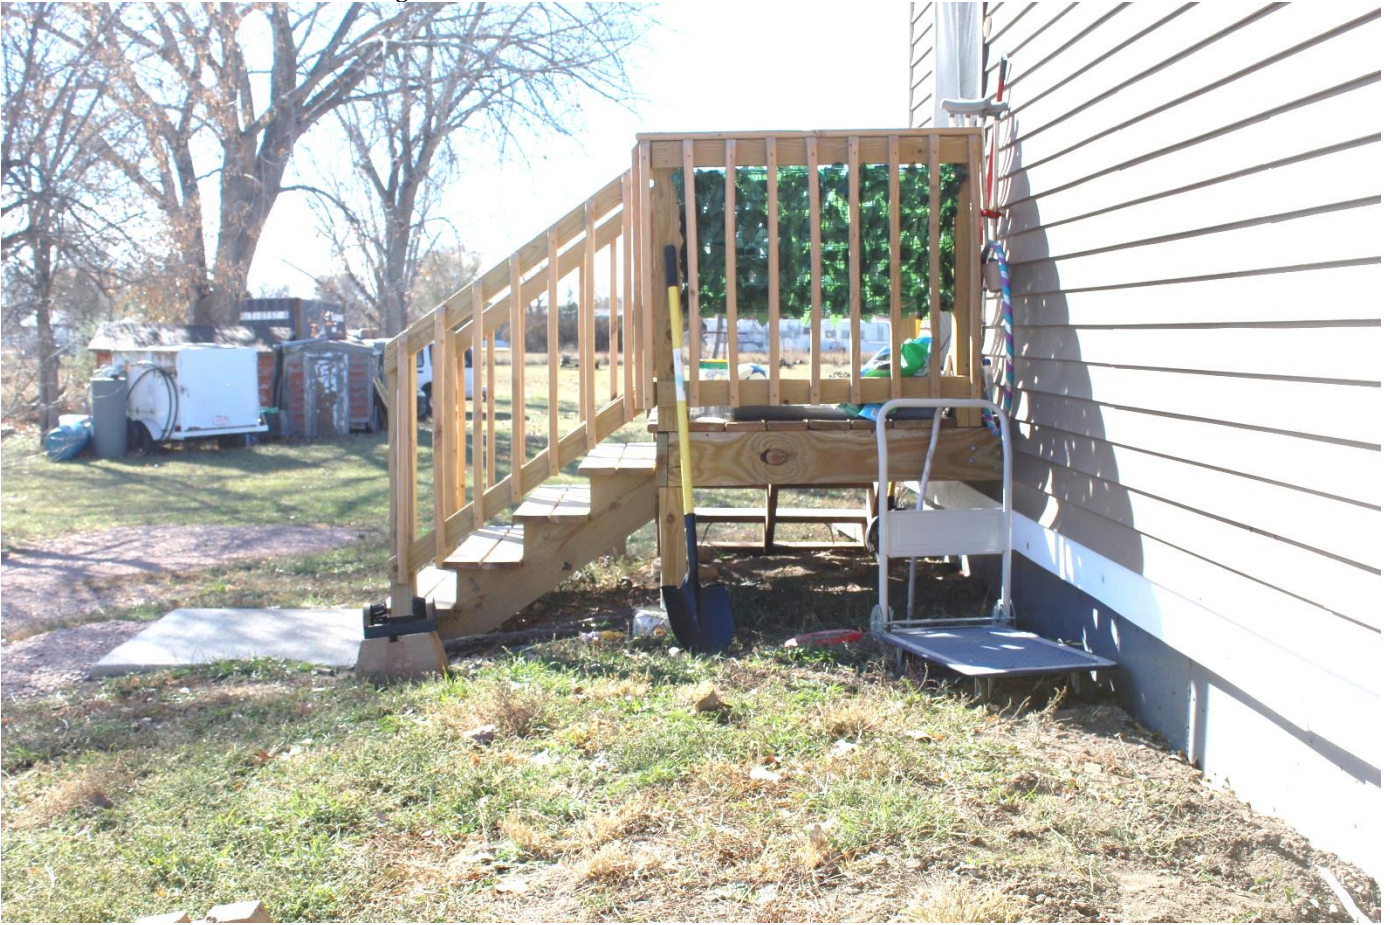
The decks & stairs are constructed of green treated wood.

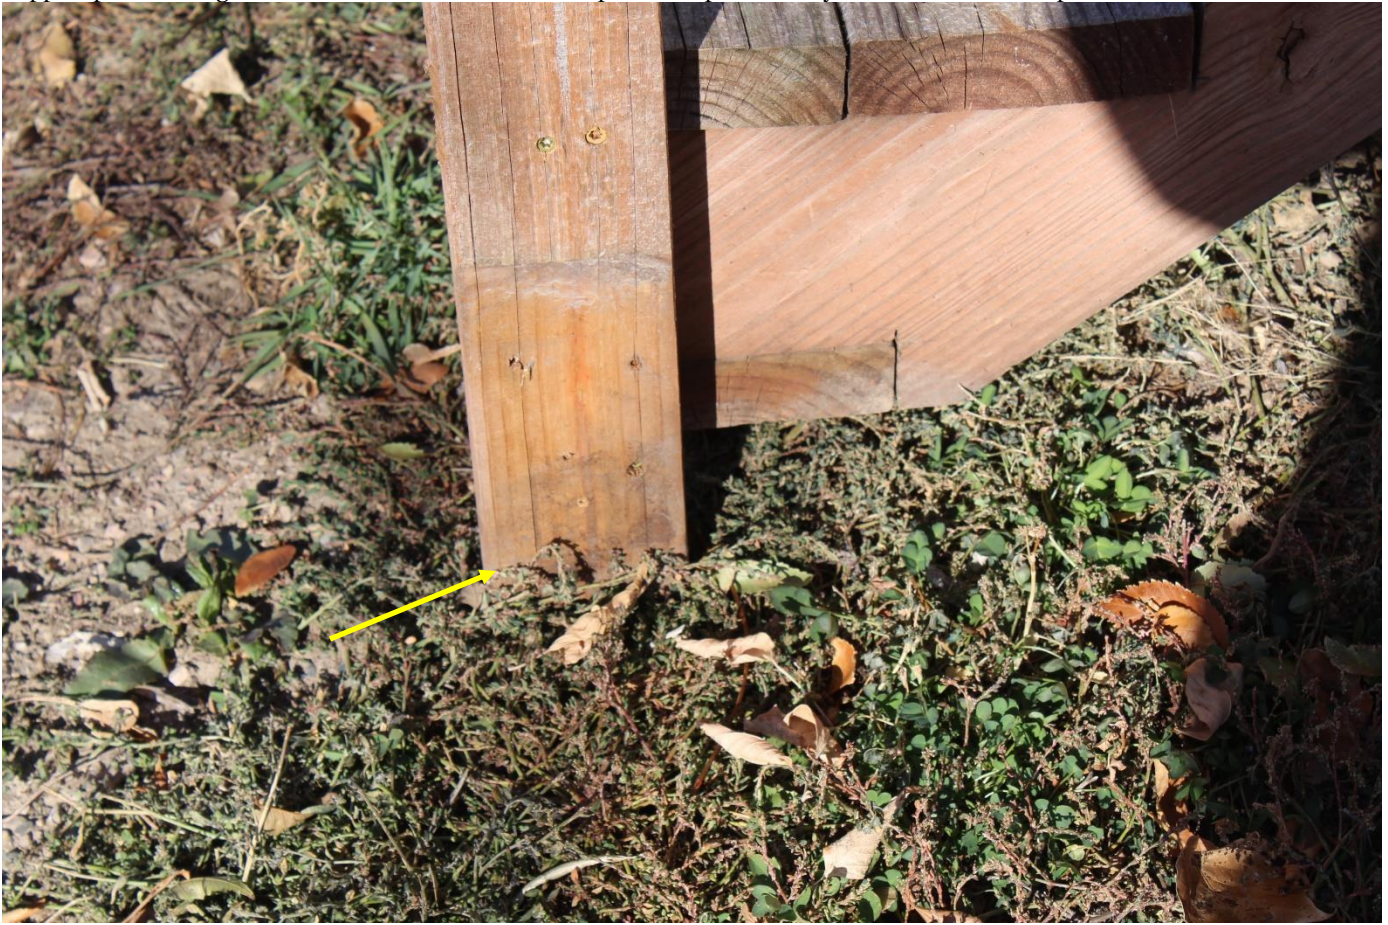
Support posts resting in the dirt will wick water into the posts and prematurely rot out the wood. Repair as needed.

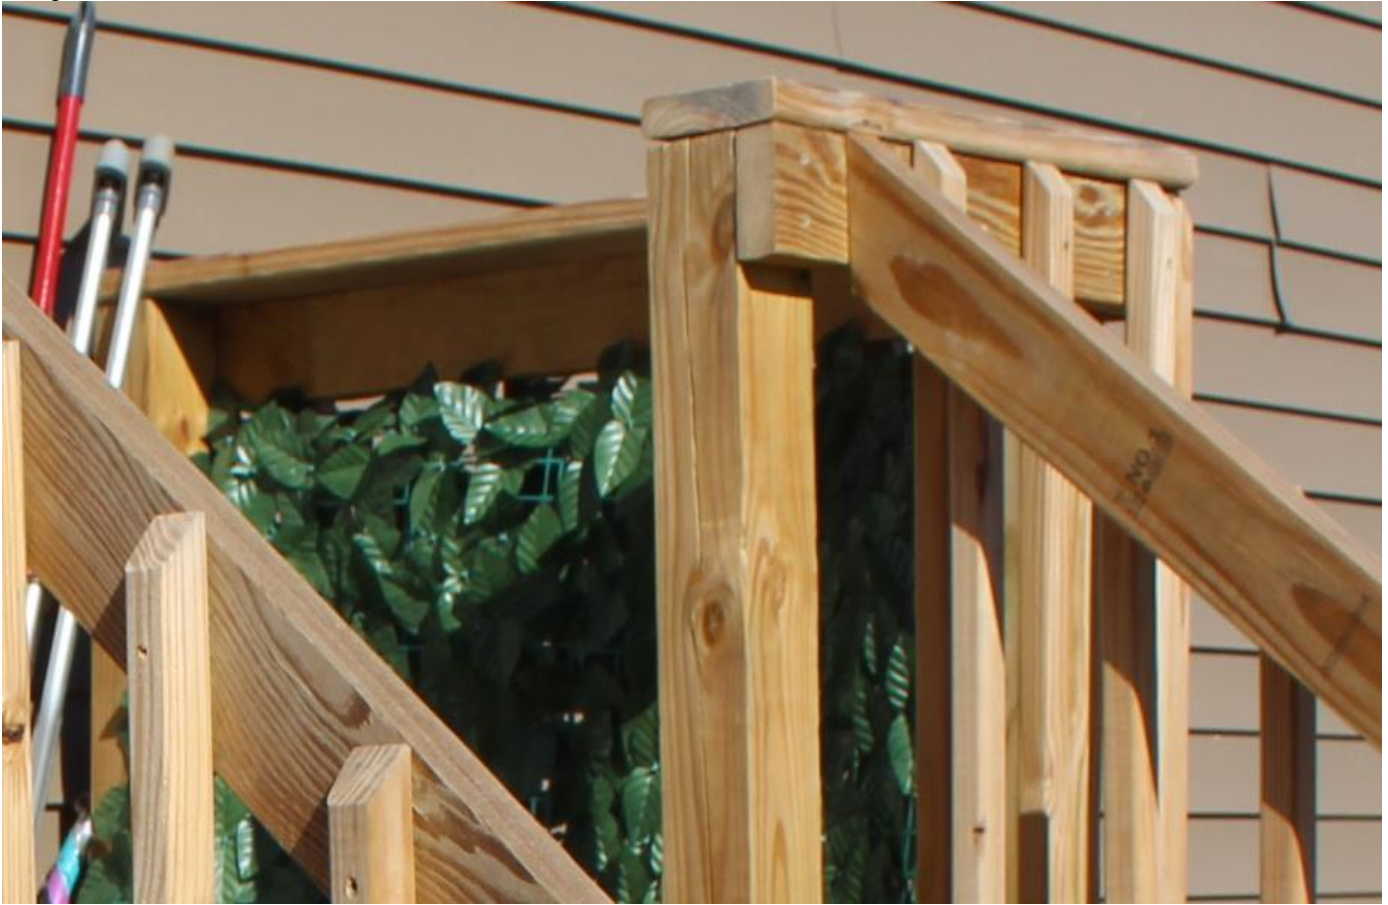
Graspable handrails should be installed to the stairs as needed.

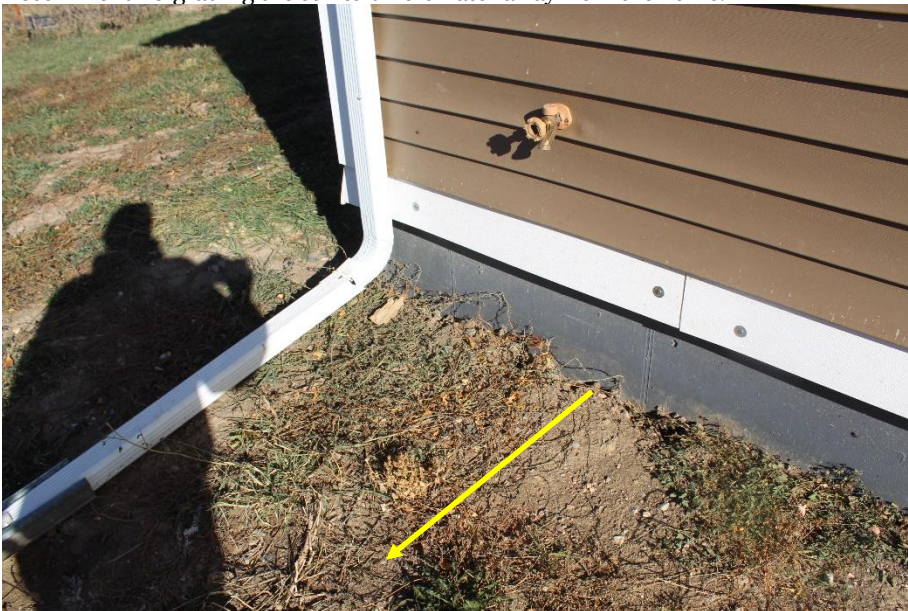
Recommend re-grading the soil to divert water away from the home.

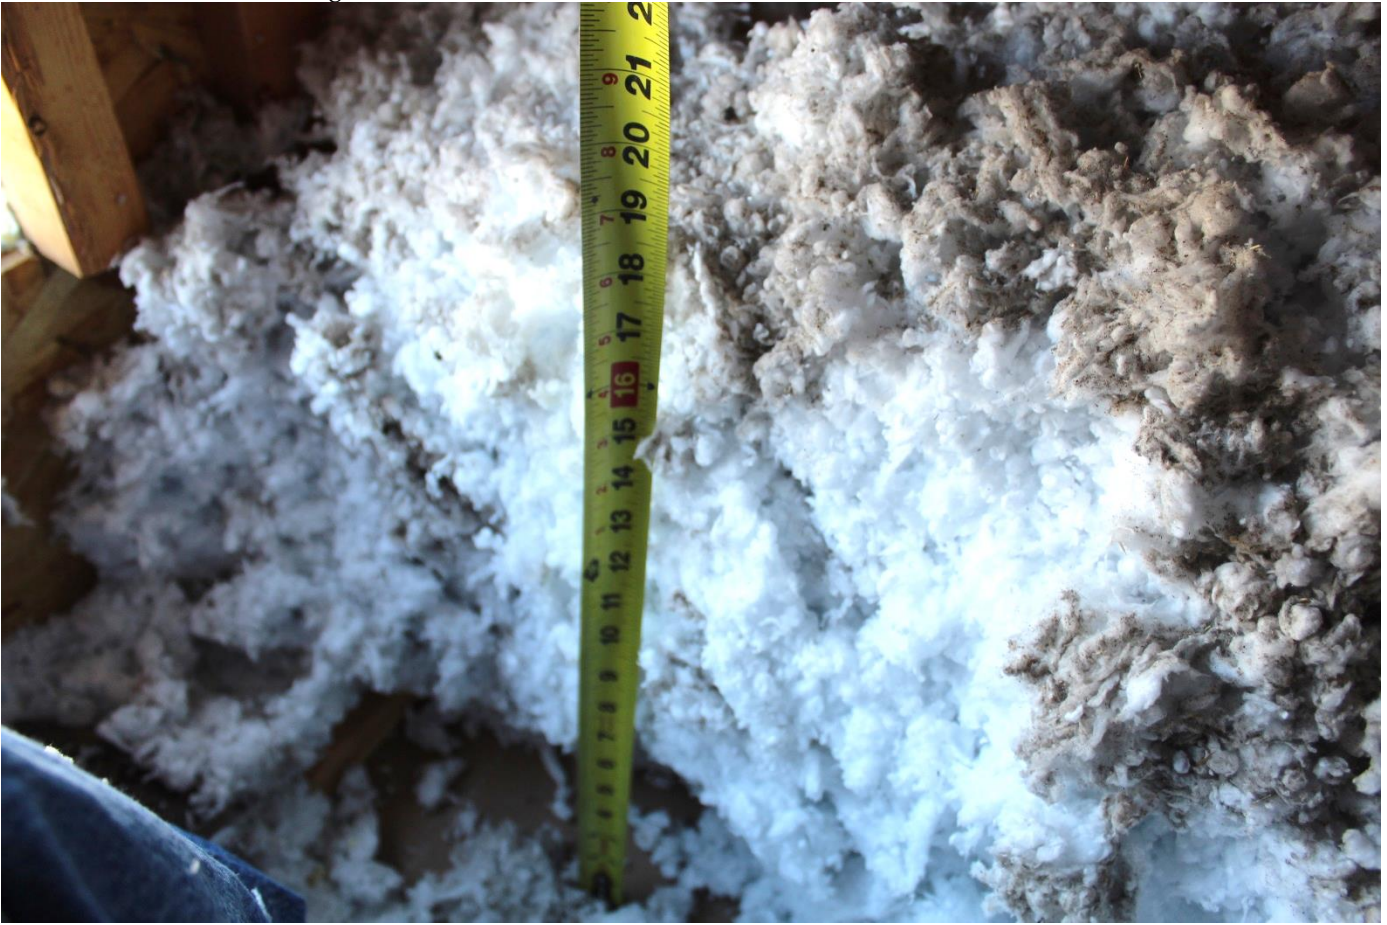
The insulation in the attic is in good condition at his time.

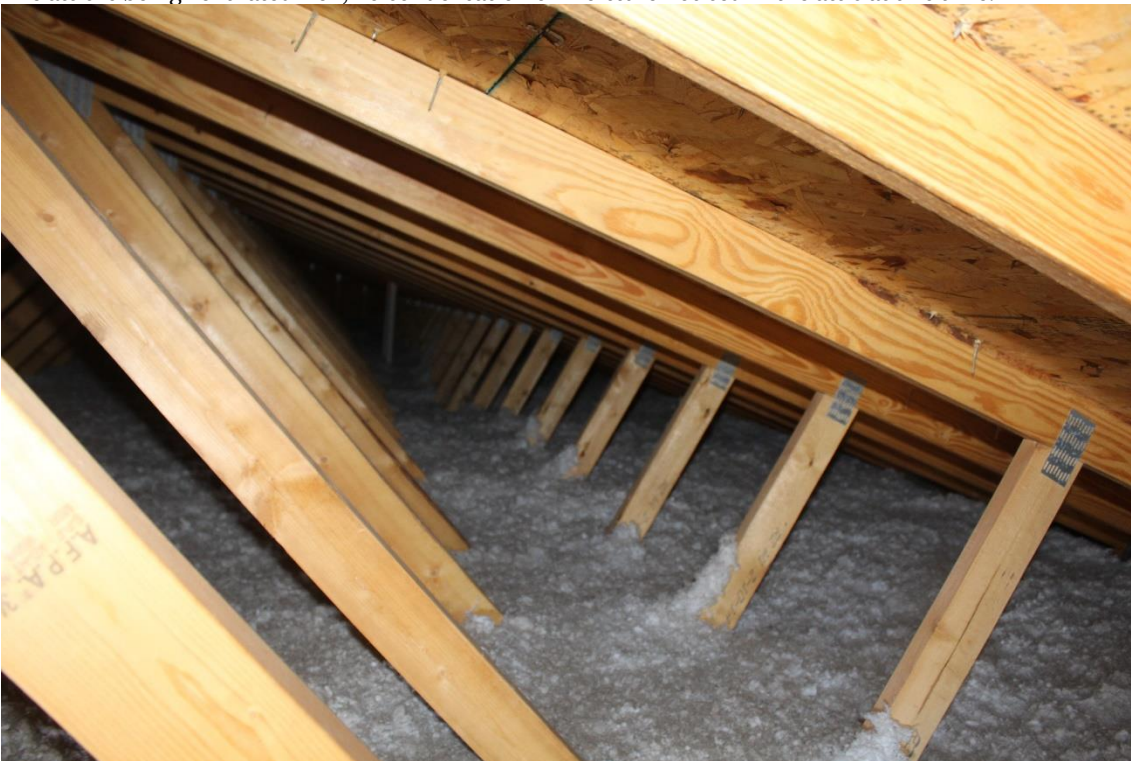
The attic is being ventilated well, no condensation or moisture noticed in the attic at this time.

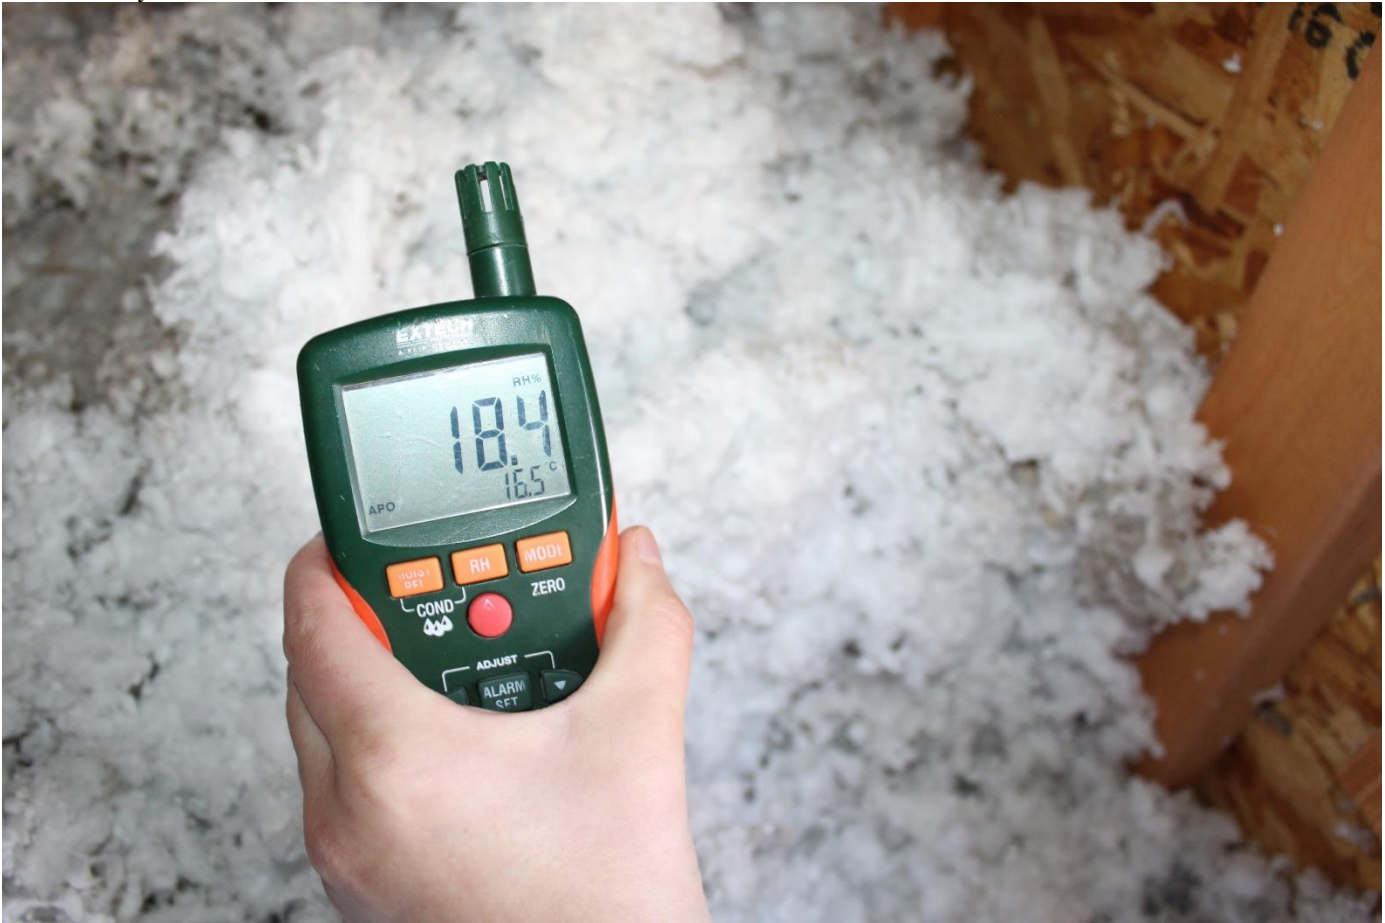
Low humidity levels noticed in the attic.

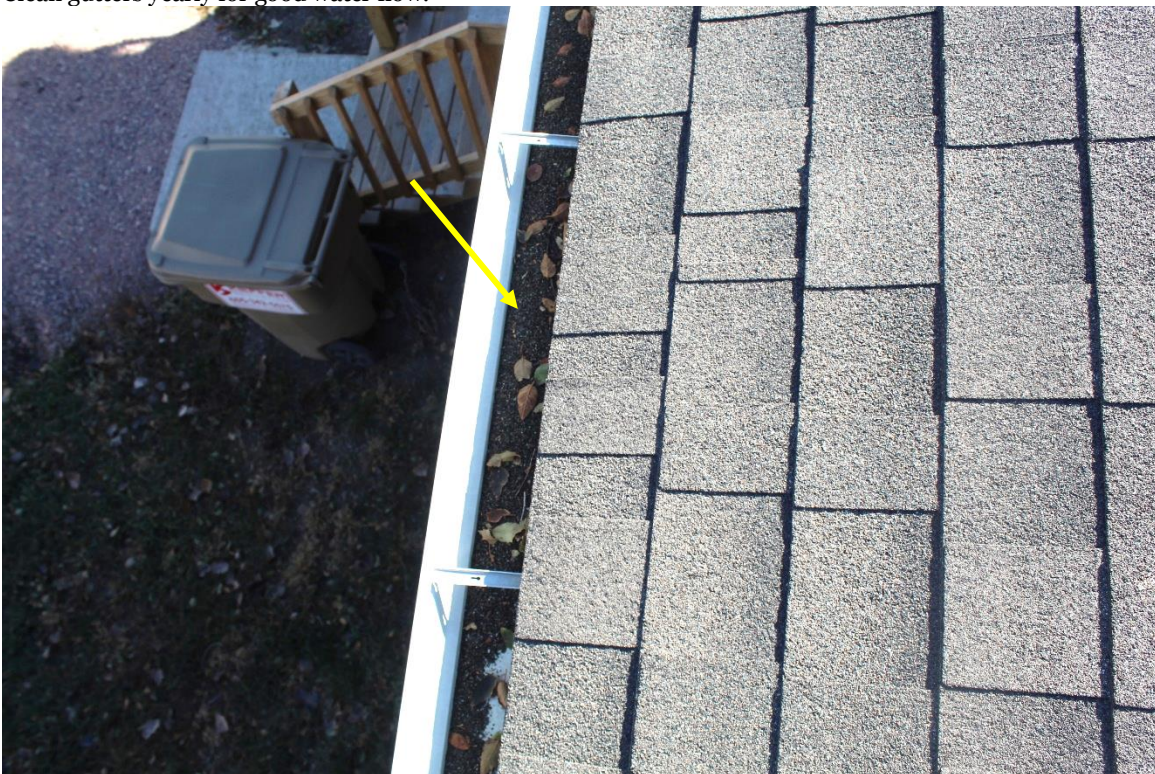
Clean gutters yearly for good water flow.

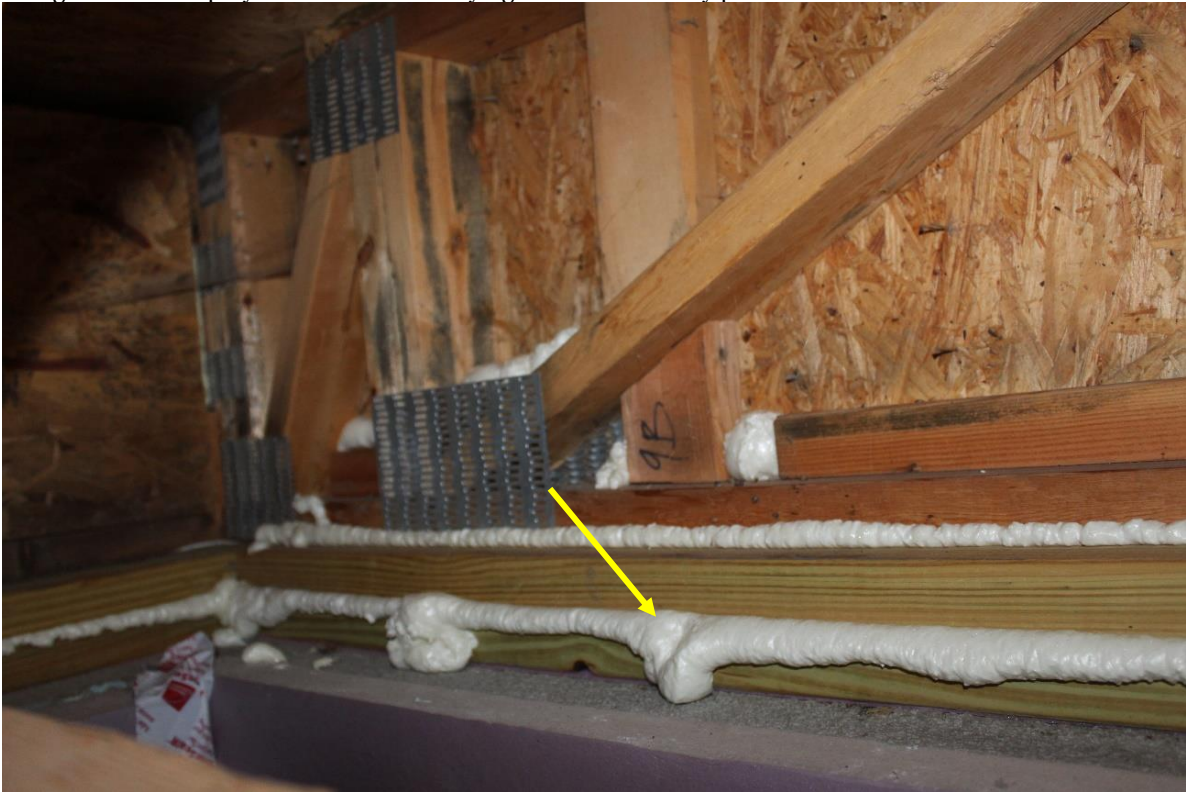
A large amount of spray foam was noticed trying to seal water entry points.

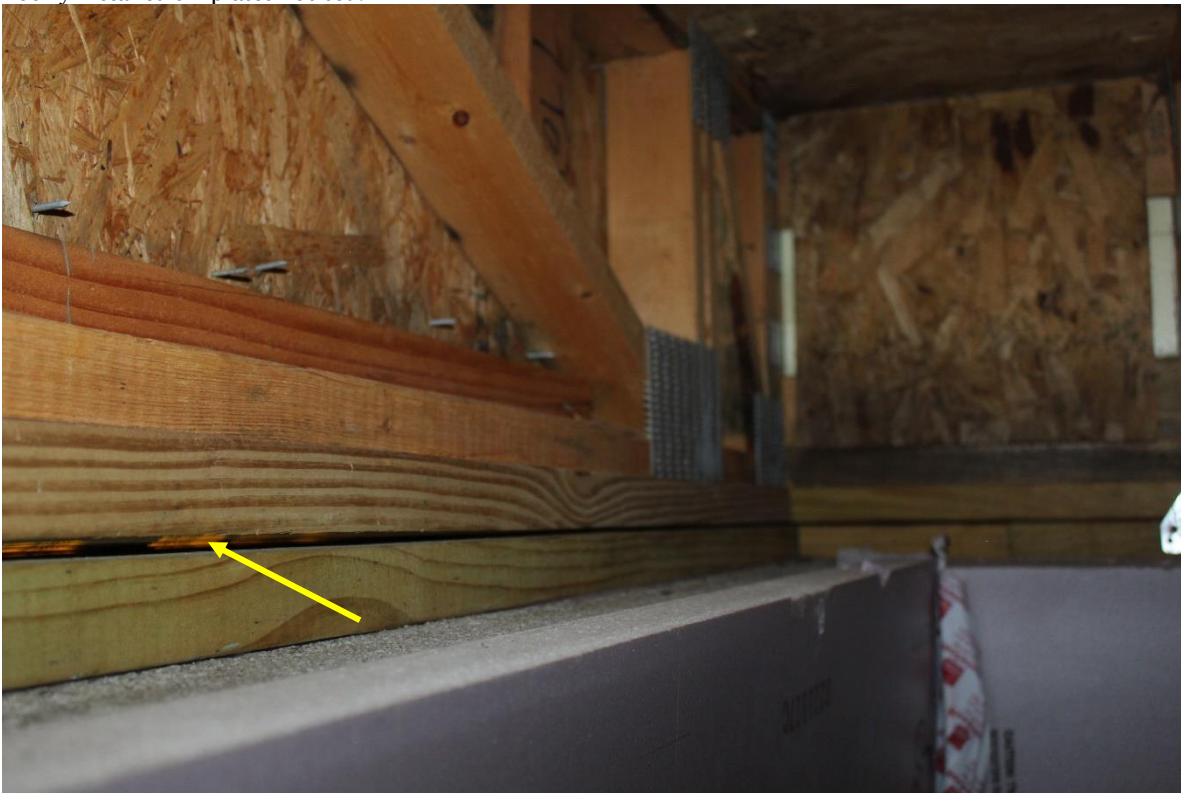
Poorly installed sill plates noticed.

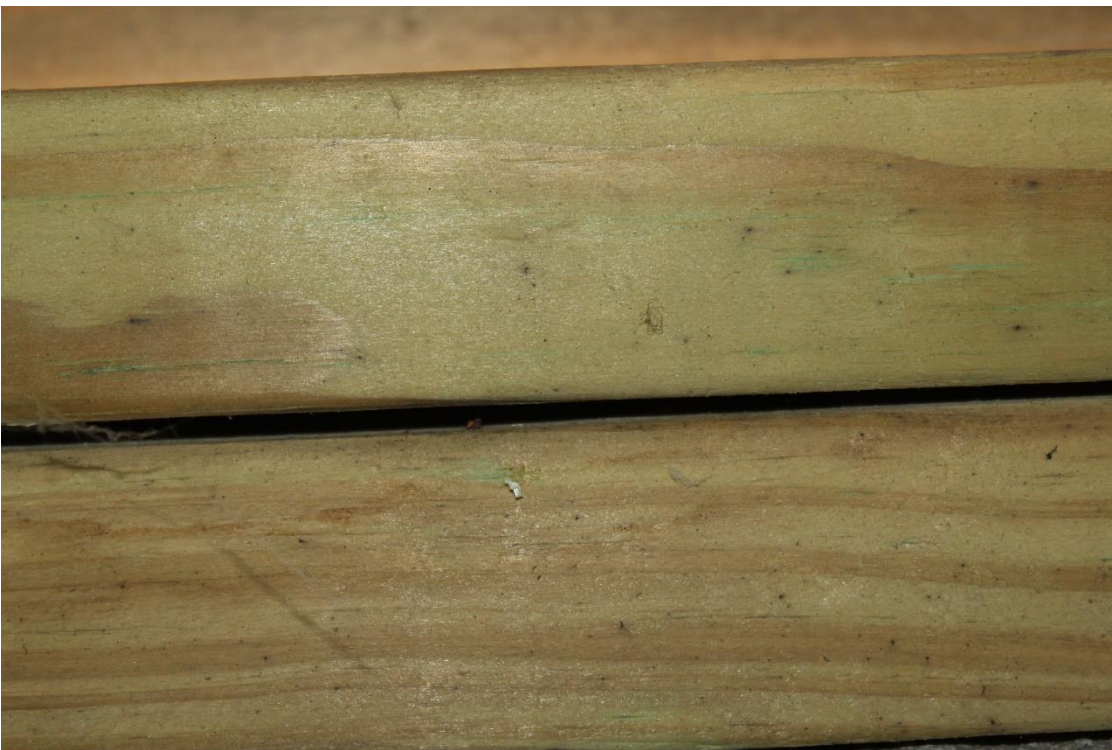
Large gaps noticed in the seal plates, the anchor bolts were not recessed into the top plate and prevented the plates from sealing.

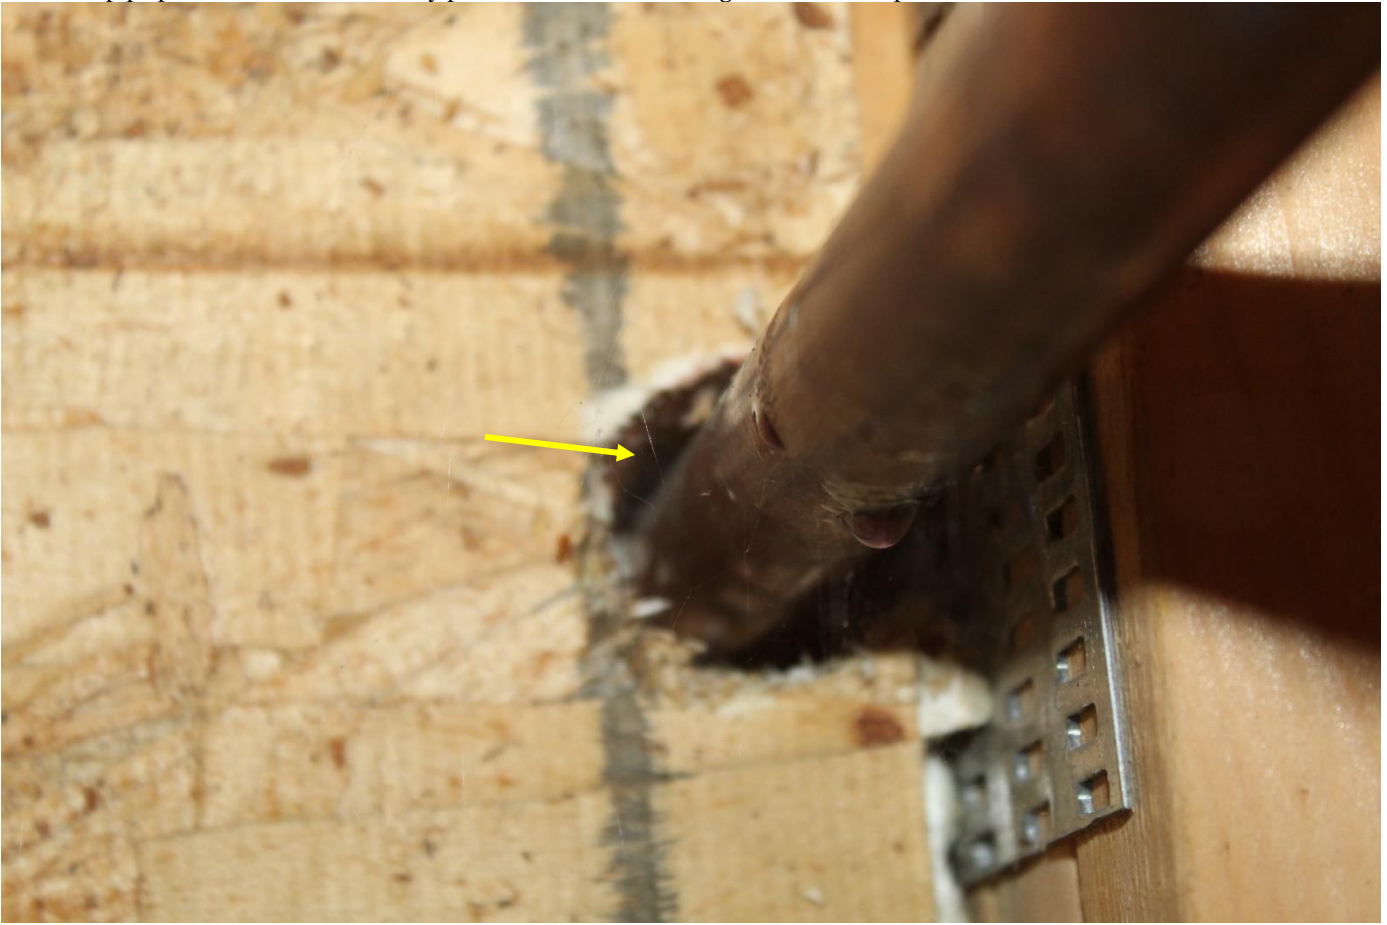
Unsealed pipe penetrations & water entry points were noticed throughout the crawlspace.

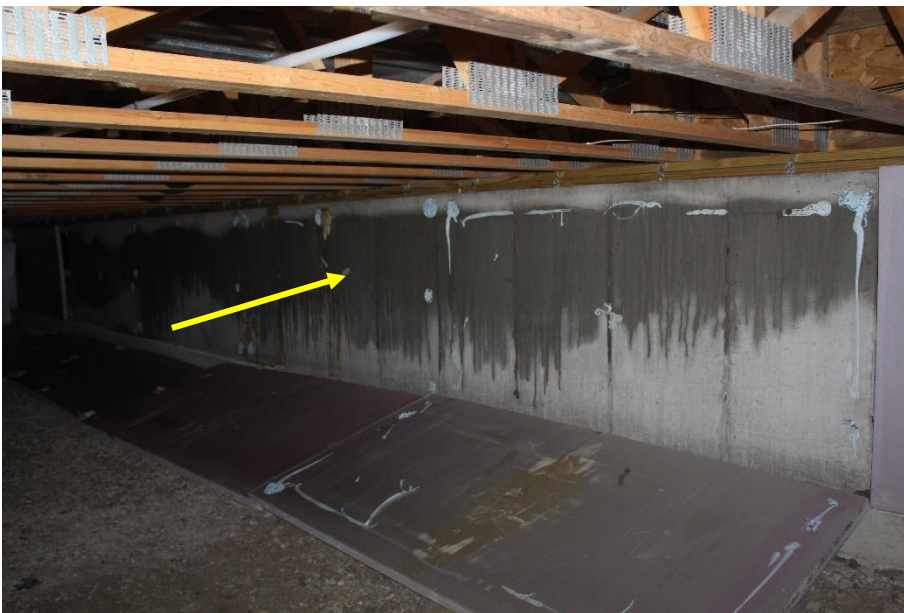
Water intrusion noticed on the foundation walls behind the insulation panels.

I recommend correcting the siding installation to prevent further water intrusion into the crawlspace, and highly recommend installing ventilation in the crawlspace as soon as possible to help relieve the moisture and condensation to prevent further mold issues. No ventilation was noticed in the crawlspace. The plans called for heat vents to be installed to make the crawlspace a conditioned area, no vents were noticed to be installed in the duct work at this time. High levels of moisture were noticed to be entering the crawlspace due to poorly installed siding, no venting, poor grading around the home and a lack of ventilation. I also noticed the exhaust from the heat recovery ventilator is not discharging condensation to the outside. All insulation panels should be removed help the concrete dry out, After the crawlspace has been dried out reinstall the insulation panels.

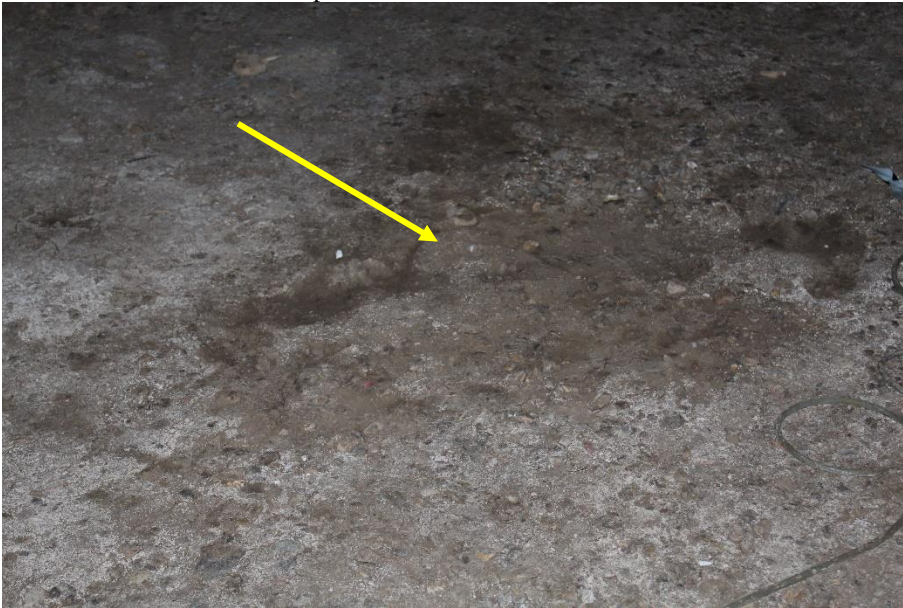
Wet soil noticed in the crawlspace.

I highly recommend installing a vapor barrier to the dirt floor in the crawl space after the moisture issues have been corrected and the area has been dried out. I do not recommend installing a vapor barrier until all water issues have been corrected and ventilation has been installed. You do not want to trap any moisture under the vapor barrier causing more mold issues. I also recommend treating the dirt floor and all wood areas for mold two or three times to kill all the mold within the crawlspace, I also recommend an air scrubber be set up in the crawl space to help remove mold spores from the air, and then do another air quality test after the crawl space has been dried out and treated for mold.

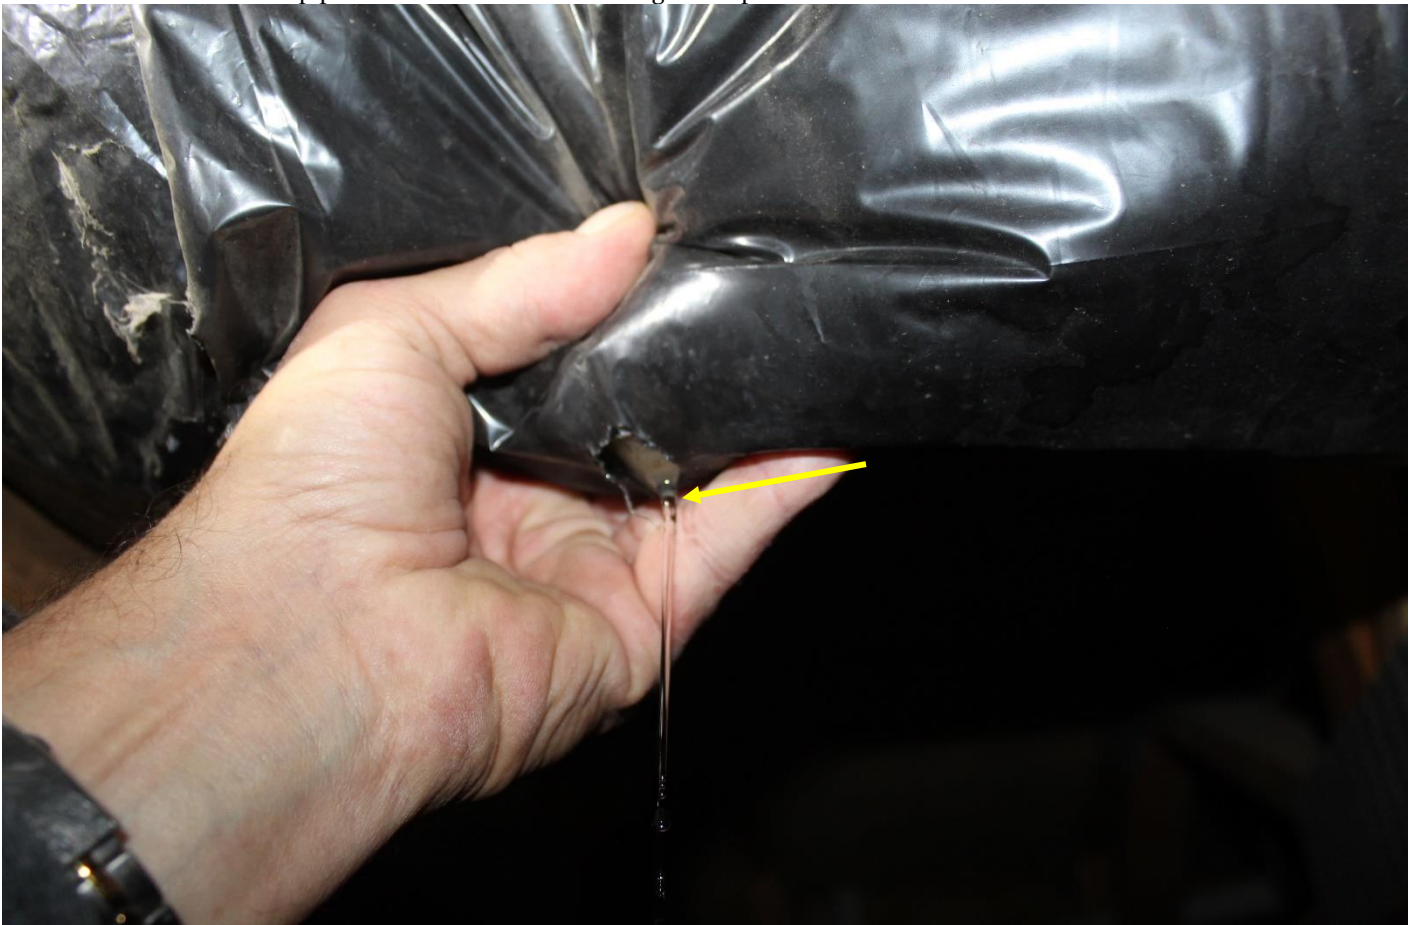
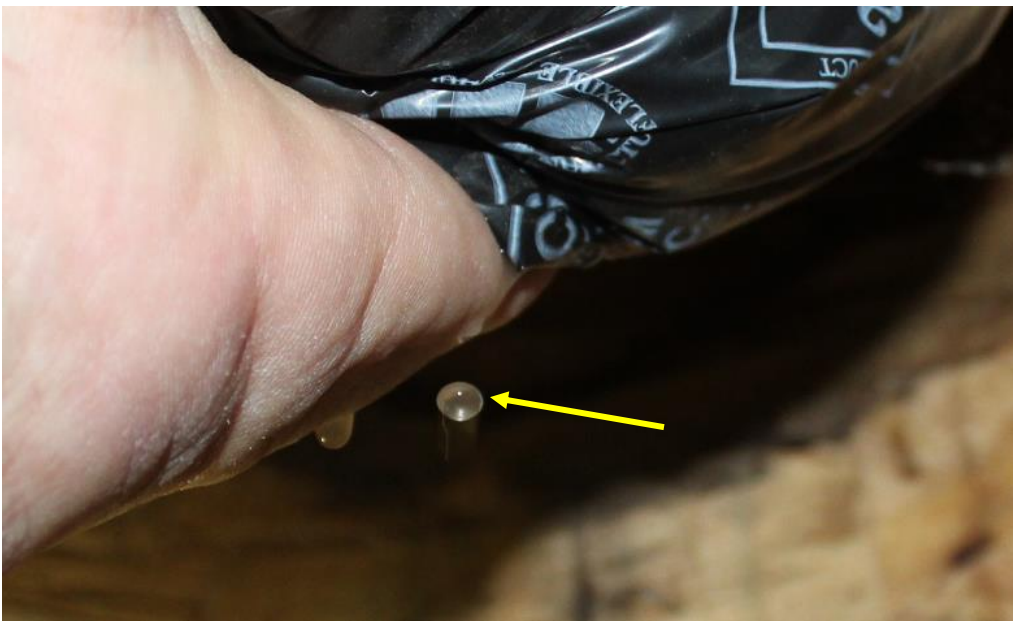
The exhaust pipe from the heat recovery ventilator is wrapped with insulation and is completely soaked with water contributing to the high moisture readings within the crawlspace. The insulation should be removed from around the ductwork and replaced to prevent further moisture damage & mold issues. The ductwork should be able to discharge the water to the outside without any obstructions causing the water to back up in the ductwork. The exterior hood appears to be preventing the water and water vapors from exiting the exhaust pipe causing water to back up in the pipe and back into the home.

Water soaked HRV exhaust pipe insulation was noticed during the inspection.

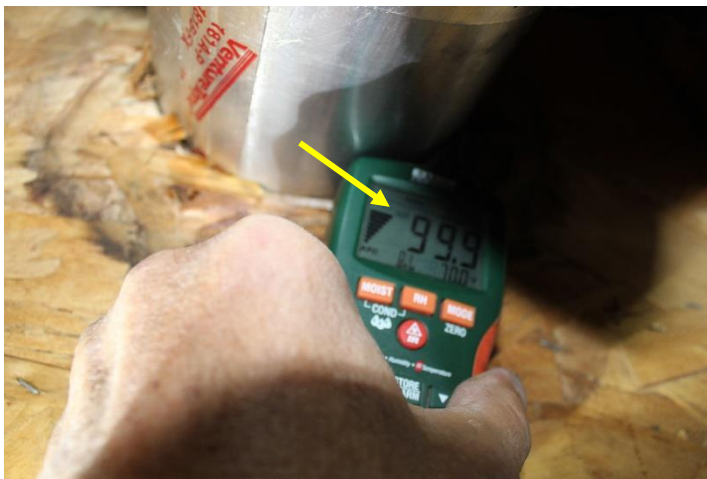
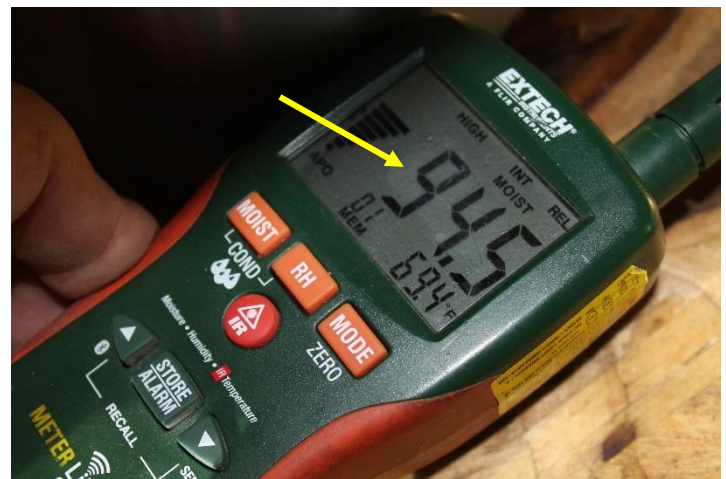
High moisture readings were taken & noticed within the crawlspace.

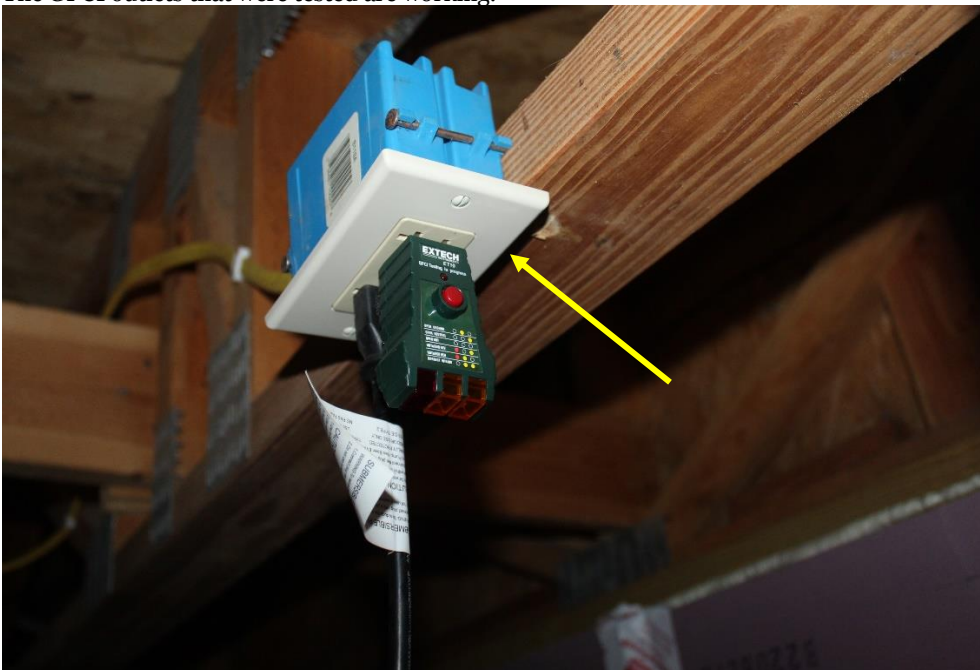
The GFCI outlets that were tested are working.
